**SUBJECT****One or Both Outside Mirror Turn Signals Do Not Operate****MODEL**

F15

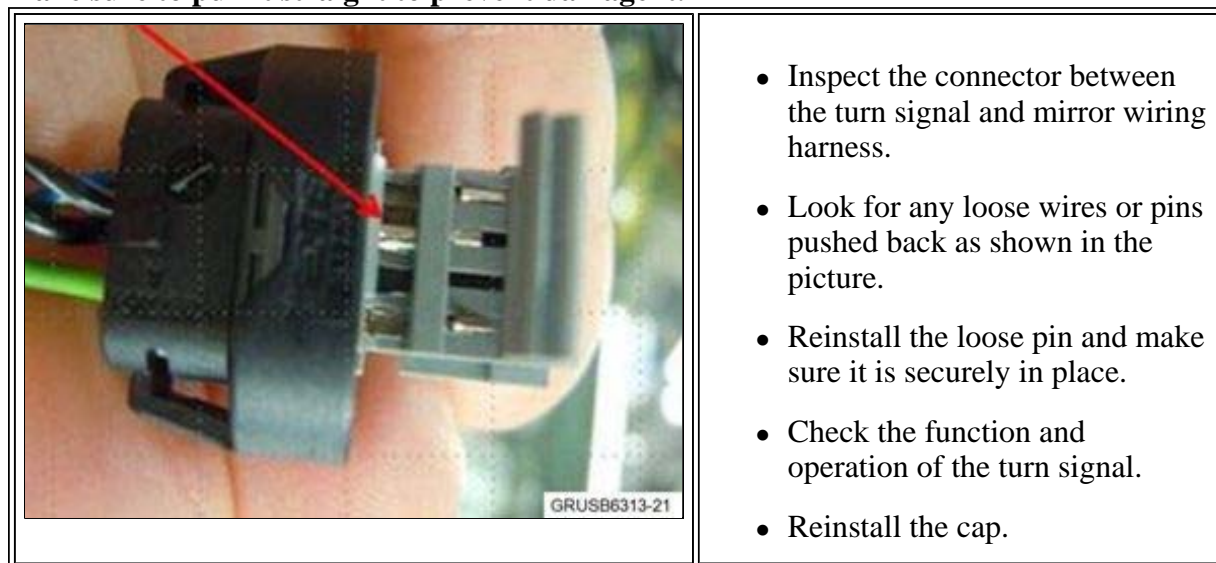
The outside mirror light assembly has a pin pushed back and makes a bad contact.

Remove the outer mirror painted cover cap. Refer to ISTA REP 51 16 041 "Removing and installing/replacing cover cap on left or right exterior mirror". **Caution: when removing the cap make sure to pull it straight to prevent damage it.**

If no trouble can be found with the pins and the problem is still present, replace the outside mirror assembly.
