This message is designed to help you determine if stock of P/N 72 11 0 303 879 is defective. Please use the follow pictures as a guide to determine if your stock needs to be returned. There will be a second message following this message to advise of the stock return process.

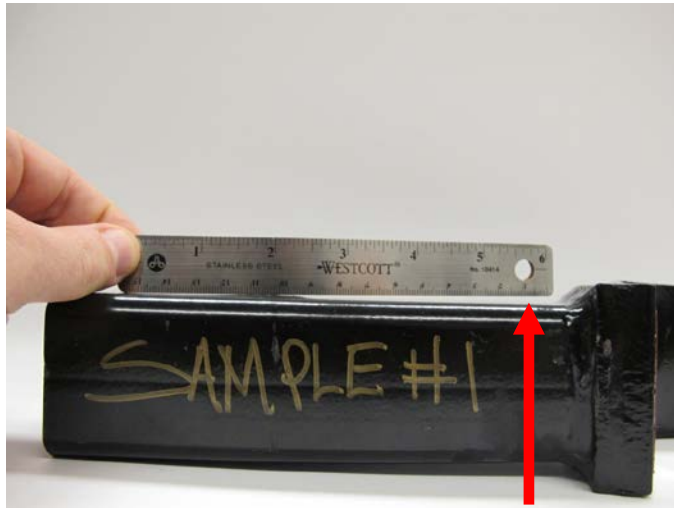
Using a straight edge, place along both sides of the unit where the hole for the retaining pin resides. As you can see below, there is an obvious dimple which may cause the ball mount to interfere with the NAS receiver. Please note the air gap between the straight edge and unit.

Picture 1: Example of defective unit

Please Note: IF EITHER SIDE OF THE BALL MOUNT is deformed, the unit will not fit in the NAS receiver and must be replaced. Good units should look like the below picture on both sides of the pin hole with zero air gaps along the length of the tube.

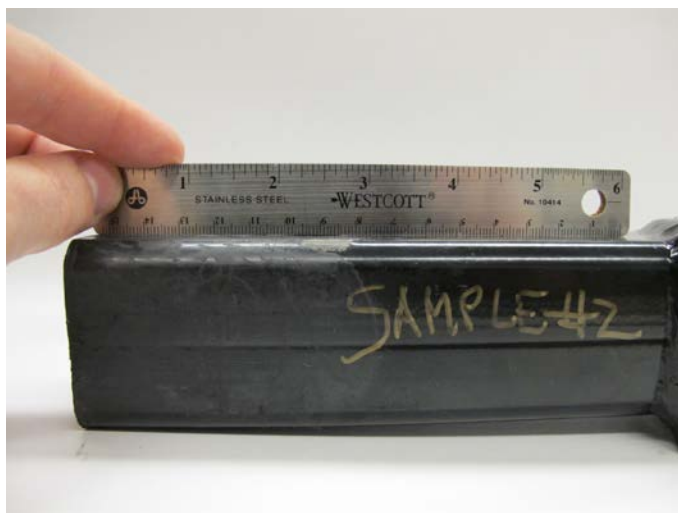
Picture 2: Example of unit with no deformity
