### Exhaust Leak on Diesel Particulate Filters

F30 (3 Series Sedan) 328d and 328xd

F31 (3 Series Sports Wagon) 328d and 328xd

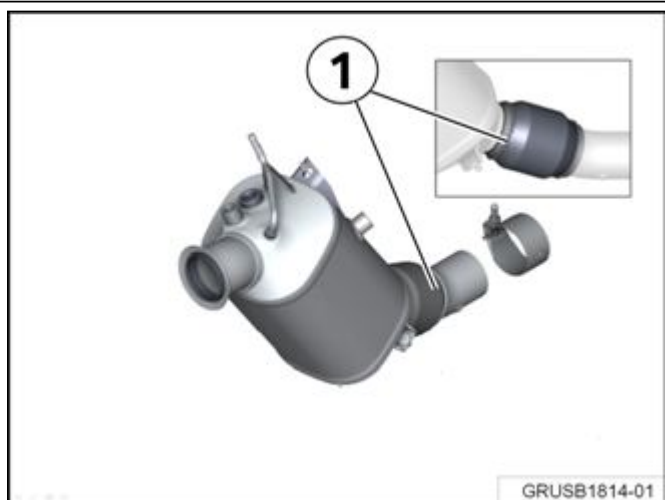
Current versions of ETK show the availability of the flexible coupling as a separate part (1).

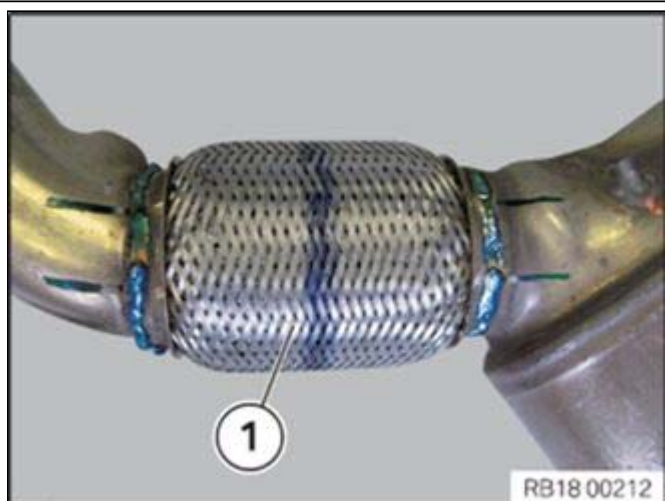
ISTA/D also has an associated repair procedure for replacing this flexible coupling (1). The repair involves removing the DPF; cutting out the old flexible coupling; and welding in the new part.

This repair option is available as a cost-effective alternative on a customer-pay basis.

The DPF must be replaced if this coupling leaks while the vehicle is still covered under warranty (no repairs to DPF).
