This Service Information bulletin supersedes SI 12 33 14 **dated December 2014.**

SUBJECT

Fault Code 1D2008 Stored in DME

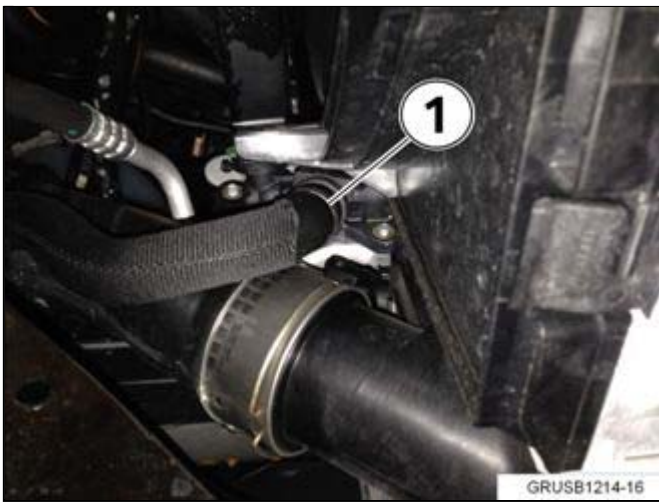
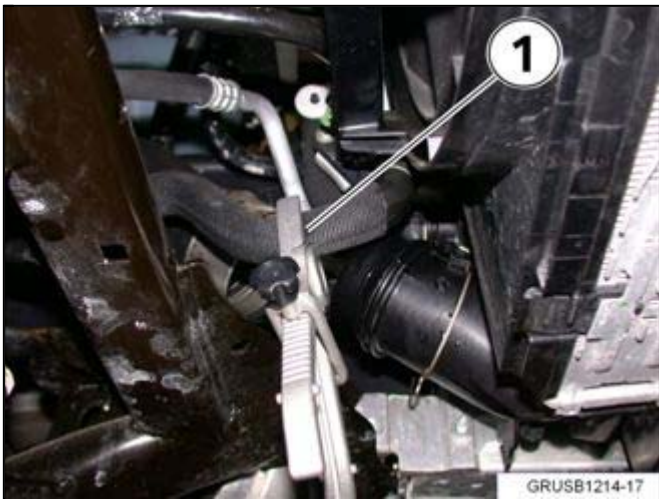
<p>Remove the front underbody protection panel (tightening torque of screws is 3Nm) to access the cooling lines to the transmission oil heat exchanger (1). (Note: All illustrations were taken on an F30 328xi N20).</p>
--	---

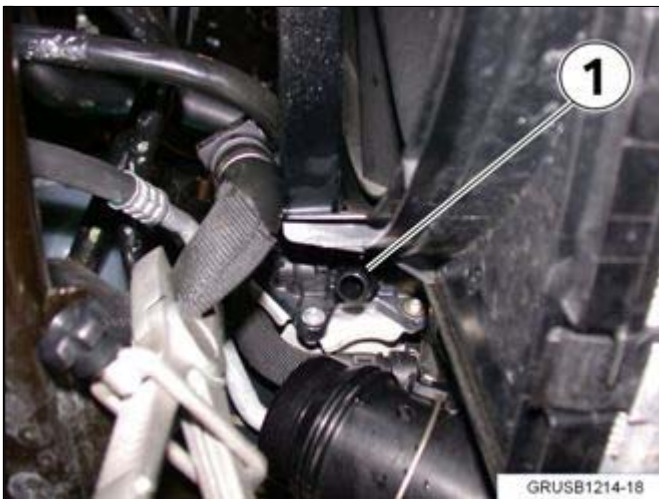
Clamp off the outflow hose (1) on the cooler with special tool 81 64 2 184 117 (SI [B04 07 11](#)). The outflow hose is the softer (rubber) of the two cooling lines on the heat exchanger.

After clamping, remove the outflow hose from the heat exchanger (1).

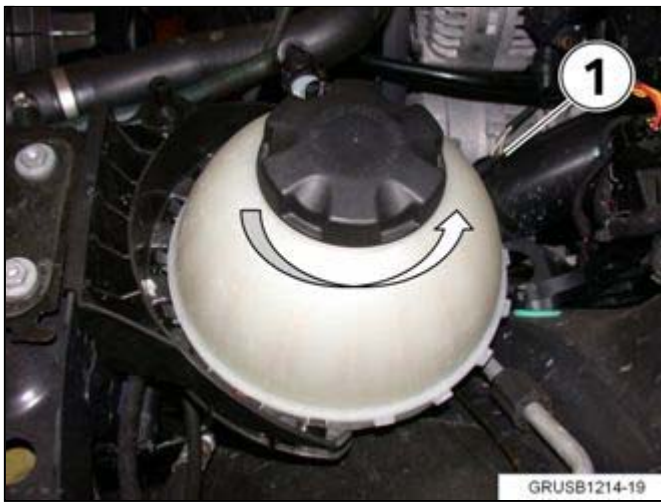
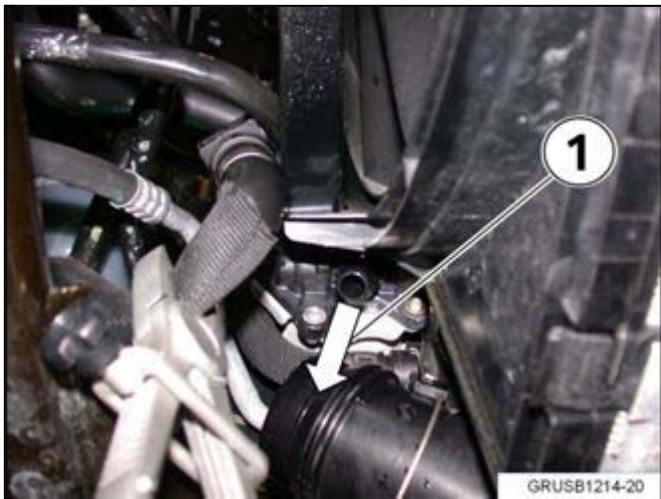
Loosen the cap on the coolant expansion tank (1).

If any coolant starts leaking out of the transmission heat exchanger (1), the internal thermostat is jammed and the heat exchanger will need to be replaced. Follow Repair Instruction RA 17 22 010, “Removing and installing/replacing transmission oil cooler for automatic transmission (N20, N26, N55).”

If there is **no coolant loss** out of the heat exchanger, replace the engine coolant thermostat.

Follow Repair Instruction RA 11 53 000, “Removing and installing/replacing coolant thermostat.”
