SUBJECT
Damage to Radiator when Removing Fan Cowl
MODEL

F56 (MINI Hardtop)

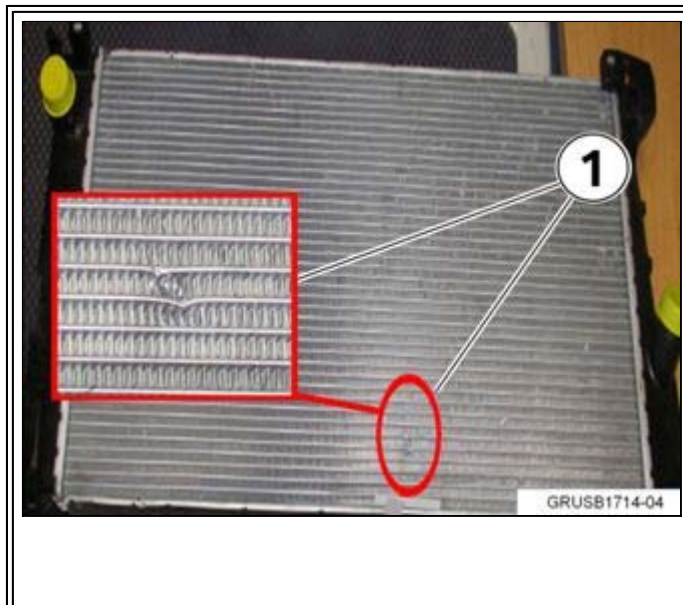
There is coolant leaking from the radiator after performing repairs where the fan cowl was removed.

Protruding parts or hose clamps come into contact with the radiator during fan cowl removal (1).
