This Service Information bulletin supersedes SI B51 14 13 **dated November 2013**.

### Rear License Plate Bracket: Seized Screws

All BMW models that use a rear plastic bracket to mount the license plate (tag)

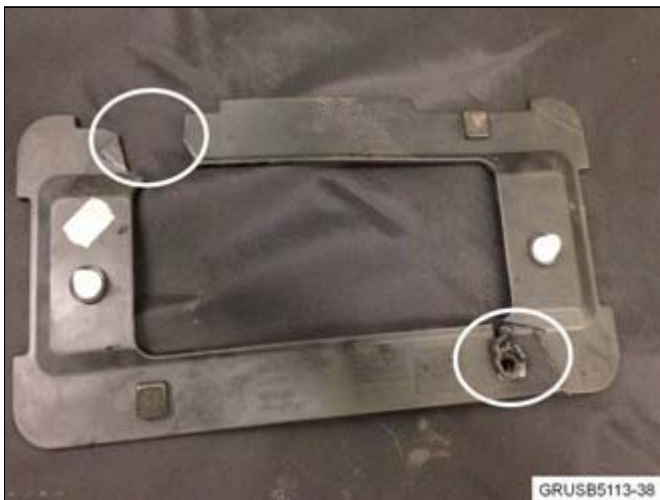
1. This picture shows a damaged plate bracket that was removed from a vehicle. In some cases, the seized screw will break the bracket, or the steel-threaded insert will spin in the plastic bracket. In this case, you can try using your power screwdriver and spin the screw and insert while pulling up on the license plate, until the insert breaks free from the bracket. Use this procedure if the tag needs to be reused.

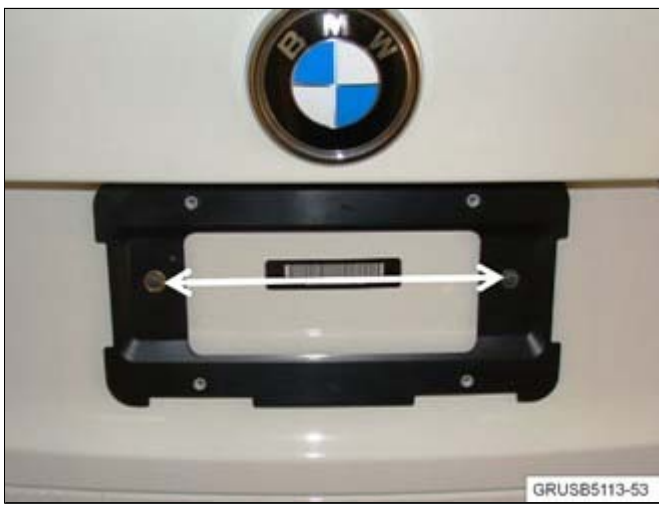
2. Caution must be used when removing a seized bracket. This picture shows the two attaching screws holding the bracket to the trunk lid (plate removed for clarity). No attempt should be made to pry the bracket from the

body without removing these two screws, because the trunk lid will be slightly damaged. **If no other procedure works, see step 4.**

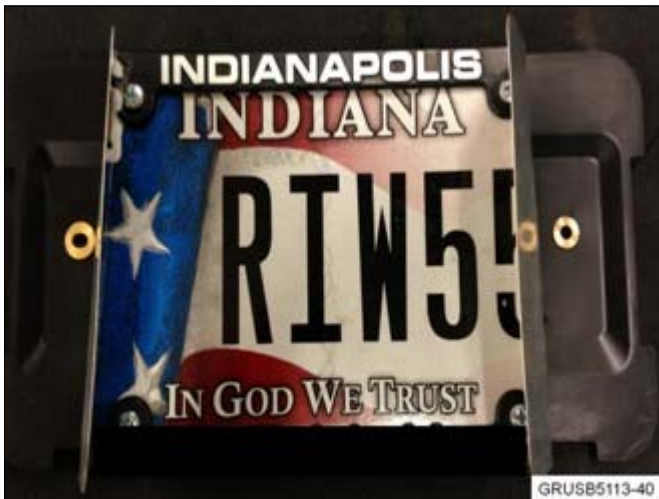
3. If the tag is being discarded, you can bend up the left and right sides of the tag to gain access to the two screws securing the bracket and remove it; then discard the complete assembly. If it has a plastic frame, this will also be broken in the process.

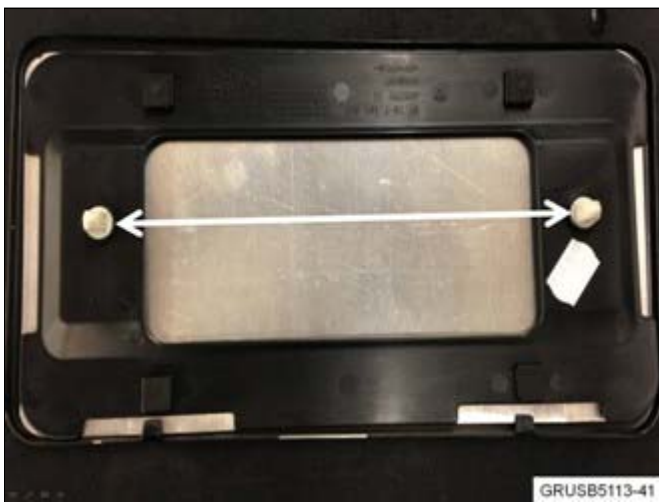
4. If the tag has a metal plate frame and no other procedure was successful, you can grasp the left and right sides of the frame and firmly pull the whole assembly from the lid. This procedure will break the two white clips and could slightly mushroom up the two holes in the metal lid. If this occurs, use a plastic or rubber hammer to work the body panel back down to the original height.

Use the appropriate method (drill out, air tool, vise, grinder, etc.) to remove the seized screws from the customer's license plate, and then install a new bracket to the lid.

**In all cases, when installing a tag, use four new screws with a small amount of anti-seize compound to prevent future seizing.**
