This Service Information bulletin supersedes SI B51 16 13 **dated November 2013.**

Bang & Olufsen Sound System: Loudspeaker Cover Rattles

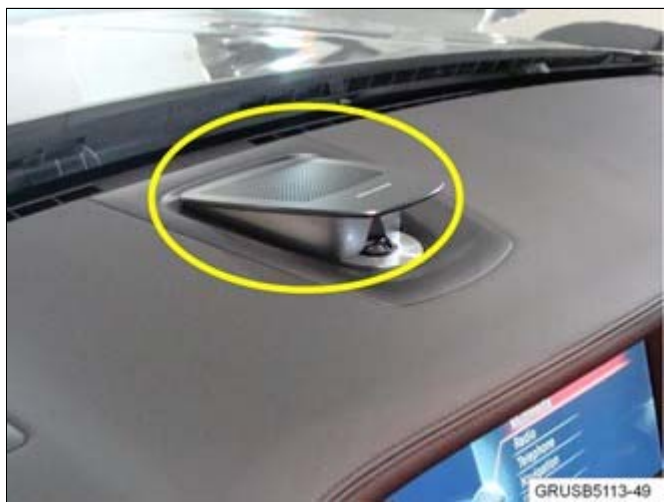
The top center loudspeaker cover rattles when driving on rough roads.

Poor loudspeaker cover fitment to the speaker assembly

Road test the vehicle on a rough road and confirm the noise is coming from the center speaker.

If the speaker cover rattles, it must be replaced.

<p>Use ISTA Repair Instruction 65 13 052 to remove the loudspeaker cover from the speaker.</p>
--
