US 58253615-01

Loose screw by starter

**Vehicles affected****E series**

K50 K51 K52

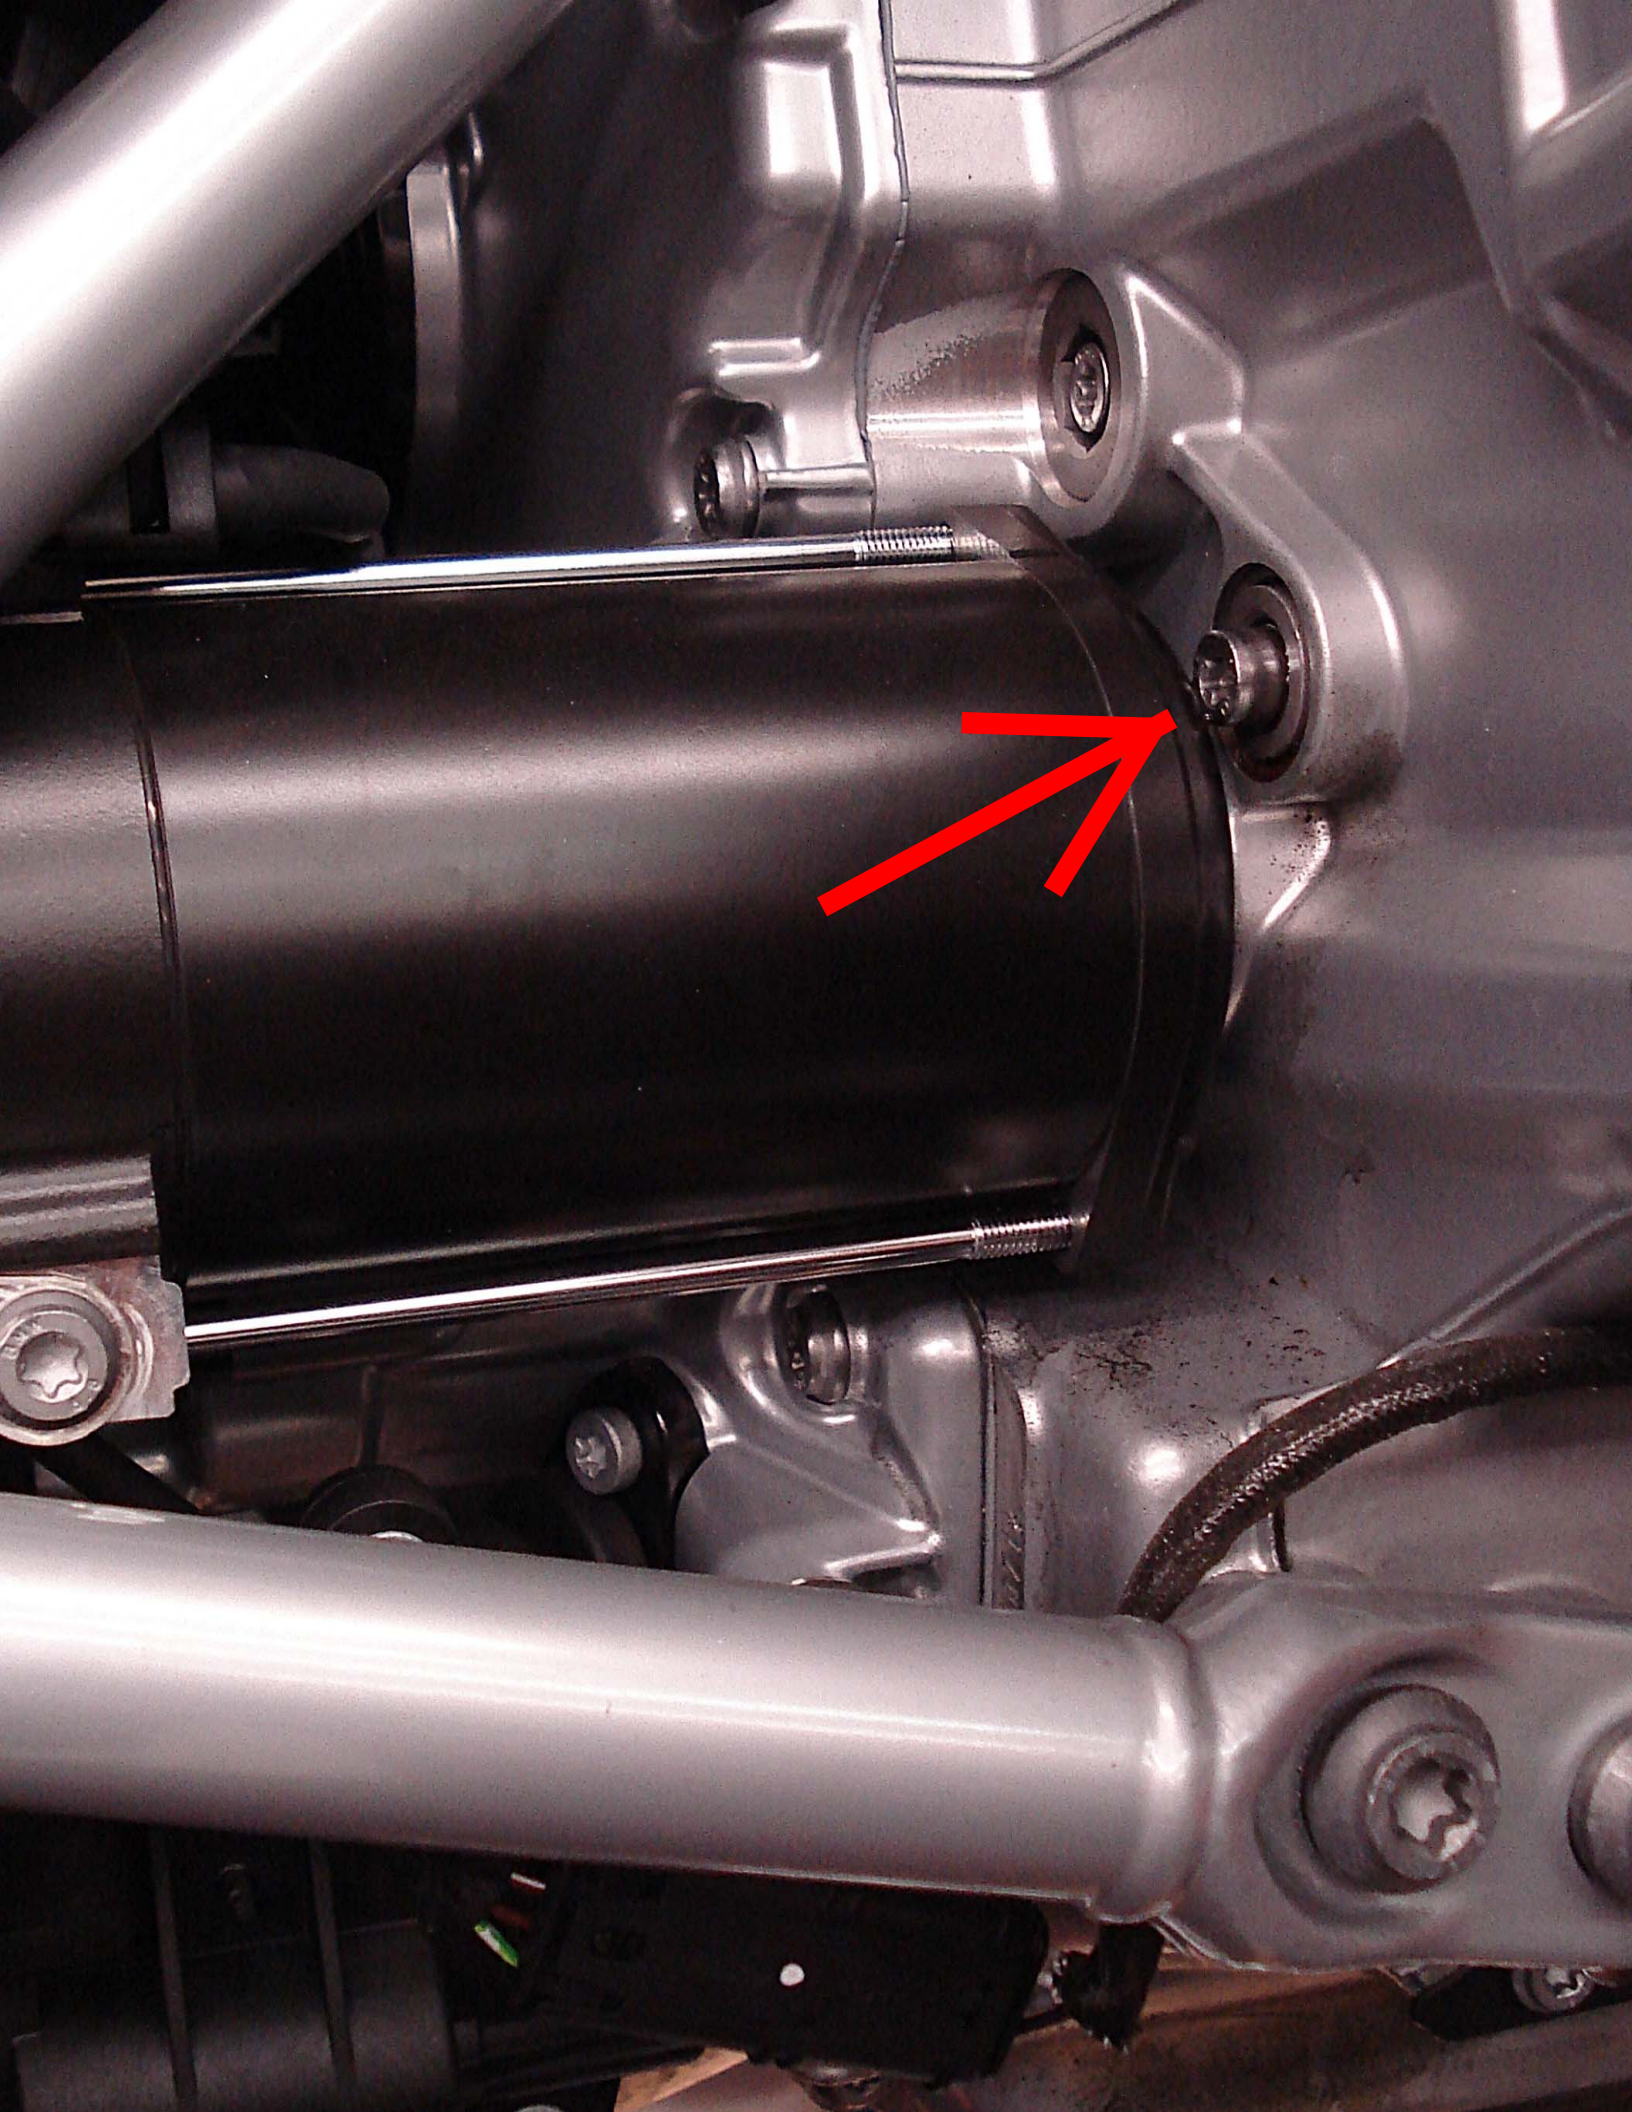
The screw for the starter double wheel is loose (see 1st picture).

Remove the screw, be sure NOT to remove the starter

double wheel axle (item #3 in 2nd picture), apply

Loctite 248 to the screw and tighten to 8 Nm
