**SUBJECT****Transportation Protective Sleeve Introduced for Windshield Wipers****MODEL**

R55 (Cooper Clubman)

R55 (Cooper S Clubman)

R57 (Cooper Convertible)

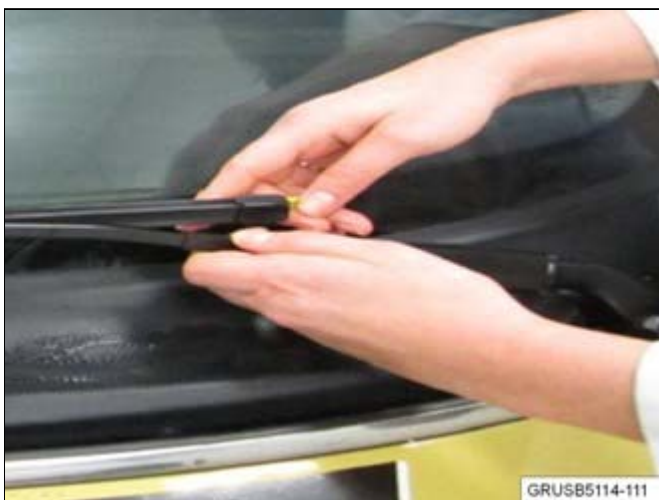
1. To remove the sleeve, slightly lift the wiper blade off the windshield glass.

Note: Do not use any tools. Always slide the sleeve by hand outwards in a straight line. Do not bend the wiper blade or sleeve.

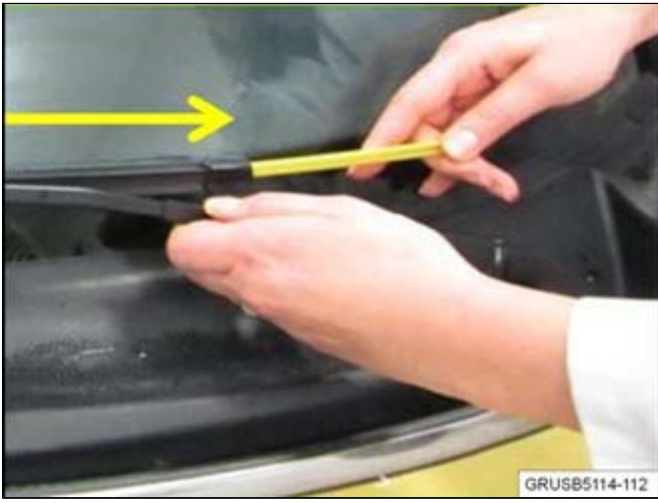
2. Grasp the end of the sleeve by hand and pull outward in a straight direction until fully removed. Repeat the same procedure for the opposite side, and then discard the sleeves.
