Luggage Compartment Open: Check Control Message Displayed

F22 (2 Series Coupe)

F23 (2 Series Convertible)

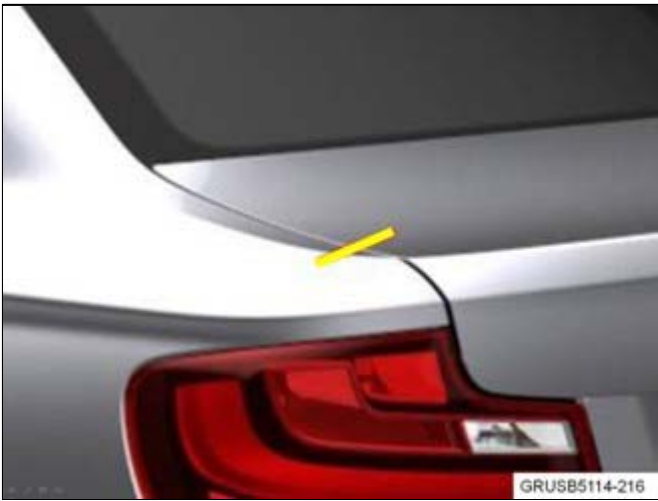
<ol style="list-style-type: none"> 1. Adjust the luggage compartment lid locking latch lower to allow activation of the micro switch.

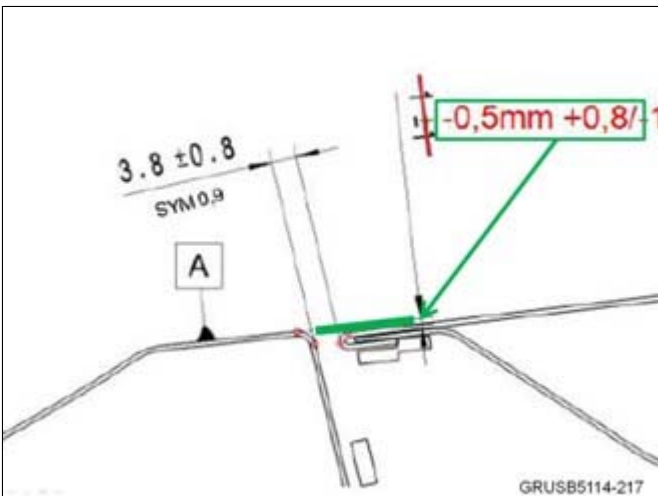
<ol style="list-style-type: none"> 2. In the illustration, the letter A is the rear quarter panel and the other panel is the luggage compartment lid. Adjust the lid locking latch to lower the lid 0.5mm below the quarter panel (A). <p>After adjustments are made, confirm the CCM is out. Also, for the F23, test for proper convertible top opening and</p>

closing.
