Impeded actuation of backrest release of 2nd seat row

Topic number	LI91.12-P-059378
Version	1
Design group	91.12 Rear seats
Date	07-09-2014
Validity	All vehicles of model series X164 up to VIN end number #A268285 Only affects vehicle with SA code - S845 - electrically folding 3rd seat row - S847- 3rd seat row, with folding individual seats
Reason for change	Text adapted and damage code updated
Reason for block

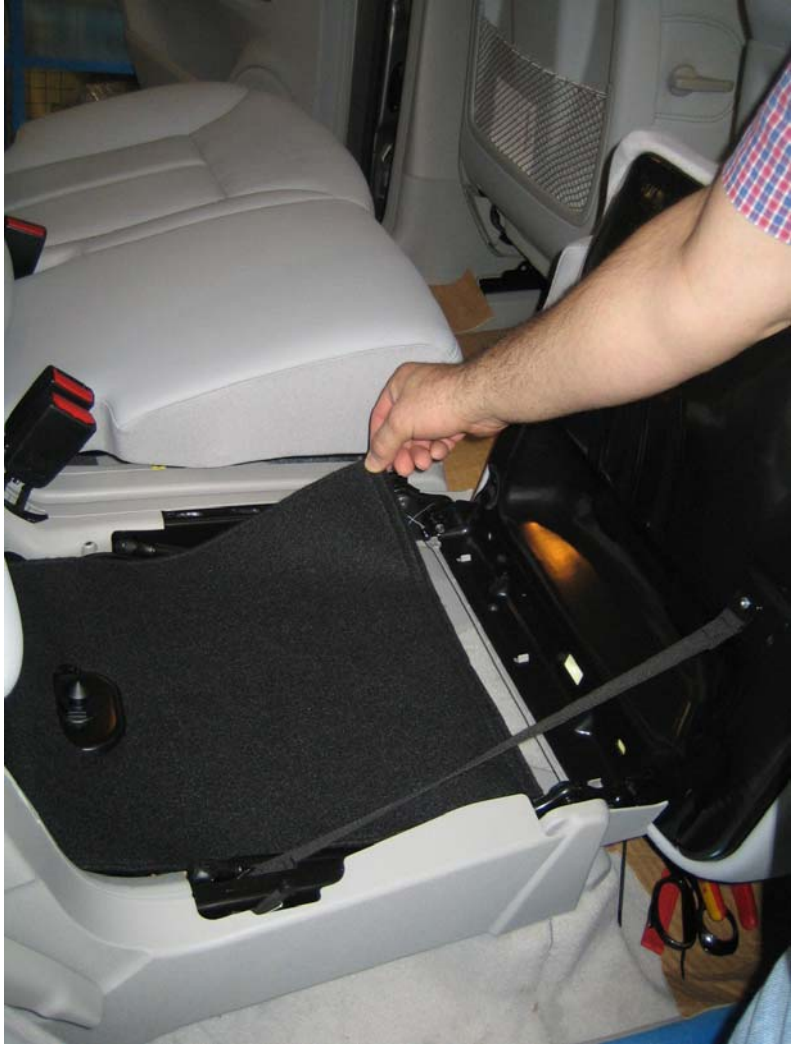
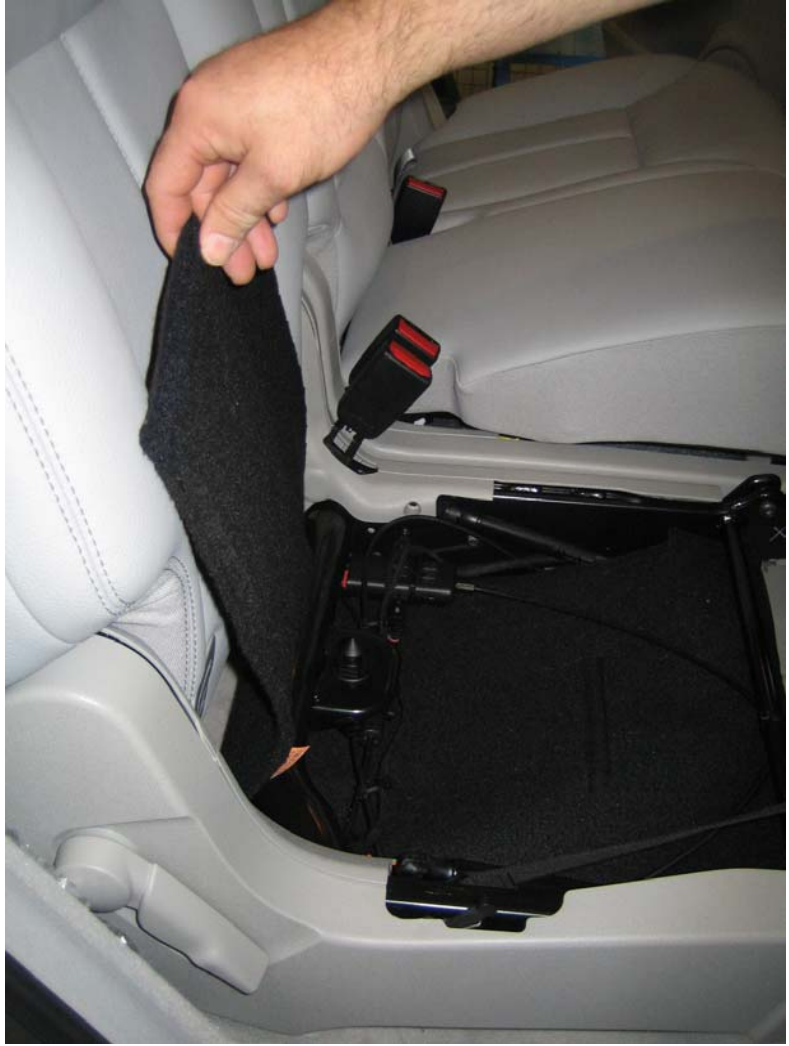
Attachments	
File	Description
Bild 1_ Entfernen Nadelfilz Teppich.pdf	Remove compressed felt carpeting

1. Remove compressed felt carpeting under seat cushion to gain access to attachment point (picture 1)
2. Cut cable tie and remove cover (picture 2).
3. Detach Bowden cable and pull loop out of guide (picture 3).
4. Cut loop in area of Bowden cable using scissors (picture 4).
5. Thread Bowden cable into the new flexible loop (A164 920 08 72). (Figure 5)
6. Push loop through guide and clip Bowden cable into the area provided. (Figure 6)
7. Clip cover back in at the points provided. Use a cable tie to secure the two components (Figure 7).
8. Install in the reverse order. Install compressed felt, making sure that the locking pin for the cushion shell is not covered by the felt.

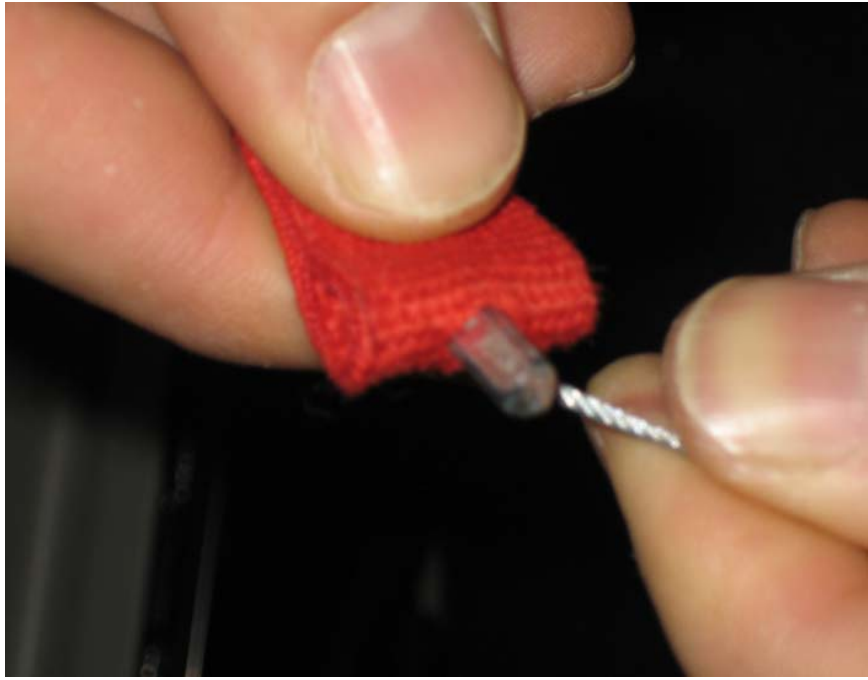
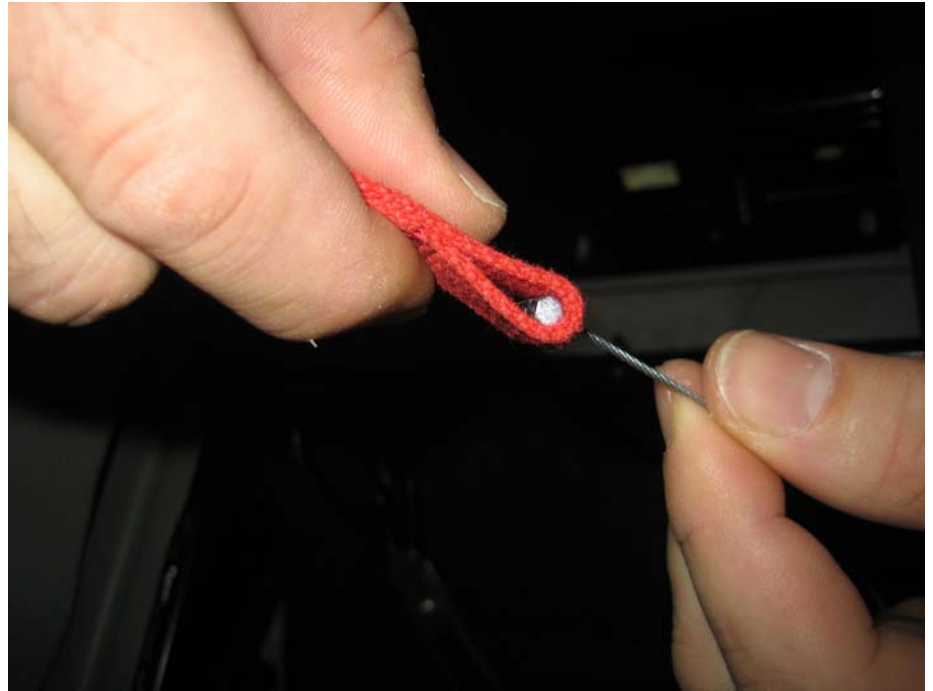
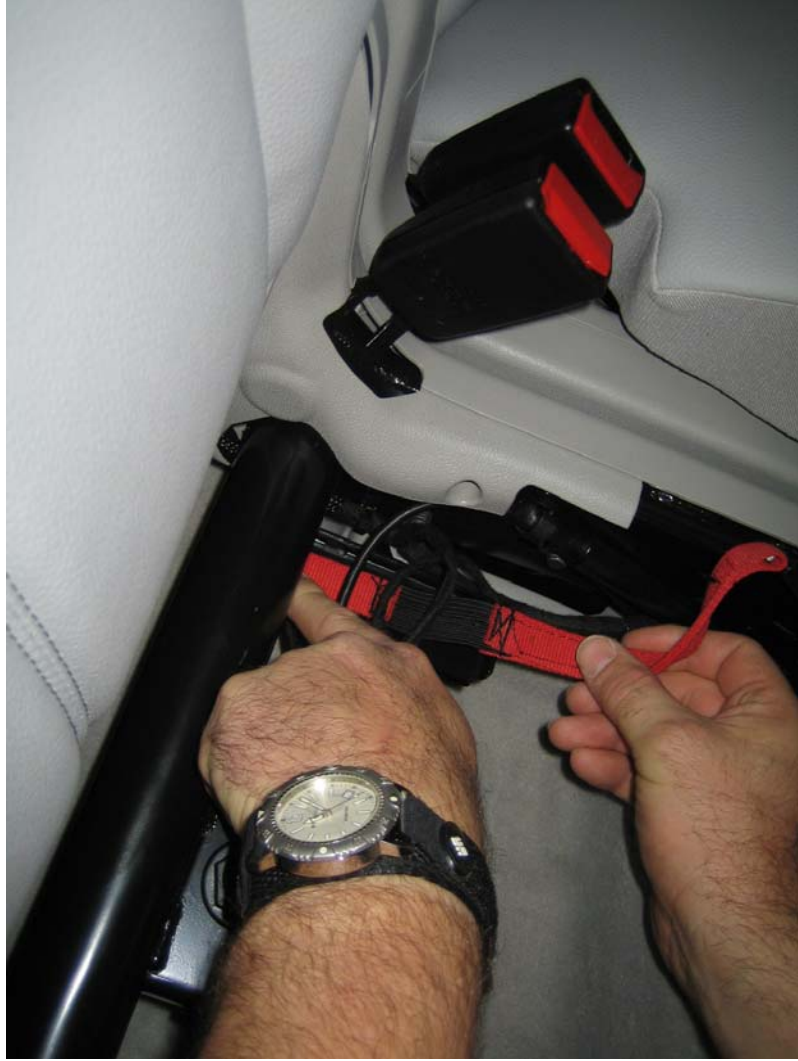
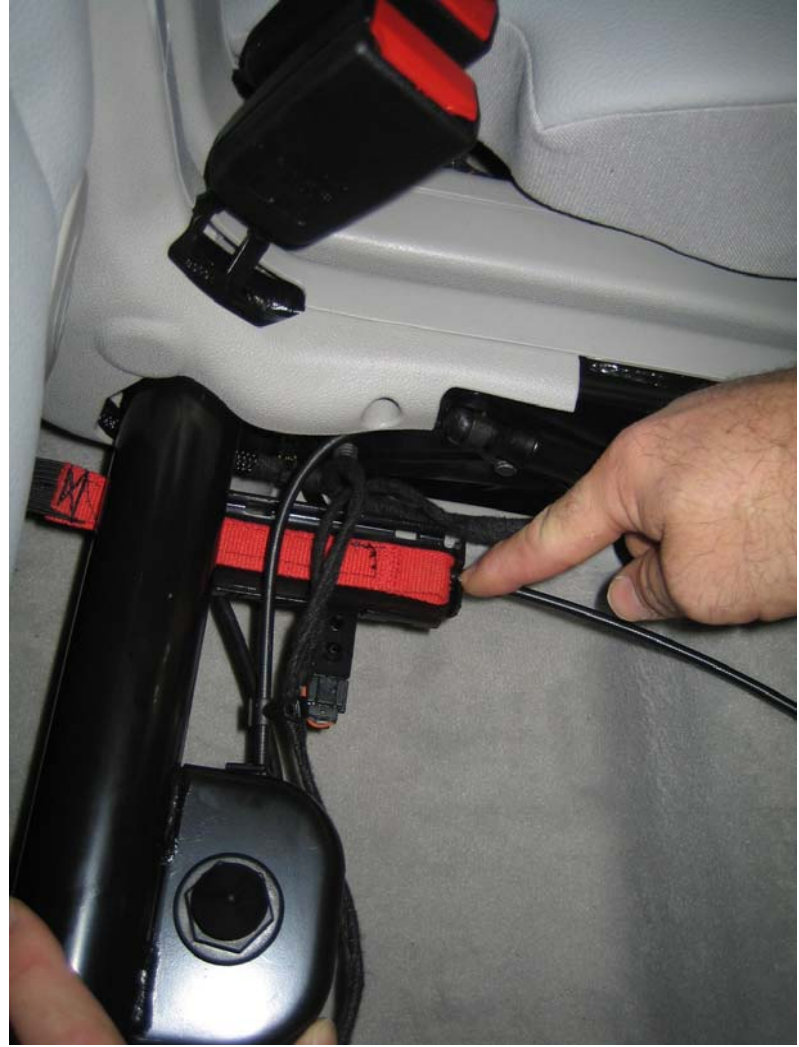
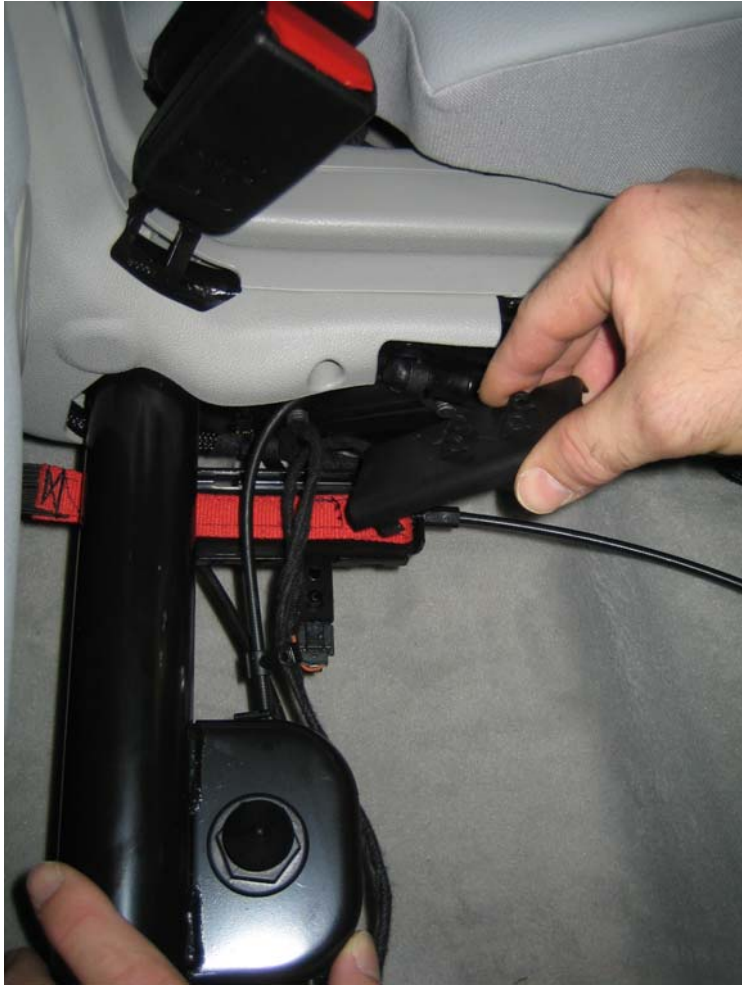
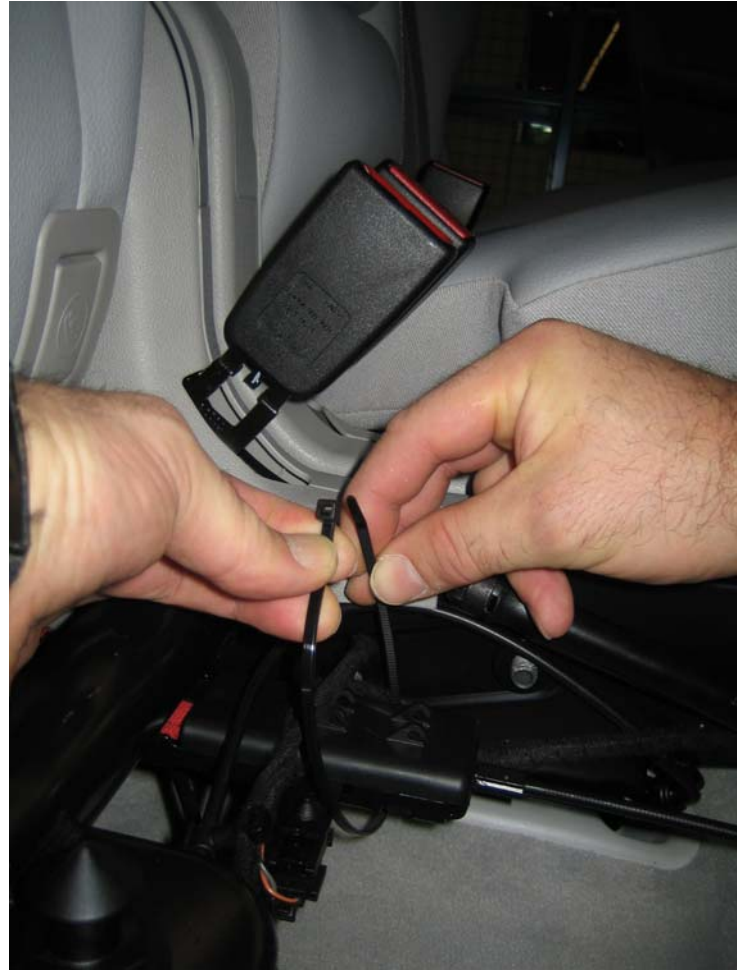
The release loop of the Easy Entry seat in the 2nd seat row is awkward to operate as it is difficult to access

As the loop is partly under the seat cushion, is rigid and its length cannot be extended, it may be necessary to adopt an awkward posture for a short time in order to release the Easy Entry seat, which makes it difficult to operate.

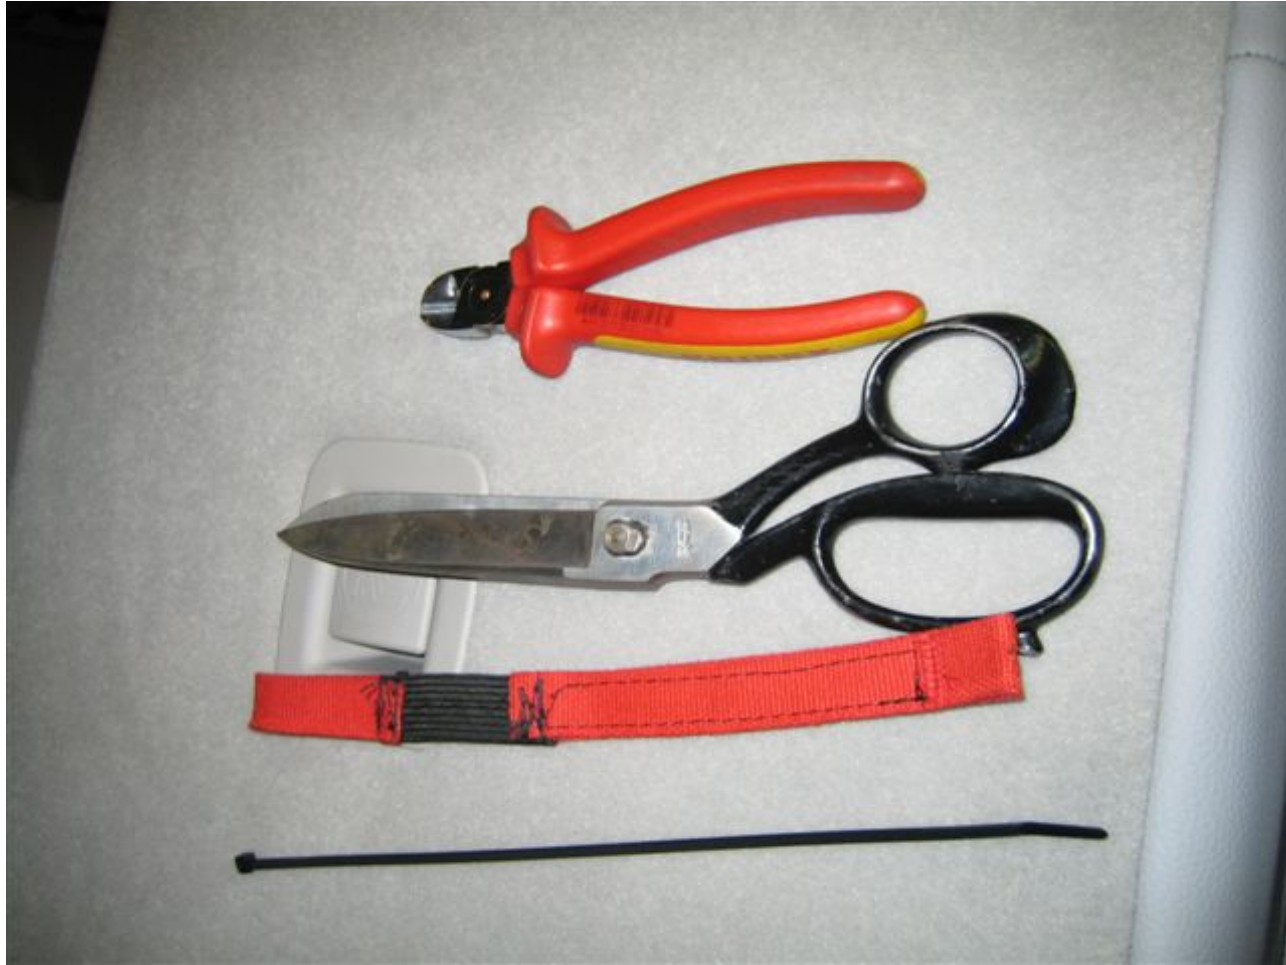
Bild 2_ Kabelbinder.pdf	Cut cable tie and remove cover
Bild 3_ Bowdenzug und Schlaufe.pdf	Detach Bowden cable and pull out loop
Bild 4_ Schlaufe.pdf	Cut loop
Bild 5_ Bowdenzug.pdf	Thread Bowden cable into new loop
Bild 6_ Verbau.pdf	Push loop through guide and clip in Bowden cable
Bild 7_ Fixierung mit Kabelbinder.pdf	Fix using cable tie
Werkzeug.pdf	Required tools
