Airscarf nonfunctional.

Topic number	LI91.29-P-059366
Version	1
Design group	91.29 Seats - electrical system
Date	07-10-2014
Validity	Model series 230 with SA code 403 (AIRSCARF system)
Reason for change	Damage code, part number and WIS reference added, description of remedy updated
Reason for block

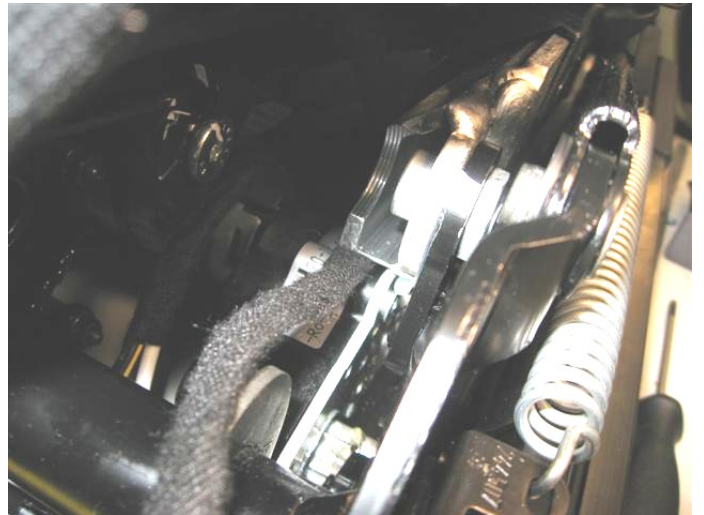
Sitz 004 _Small_.jpg:

The electrical wiring harness is trapped between the height adjustment gearing and the cushion frame.

Attachments	
File	Description
Sitz 004 _Small_.jpg	Damage profile

Check the electrical wiring harness for damage (see Sitz 004 _Small_.jpg) and repair if necessary.

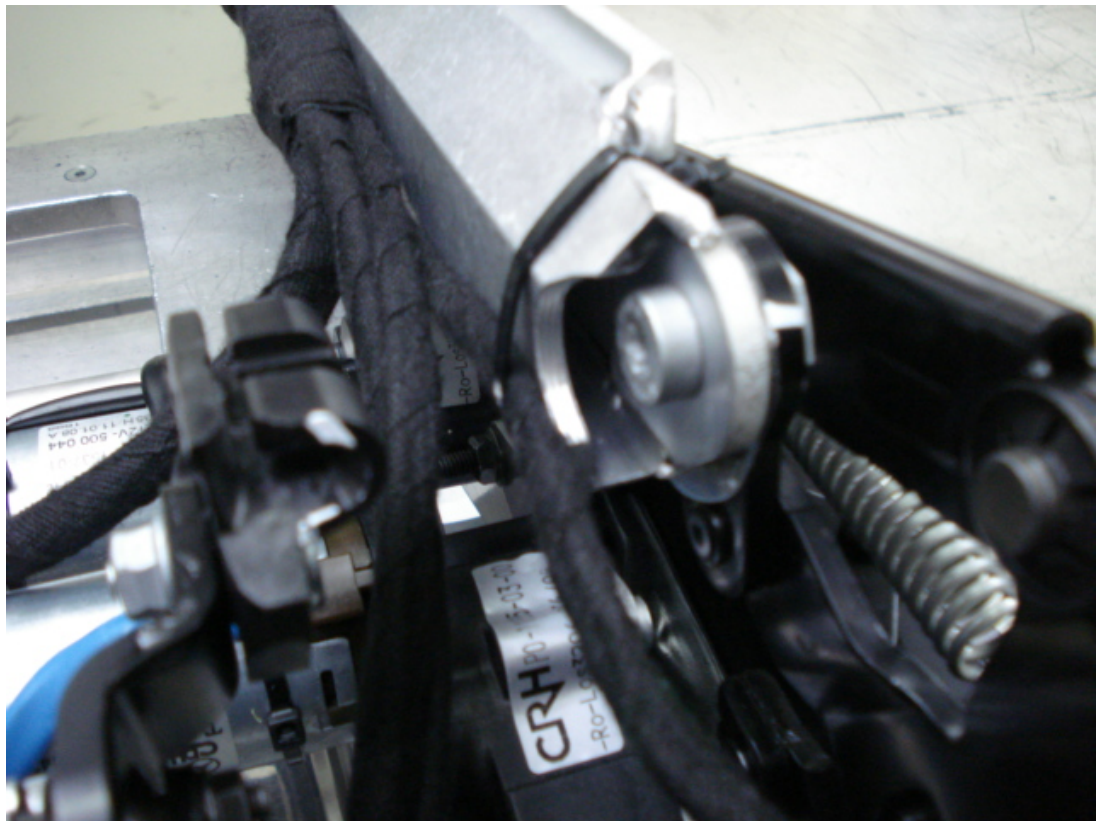
Abhilfe.jpg:

Attachments	
File	Description
Abhilfe.jpg	Remedy for attachment of wiring harness using cable ties

Then secure the electrical wiring harness using additional cable ties (see Abhilfe.jpg).
