Noise from active multicontour backrest with seat ventilation switched on

Topic number	LI91.30-P-048290
Version	2
Design group	91.30 Seat heater, seat ventilation
Date	07-12-2014
Validity	Model series 221 as of model refinement package with seat ventilation (401) and DS (432) up to production date 22.09.2009
Reason for change	Damage code and part number added
Reason for block

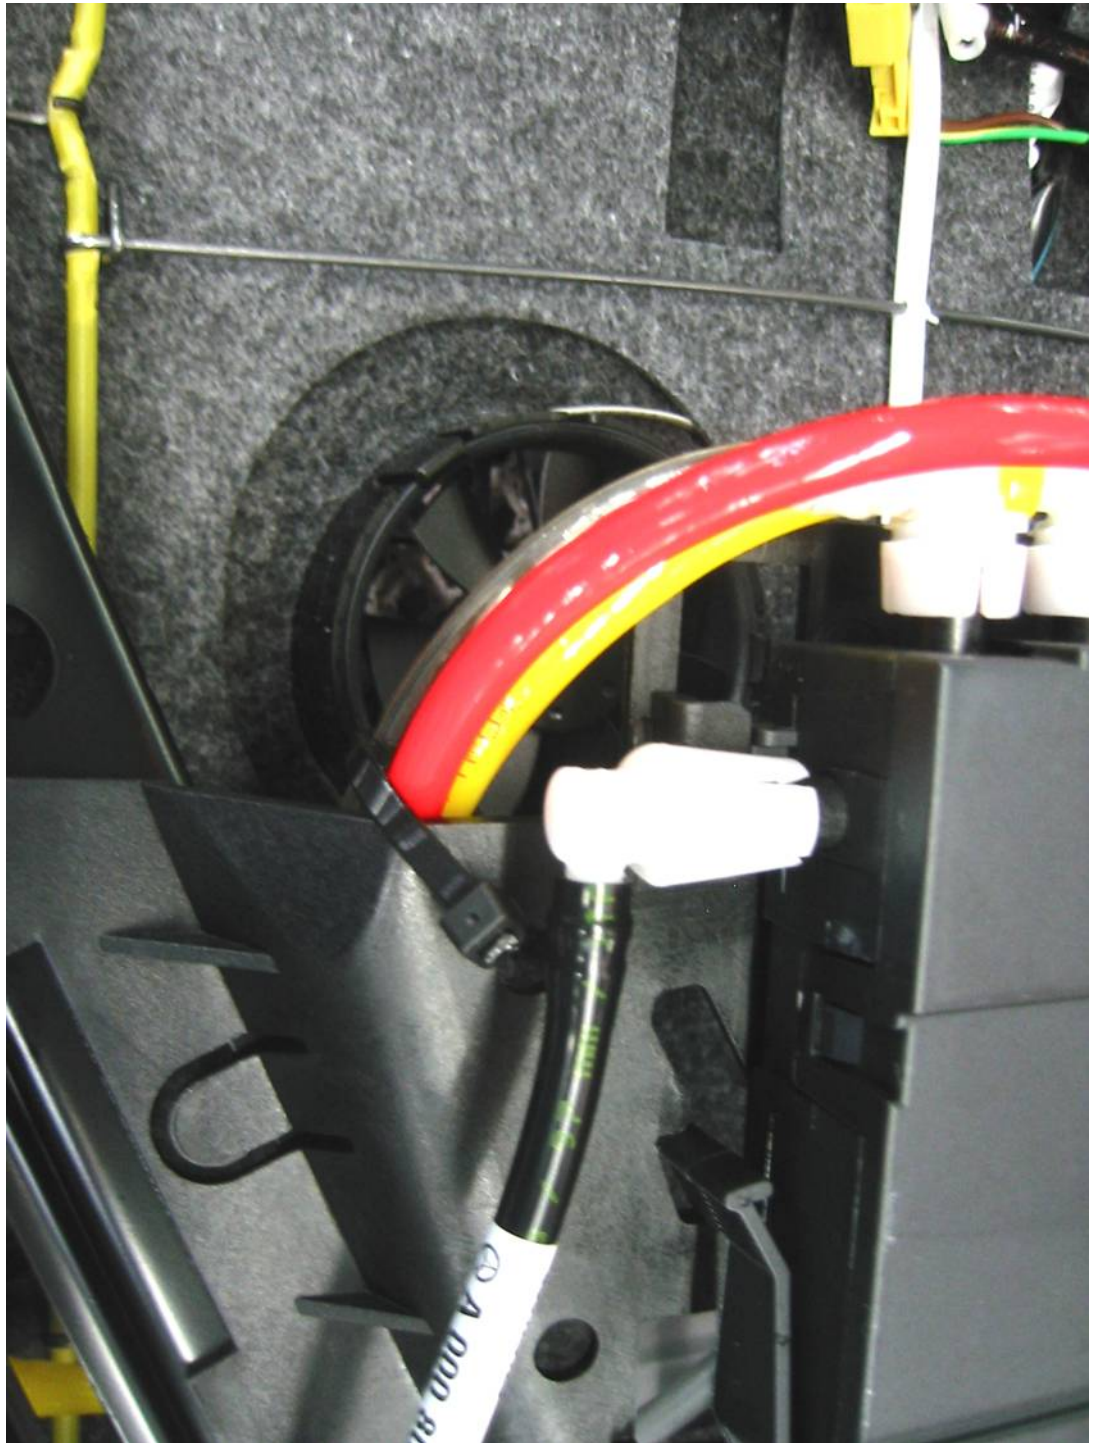
Pic_1.jpg:

When a person sits on the seat, the yellow pneumatic line can slip over the bracket of the control unit for the active multicontour seat and then scrape against the fan of the backrest.

Attachments	
File	Description
Pic_1.jpg	Positioning of cable tie

Attach a cable tie to the bracket of the multicontour backrest and fix the three pneumatic lines (yellow, red, transparent) in place as shown in the illustration in the attachment (Pic_1).
