## Technical product information

| <b>Topic</b> | Continental Series, Flying Spur and Mulsanne - Main harness identification |

### **Section 1 - Main harness information, Continental Series and Flying Spur**

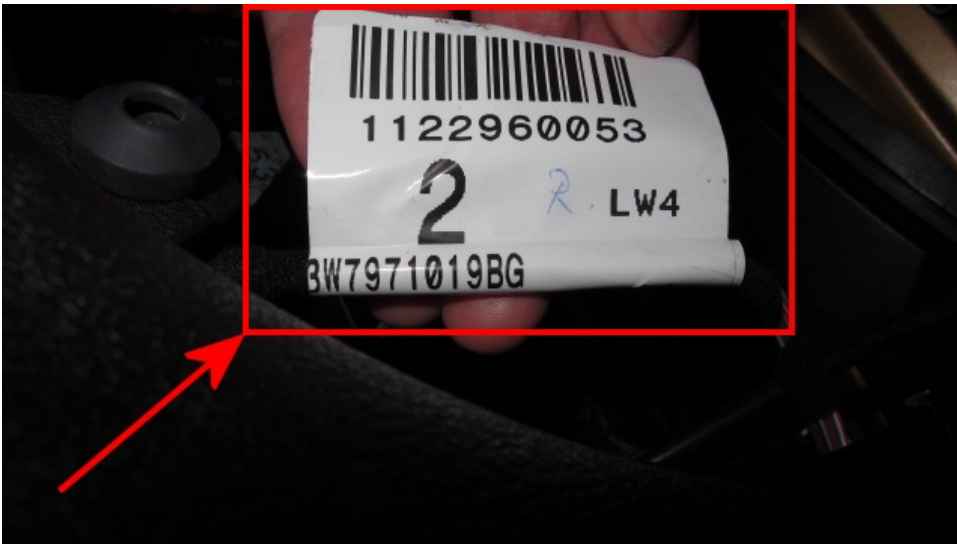
Figure 2 shows the front face of the label which includes part number information

1. Please ensure that clear photographs of the main harness labels as Figures 2 - 3 and 4 are attached to the DISS ticket before submitting

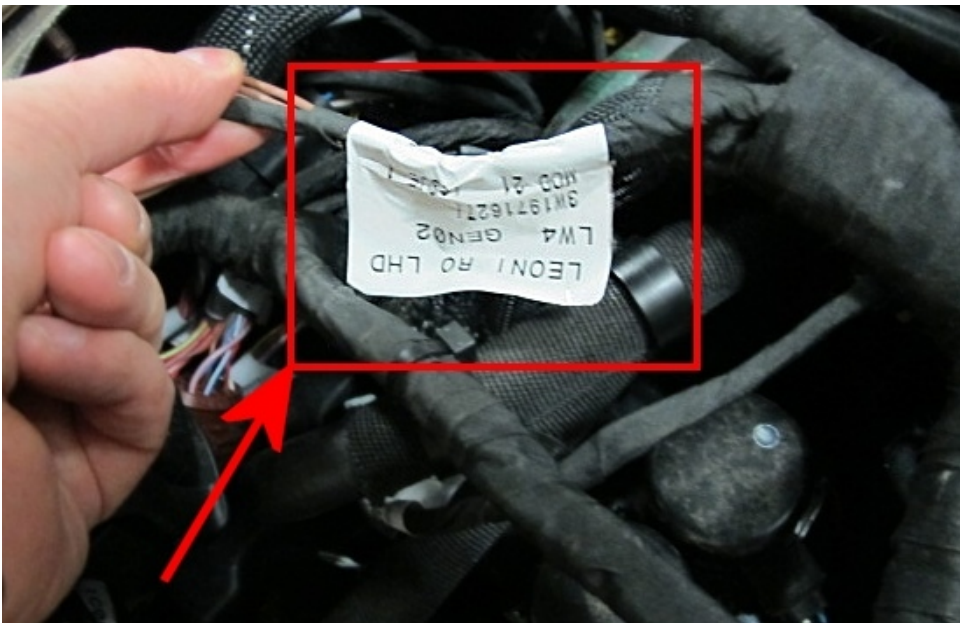
Figure 6

**V8T** – The engine identification label is fitted to the earth lead branch off section within the plenum (Figure 6)

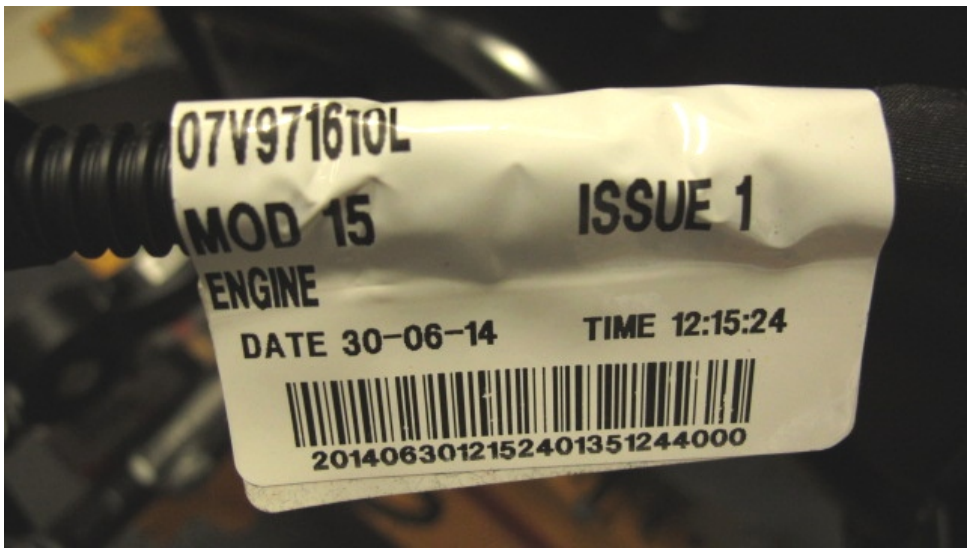
- Manoeuvre the earth leads back under the engine bay fusebox and secure the earth leads back to the applicable earth studs
- Ensure clear photographs of the label information is provided within the DISS ticket as shown in Figure 11 and 12
