<b>Topic</b>	Premium audio – amplifier – bass function check (SC14/06)
<b>Market area</b>	Worldwide Bentley (1WBE)
<b>Brand</b>	Bentley
<b>Transaction No.</b>	2036964/1
<b>Campaign number</b>	EA06
<b>Note</b>	
<b>Type</b>	Workshop campaign
<b>US code</b>

### Flying Spur

### Technical background

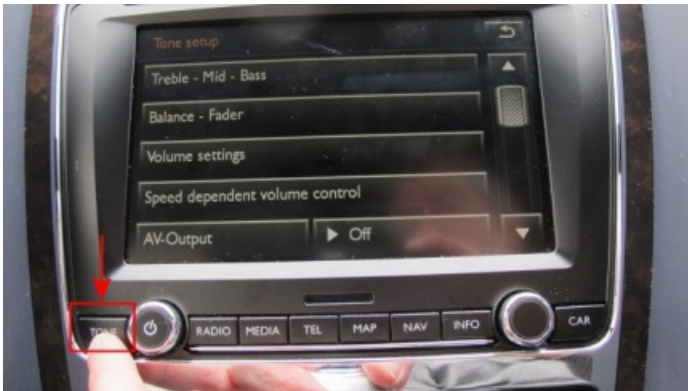
Figure 1

2. Select Tone (see Figure 1)

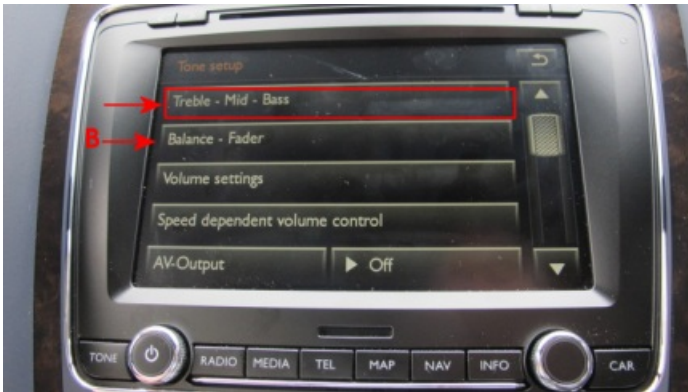
Figure 2

3. Select Treble-Mid-Bass (see Figure 2)

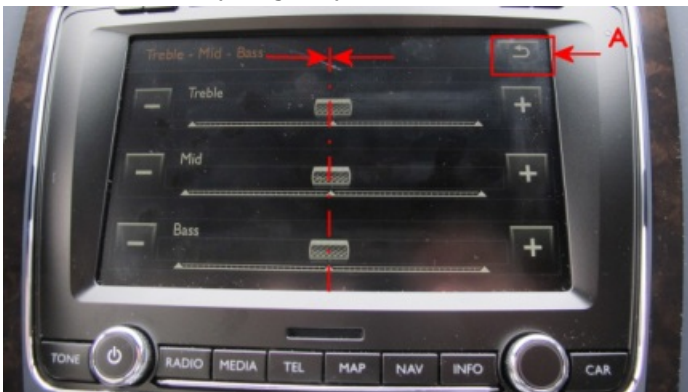
Figure 3

4. Set the three levels to middle position (see Figure 3)
5. Select return –A- (see Figure 3)
6. Select Balance - Fader –B- (see Figure 2)

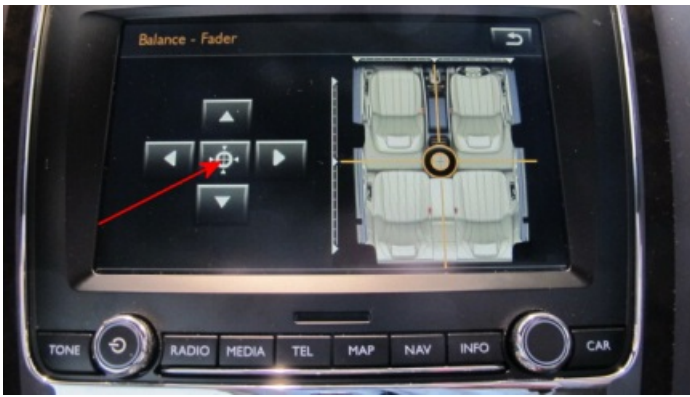
Figure 4

7. Set balance to centre of cabin using middle button (see Figure 4)

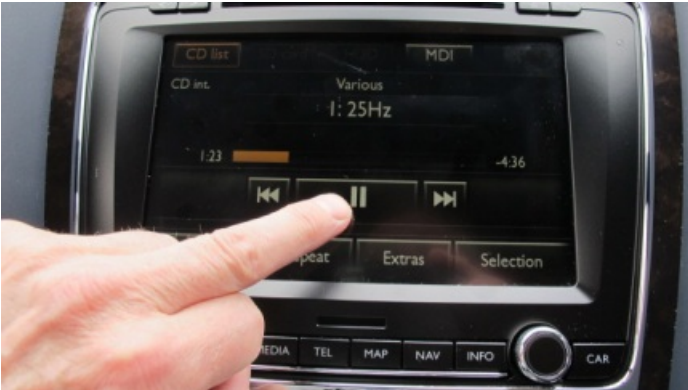
Figure 7

11. Perform the amplifier bass test. Ensure the Tone settings are as specified above. Select track 1, 25 Hz test signal, whilst playing this frequency pause the track (see Figure 7). At the point of pause the sound decay should be quick and reasonably clean as per sample track 2. If this is the case apply blue campaign identification mark (see figure 10), no further action is required. If at the point of pause the sound decay is extended and grainy as per sample track 3 then the amplifier must be removed and replaced but only when the new amplifier part is available (see section 'Parts supply' above)

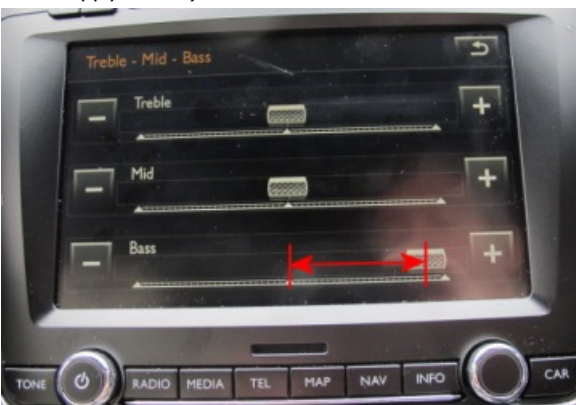
Figure 8

12. If confirmation is required, as a secondary check, the bass adjustment should be tested whilst playing a music track rich in bass. During playback adjusting the bass virtual slider from the middle to the high position should result in a significant change to the bass response if this is not the case then the amplifier is suspect (see Figure 8)

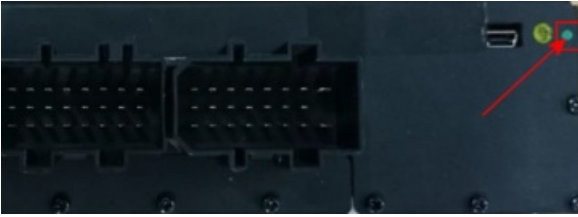
Figure 9

**Note:** For information any amplifiers already fitted to the vehicle during manufacture known to have the correct link fitted and therefore function correctly will have had a green identification mark applied at the factory (see Figure 9)

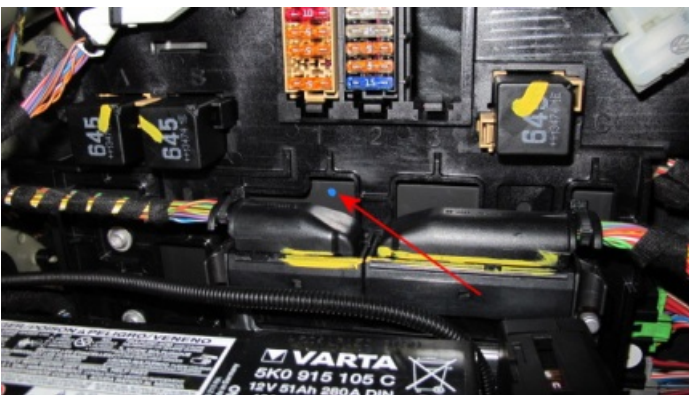
Figure 10

On completion apply blue campaign completion mark to the front face of the audio amplifier adjacent to the starter battery (see Figure 10)

The replacement audio amplifier is not expected to be available until early 2015. Therefore until that time test each applicable vehicle. Where the amplifier is found to be functioning correctly apply the blue campaign completion mark to the front face of the audio amplifier adjacent to the starter battery (see Figure 10).

If the vehicle is not already listed as required in the "Repair History" (ElsaPro), check for the presence of a blue or red paint identification mark on the amplifier (see Figure 10), should neither be evident carry out the required work in accordance with these instructions

1. Remove and replace audio amplifier Rep Gr.91 Audio amplifier – To remove and fit
2. On completion apply blue campaign completion mark to the front face of the audio amplifier adjacent to the starter battery (see Figure 10)
