SERVICE CAMPAIGN BULLETIN

CAMPAIGN REF: 02B
TITLE : HVAC Drain tube valve replacement
DOCUMENT # : 12 A 004
AFFECTED VEHICLES : McLaren P1™

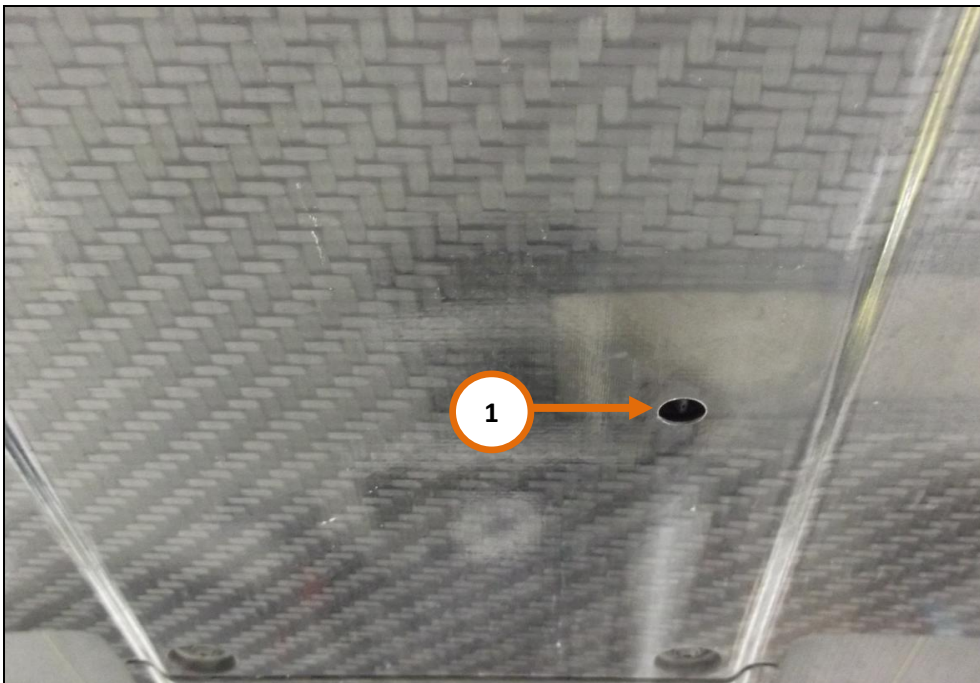
1. Lift the vehicle on platform. Please refer to BA-RM-01A001-00-001 – Secure/Lift vehicle on platform.
2. Locate the HVAC drain tube valve in the front floor panel (1).

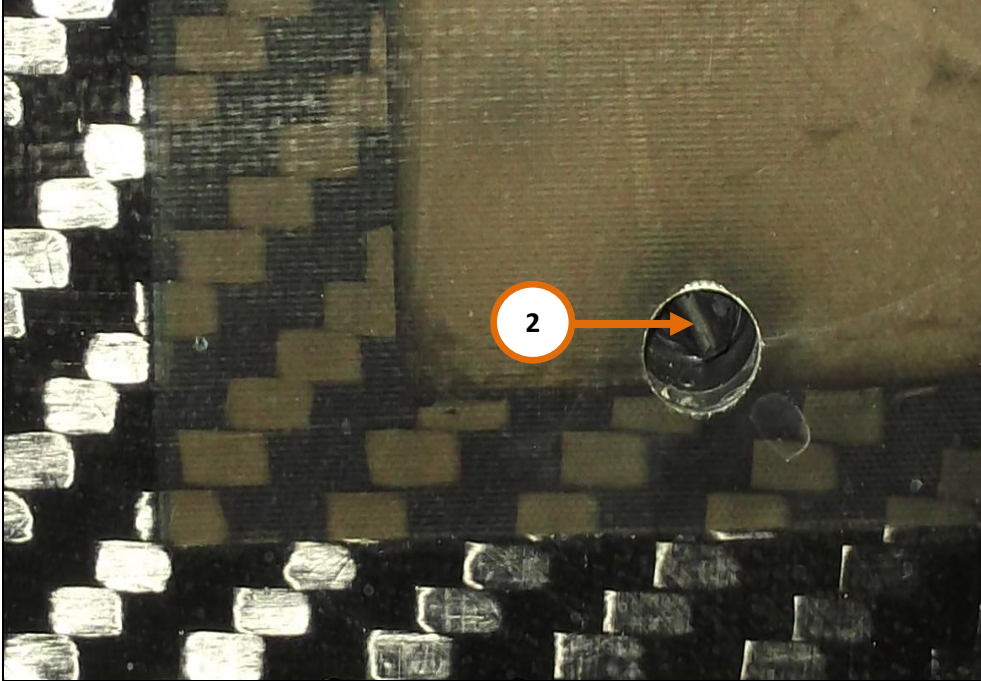
3. Remove the valve (2) from the drain tube using a pair of long nose pliers.

Care Point: It is not necessary to remove the drain tube to replace the valve.

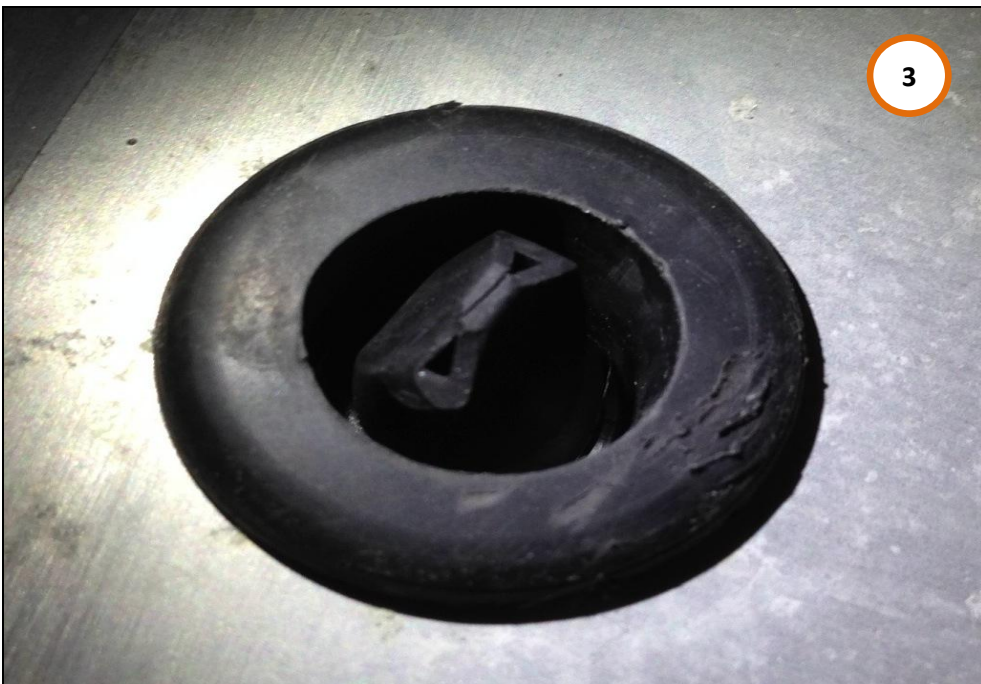
4. Install the new drain valve 11A7034CP into the drain tube, ensuring that it is correctly located (3).
