| <b>L83X-A.01.14</b> | <b>To:</b> Official After Sales Network<br><b>Subject:</b> Installation Of Rubber Boot Onto Alternator<br><b>Date:</b> 14 <sup>th</sup> /02/14<br><b>Pages</b> 4 | |

Installation of rubber boot onto alternator.

All Lamborghini Model Aventdor MY 12, 13 and 14 Coupe And Roadster from VIN CLA00091 to VIN ELA02542.

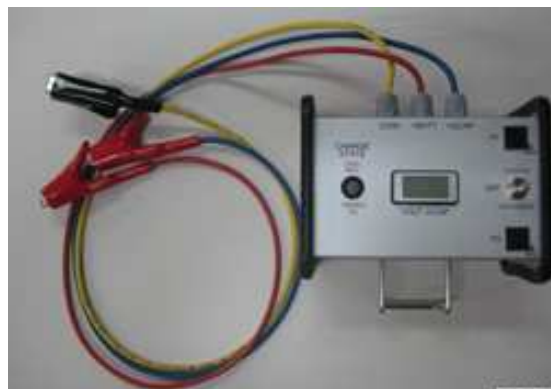
Aventador MY 2013 and followers:  
 Super-capacitor Charge and Discharge tool (p/n. 69195291)

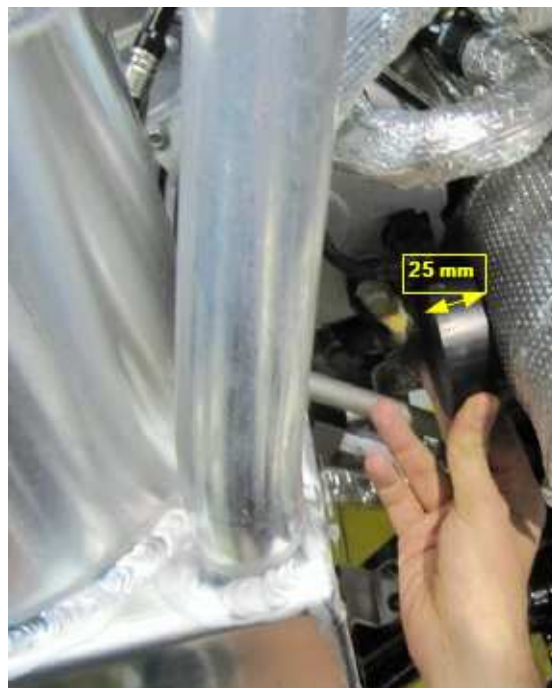
8. Check the distance between firewall and positive cable is 25 mm.
