L83X-A.09.14  
+  
L83X-A.10.14

**Subject**  
Air duct update.

All Lamborghini Model Aventador Coupè Roadster MY 12,13 and 14 from VIN **CLA00091** to VIN **ELA02533**.

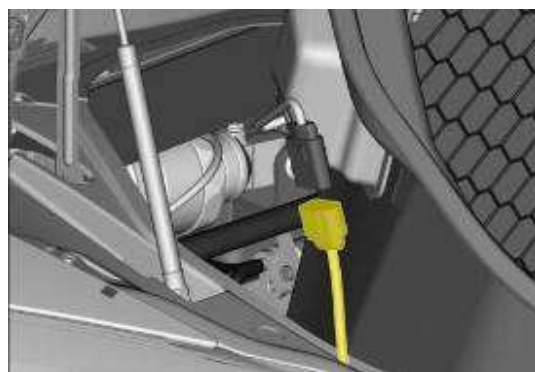
Lift trunk and disconnect plug from the 12V socket.

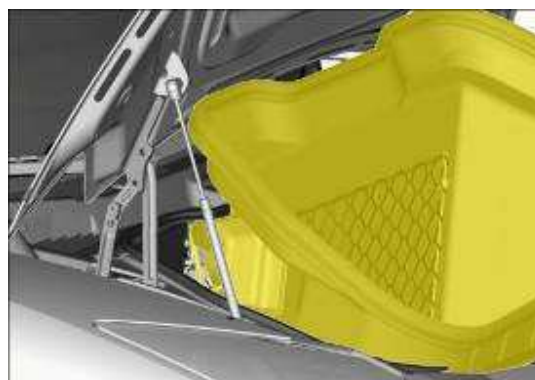
Remove trunk to get access to battery.

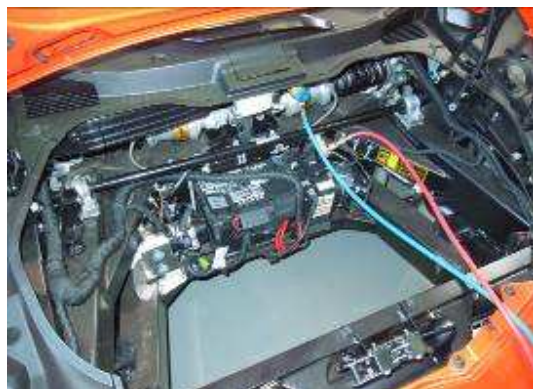
4. A/C system discharge.

- Connect hoses of A/C charging station to vehicle through HP and LP quick connectors.

- Operate phase of refrigerant fluid savage.

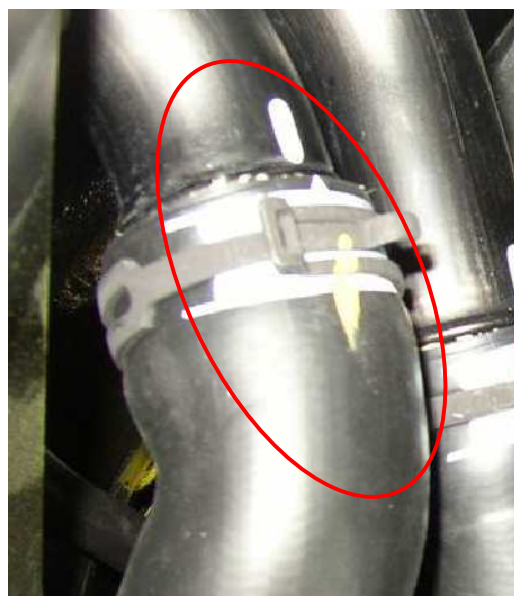
During reassembly align marks respectively present on radiator and pipe, to install component as it was in origin. **If any marks are present, use a marker pen to sign them before disassembly.**

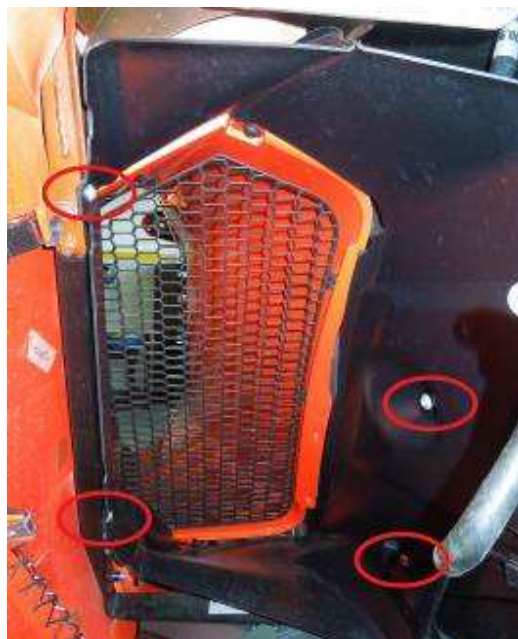
## 12. Air duct disassembly.

Remove 4 screws and take component off.

Screw tightening.

Torque: **9Nm**

Replace air duct.

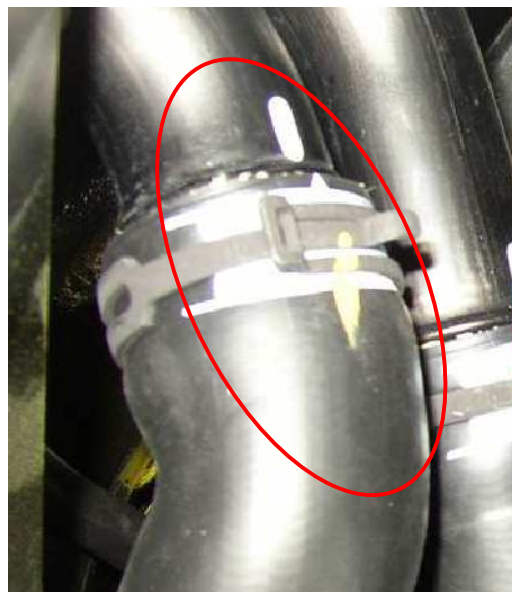
During reassembly align marks respectively present on radiator and pipe, to install component as it was in origin. **If any marks are present**, use a **marker pen** to sign them before disassembly.

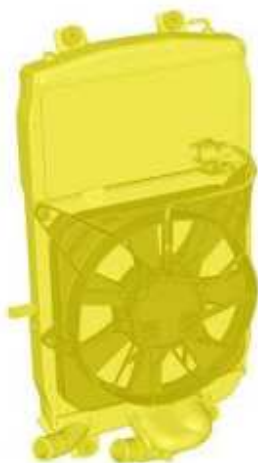
Now remove right radiator assembly that includes electric fan, cable clamp bracket, washers, spacers, buffers and condenser.

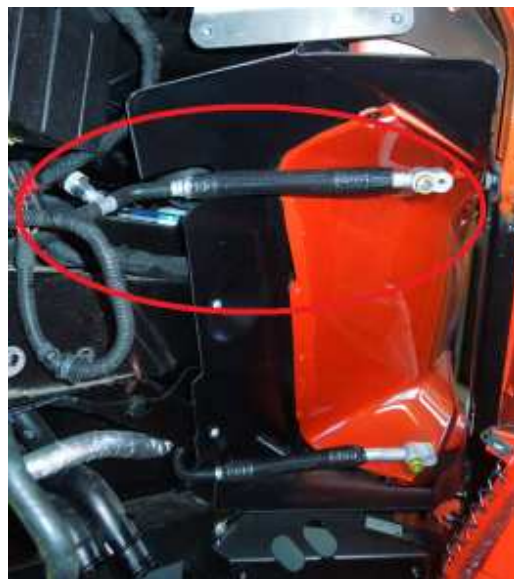
#### 17. Air duct disassembly.

To remove easily left duct, release from chassis and remove a part of air conditioning hose.

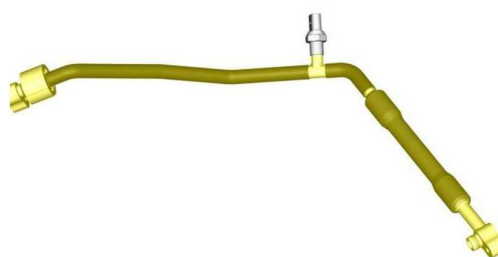
Disconnect plug of pressure switch.

Release cable clamp that fix it to chassis.

At last remove screw that fix hose and then take it off.

Screw tightening.  
Torque: **9Nm**

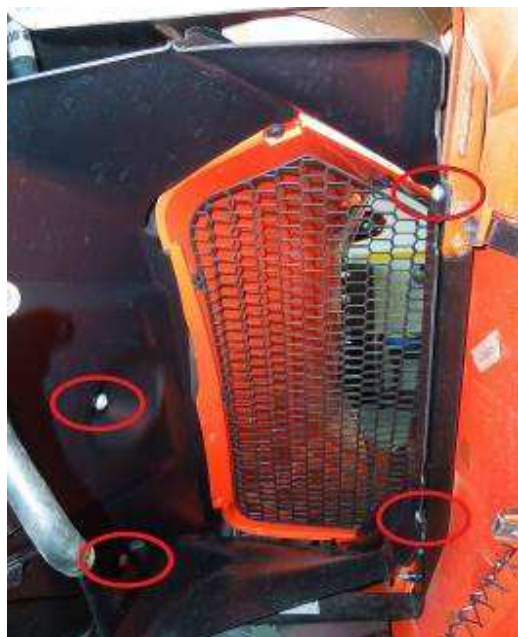
Remove 4 screws that hold duct and separate it from vehicle.

Screw tightening.  
Torque: **9Nm**

Replace air duct.
