BT14-012

April 30, 2014

## G37 AND Q60 CONVERTIBLES; CONVERTIBLE TOP SERVICE INFORMATION

**APPLIED VEHICLES:** 2009 – 2013 G37 Convertible (V36)  
2014 Q60 Convertible (V36)

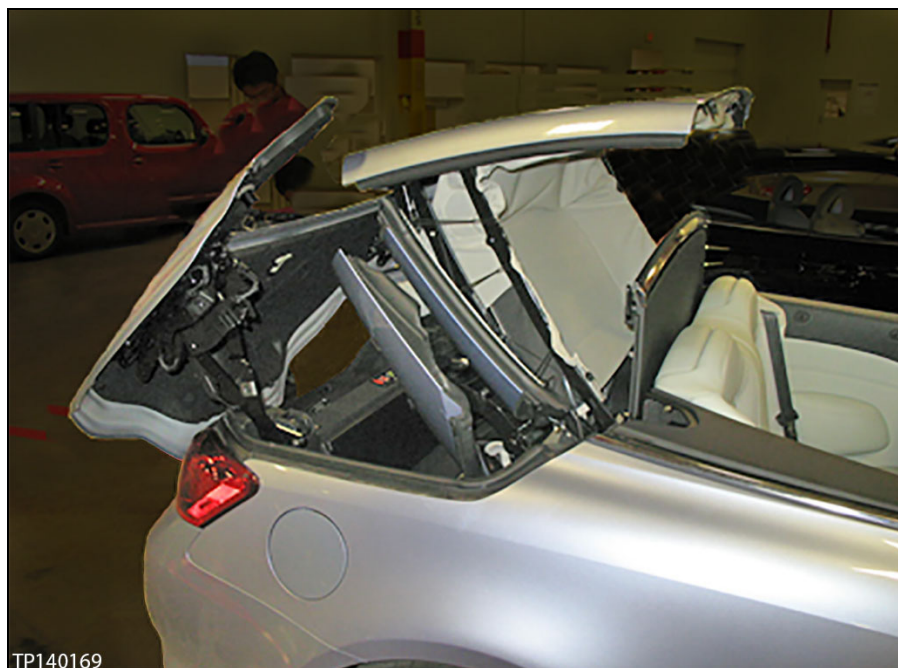
Figure 1

If the hydraulic unit assembly (pump assembly) needs to be tested for any reason, the convertible top should not “sink” or drop further than 250 mm (9.84 inches) within one (1) minute or less when opened as shown in Figure 1.

- If the convertible top sinks further than 250 mm (9.84 inches) within one (1) minute or less – the pump assembly needs to be replaced.
- If the convertible top does not sink further than 250 mm (9.84 inches) within one (1) minute or less – the pump assembly is OK.

**NOTE:** This instruction supersedes the previous 15 mm measurement threshold specified in SIR video # 165.

**CAUTION:** The convertible top should only be partially opened for service and should not be left in this position as damage may result.

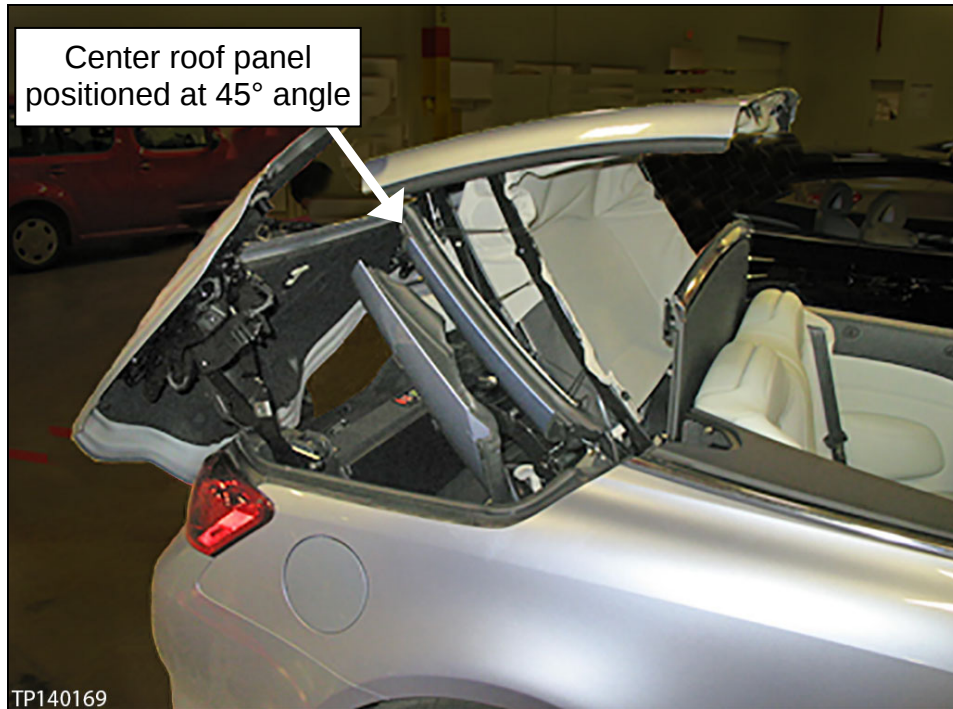
Figure 2

1. To check for excessive “sinking”, open the convertible top in the position shown in Figure 2.
