2014 Nissan NV Passenger Van Seatbelt Retractor Bolt Dealer Inventory Inspection

Reference: PC289

PROCESS NAME:	NV-PASSENGER VAN Seatbelt Retractor Bolt Inspection			PNC:	PC289	DATE:	06/04/14
VEHICLE AFFECTED:	2014	NISSAN	NV-P			REV:	01

Seatbelt Retractor Bolt Inspection

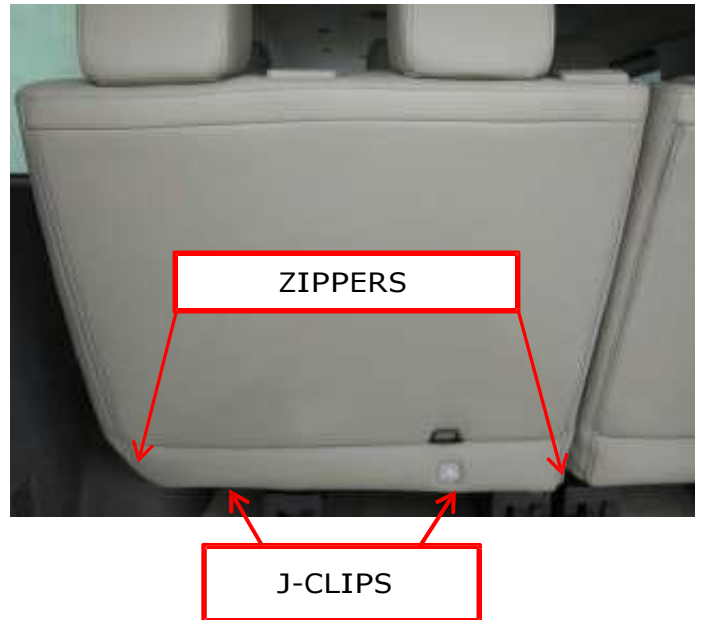
Figure 1

1. Using suitable tool, unzip seat back covers and unlatch J-clips hooked to bottom of seat frame allowing a visual of seatbelt retractor retaining bolt.

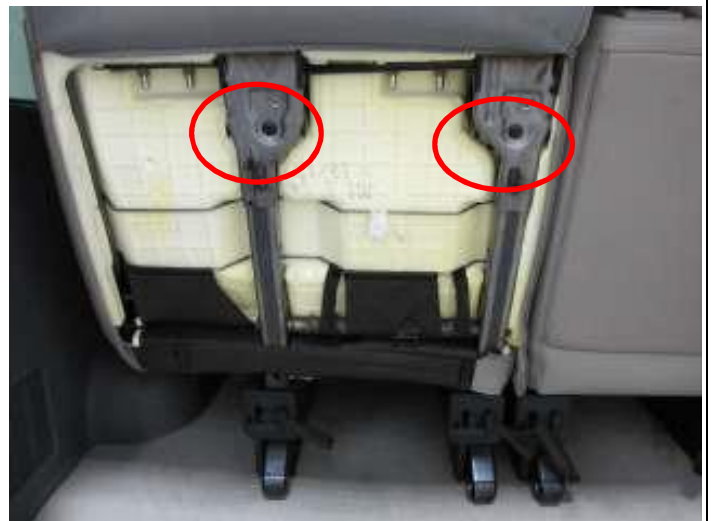
Figure 2

2. Fold trim over the seat to allow visual inspection of the seat belt retractor retaining bolts (Figure2).

- Verify seatbelt retractor retaining bolts are in place (Figure 2).

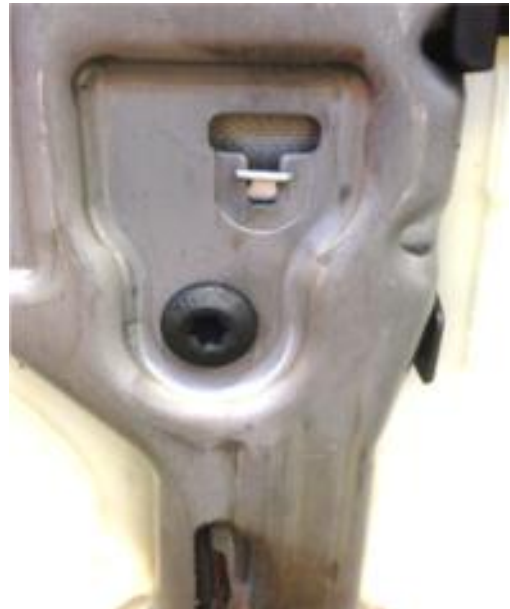
Figure 3

3. Torque instructions
Verify correct torque using a torque wrench set for 55 Nm.(40ft-lbs)
(Figure 3).

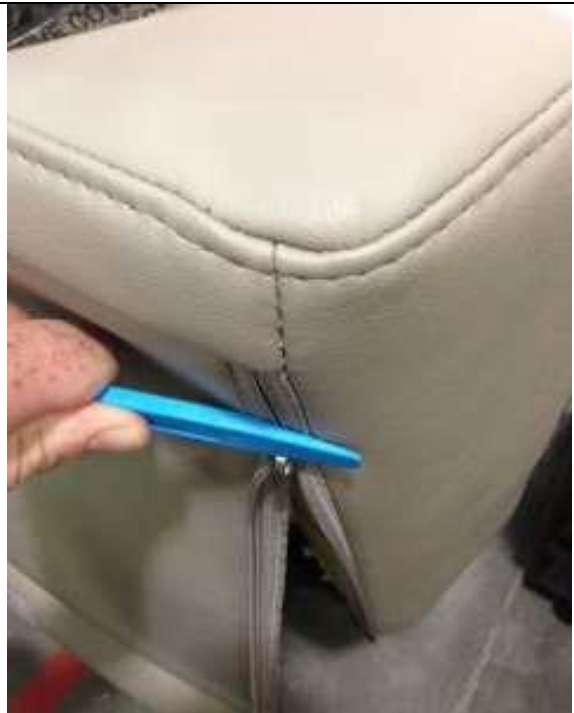
Figure 4

4. Return rear seat back cover to its original position, Secure J-clips and zippers (Figure 4).
- NOTE make sure that the child seat latch is positioned correctly once seat back cover is in place.

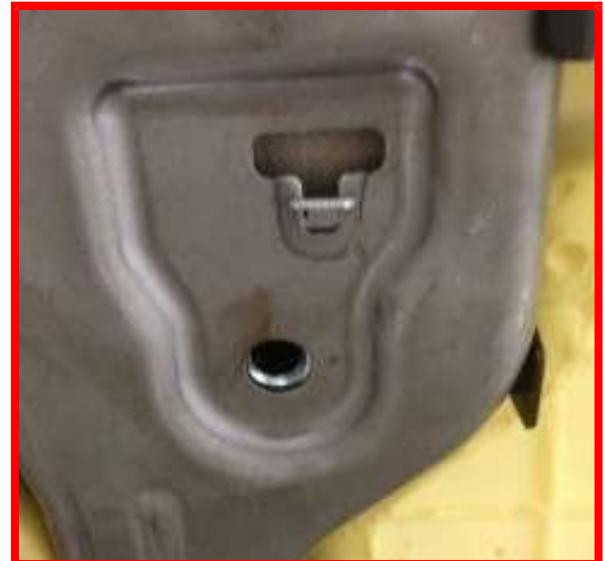
Figure 6

If the retractor bolt is missing as in figure 6, please email the following information,

Missing Retractor Bolt

- Dealer name
- Dealer code
- Contact name
- Contact phone number to,

NNAFQASupport@Nissan-usa.com
