NISSAN BULLETIN

2014 Nissan Frontier Crew Cab Rear Seatbelt Anchor Weld Nut Inspection Quality Hold - Dealer Inventory Inspection

Reference: PC307

PC307 Inspect Rear Seat Belt Weld Nuts

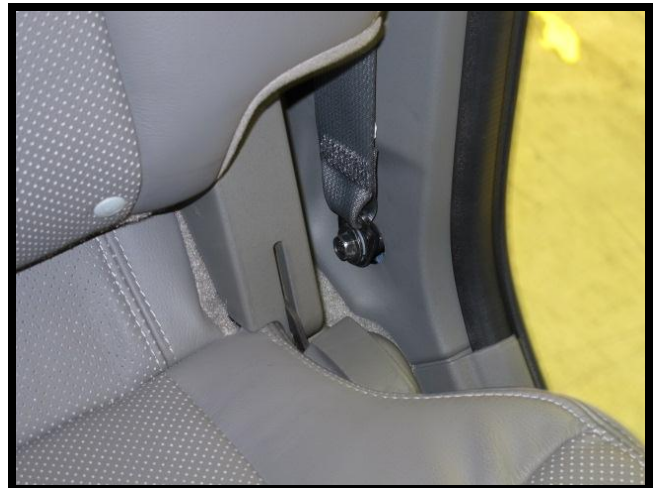
1. Locate and remove the Driver side rear seat belt anchor bolt as shown in Figure 1 using a 14 mm ratcheting wrench.

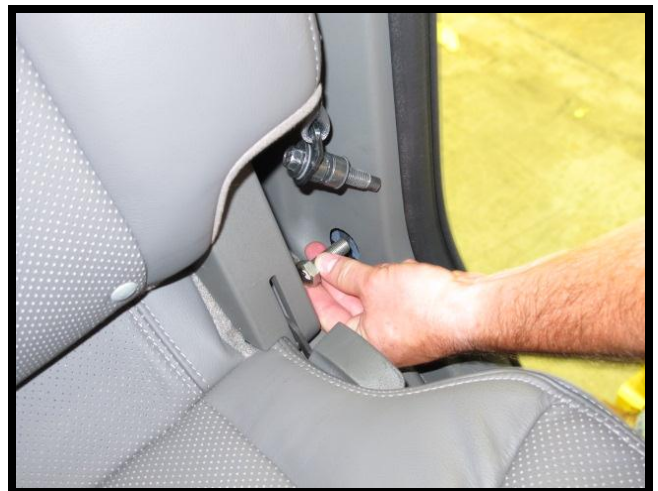
2. Insert the **oversize inspection bolt** into the Driver side rear seat belt anchor bolt hole and attempt to thread it in by hand as shown in Figure 2 (up to three attempts).
3. Repeat Steps 1-2 on Passenger side rear seat belt anchor bolt.

4. Does the **oversize inspection bolt** thread into either side rear seat belt anchor bolt hole?
- If the **oversize inspection bolt DOES NOT** thread into either side rear seat belt anchor bolt hole after three attempts, then reinstall the original bolts. Torque the side rear seat belt anchor bolts to 49 N•m (36 Ft lbs) using a 14 mm torque adaptor (J-49752), submit claim using the Op Code PC3070 (see claims info) and release the vehicle.
 - If the **oversize inspection bolt DOES** thread into either side rear seat belt anchor bolt hole, then the weld nut may be an incorrect size and **the vehicle must be HELD until further direction is provided**. Do not submit a warranty claim. Send an E-mail with the requested information:
