US 59823415-02

Cylinder head cover seal set

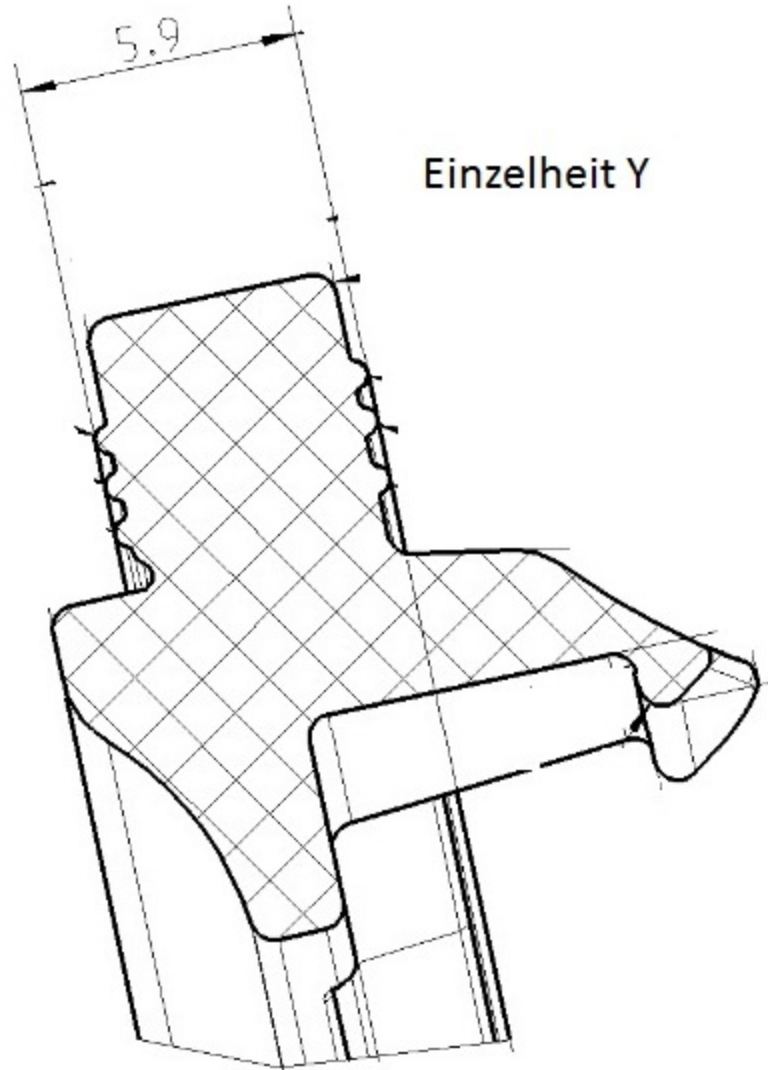
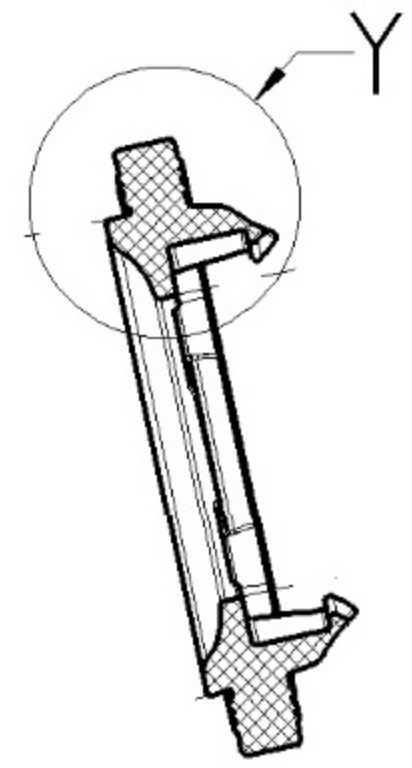
The largest outside diameter must be 54.0 mm, and the height of the seal cross section in this area is 5.9 mm (see accompanying diagrams).

(Incorrect part: Outer diameter 51.5 mm, height at that point 4.6 mm).

$\varnothing 54_{-0.5}$

Before fitting a new cylinder head cover seal set 11 12 7 723 216, compare the dimensions of the inner (small) seal with the old part.

1. The stock of replacement set is currently being checked by the supplier in Dingolfing.
  2. If an incorrect part is discovered before it is fitted, send it in as a parts claim.
  3. If an incorrect part has already been fitted, submit parts warranty claim.
-
