TECHNICAL BULLETIN
LTB00661NAS1
22 OCT 2014

SECTION: 501-10

Third Row Seat Will Not Fold Or 'Sticks' In Operation

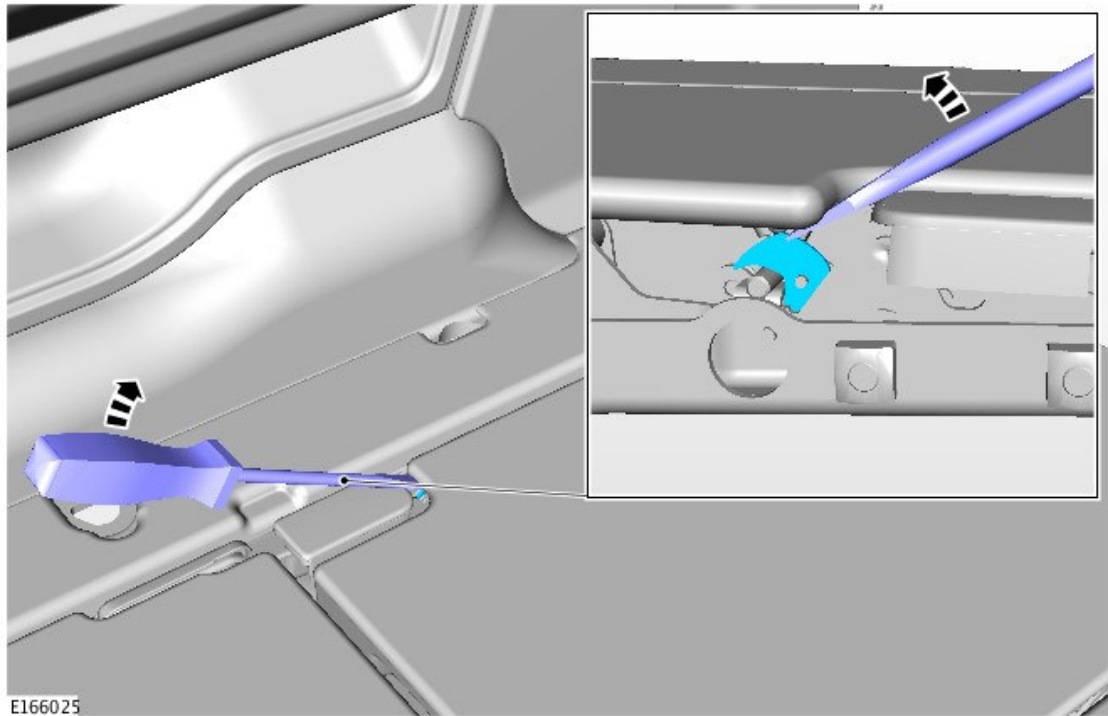
1.

**NOTE:** Right-hand seat shown; left-hand seat similar.

Using a suitable tool, lever the right-hand third row seat latch and release the seat.

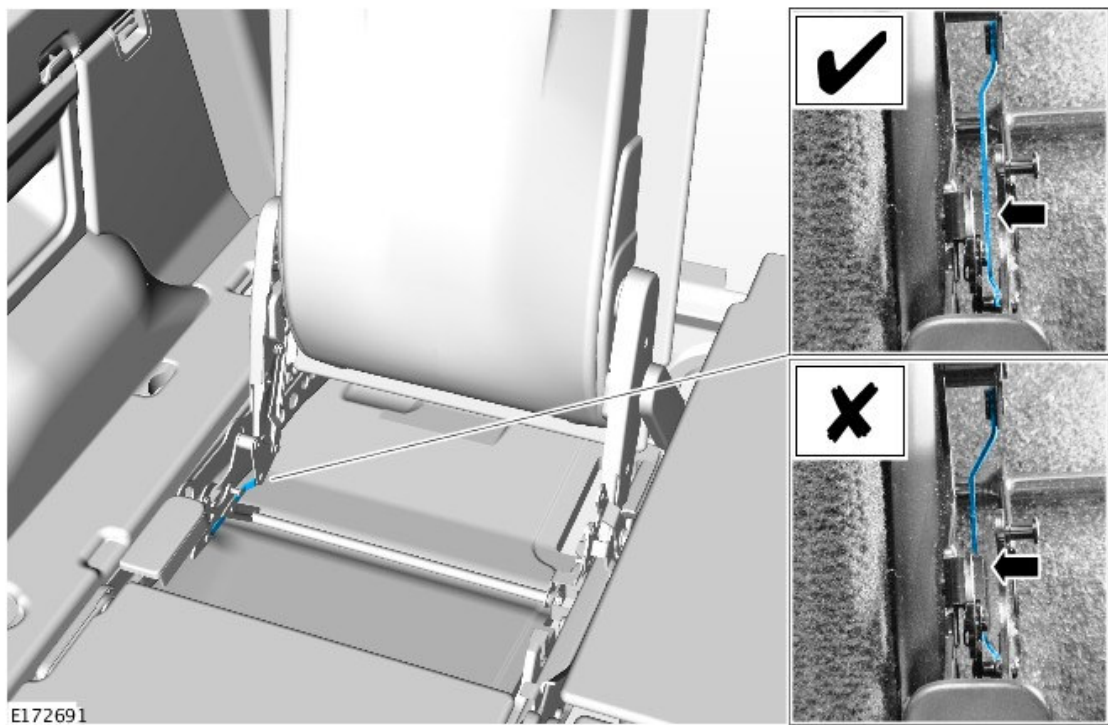
2. Inspect the linkage.

- Using a suitable tool, reposition the linkage to one side as shown.

3. Check the operation of the right-hand third row seat.
