# TECHNICAL BULLETIN

## LTB00401NAS4

### Wheel/Tire Balancing and Optimization

**Situation:** The steering wheel may exhibit a vibration / shimmy while driving.

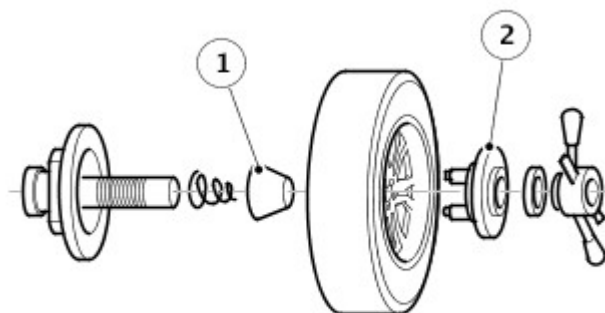
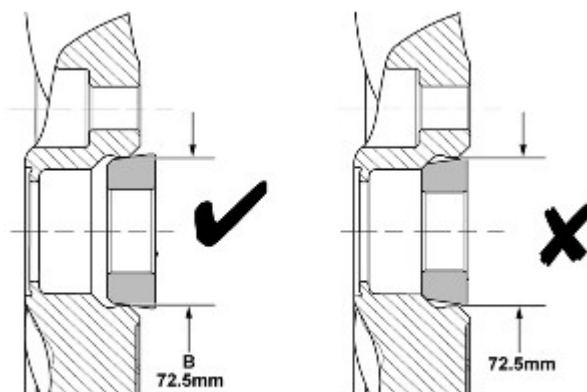
E160494

Mount each wheel/tire assembly (using the correct wheel-fitting attachment) to the balance machine and balance until the residual imbalance dynamic is minimized.

- Target is 0g (zero grams) on each plane; maximum is inner 5g / outer 5g.
- Use the 'bulls-eye' balancing mode to minimize residual imbalance.

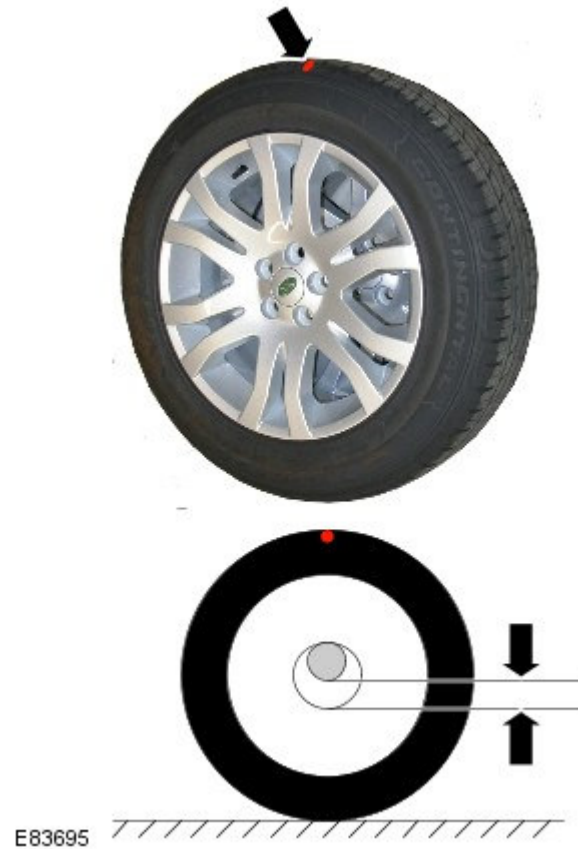
**NOTE: If RFV equipment is not available and the tire has not been removed from the wheel and the RFV spot (red dot) is still visible, install wheel/tire assembly with red dot 'up'.**

Prior to tightening the wheel nuts, the marked high point of RFV must be installed to the vehicle with the RFV high point 'up'.
