NUMBER: 08-040-14 REV. A

Police Vehicle A/C Inoperative

This bulletin involves relocating the A/C fuse within the front Power Distribution Center (PDC).

2011-****2013**** (LD) Charger

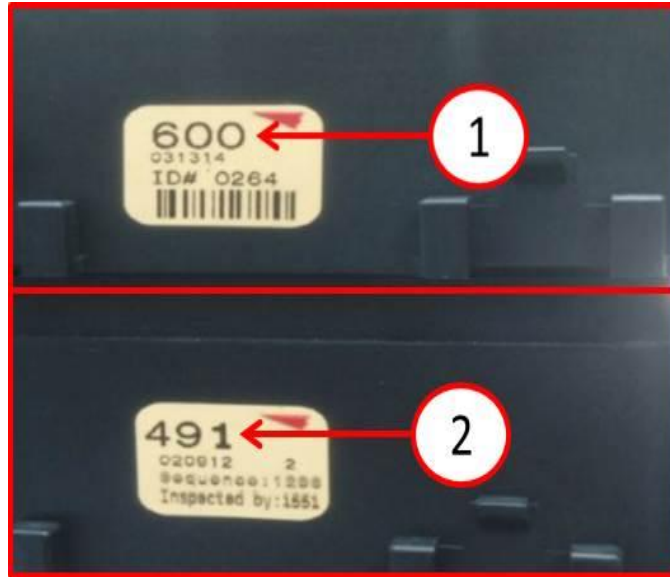
Fig. 1 PDC Identification Numbers

2. ****Check the PDC identification number. Late built PDCs do **Not** have this issue, see (Fig. 1).****

NOTE: **The identification number should be located on the outside of the PDC next to the fender.**

- 1 - Late built PDC
- 2 - Early built PDC

3. ****Is the PDC identification number 491 (early built)?**
 - a. Yes >>> Perform this repair procedure, proceed to [Step #4](#).
 - b. No >>> This bulletin does not pertain, normal diagnostics should be performed.**

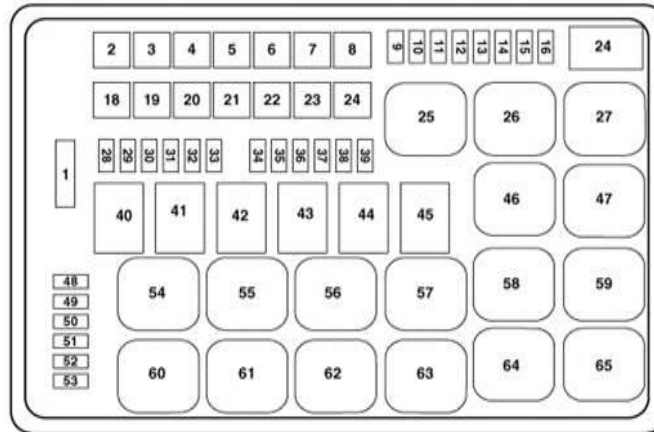
Fig. 2 Fuse Locations

-
4. Refer to fuse location diagram for fuse cavity locations ([Fig. 2](#)).

5. Is there a 10 Amp fuse in cavity 12 of the PDC?
 - a. YES>>>Perform the repair procedure, proceed to next [Step #6](#).
 - b. NO>>> This Bulletin doesn't pertain, normal diagnostics should to be performed.
6. Disconnect the battery.
7. Remove the main B+ battery feed from the front PDC.
8. Release the retaining tabs that secure the PDC to the mounting bracket.
9. Turn the PDC over to expose the bottom side of the PDC.
10. Remove the PDC bottom cover.
11. Remove and discard the white plastic terminal lock see ([Fig. 3](#)).

24. Install the front PDC to the mounting bracket.
25. Connect the B+ power feed to the front PDC.
26. Remove and discard the 10 amp fuse from cavity 12 of the PDC.
27. Install the new 10 amp fuse provided in the repair kit into cavity number 53 of the PDC, for location see (Fig. 2).
28. Reconnect the battery.

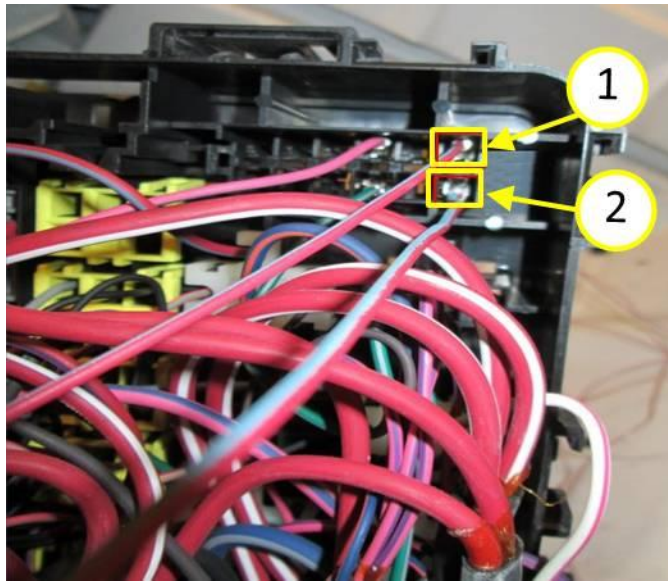
Fig. 4 New Circuit Location

- 1 - Cavity 53A
- 2 - Cavity 53B

12. Insert the terminal wire color RD/LB without eyelet end provided in the repair kit into cavity number 53B of the PDC.
13. Insert the terminal with wire color RD/LB with eyelet end provided in the repair kit into cavity number 53A of the PDC ([Fig. 4](#)).

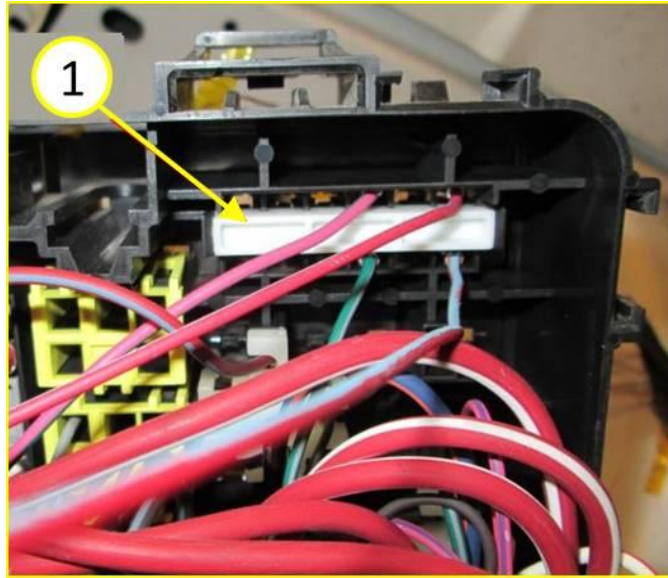
Fig. 5 New Lock Installed

1 - White terminal lock installed after new circuits were installed.

-
14. Install the NEW white plastic terminal lock provided in the repair kit, see ([Fig. 5](#)).

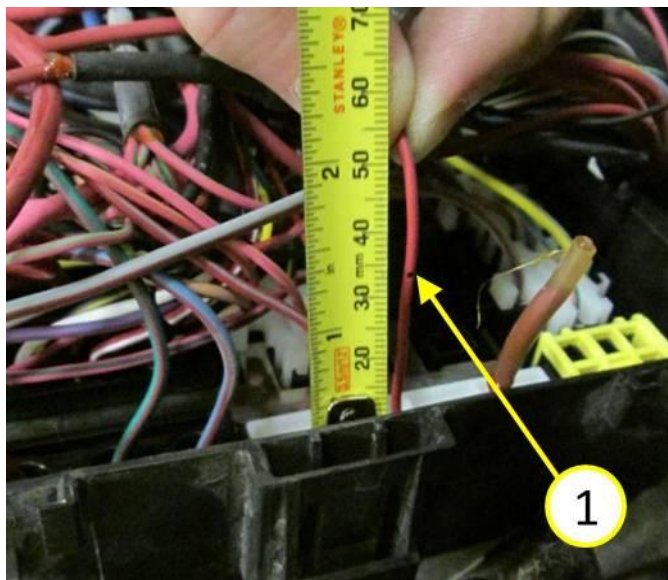
Fig. 6 Cut Wire From Cavity 12

Customer comments A/C is warm. On further inspection the technician will notice the A/C clutch fuse is loose in its cavity (#12) in the PDC. This will cause a poor connection and the fuse cavity to be distorted.

1 - Location to cut wire

15. Locate the RD/LB wire located in cavity 12. Place a mark on the wire approximately 35mm (1.375 In.) up from the terminal, see (Fig. 6).

16. Cut the wire at the mark made in the previous step.

17. Place the clear heat shrink tube provided in the repair kit over the remaining wire in cavity 12 of the PDC.

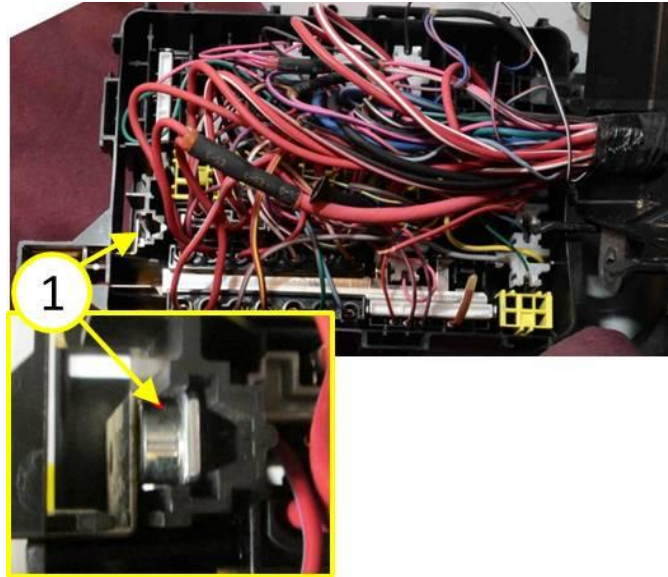
Fig. 7 Install Buss Nut

1 - Location for Buss nut.

18. Route the remainder of the wire cut from cavity 12 back through the PDC to the opposite side closer to the wire installed in cavity number 53B.
19. Splice wire cut from cavity 12 to the wire installed in cavity 53B . Refer to the detailed repair procedures available in: DealerCONNECT> TechCONNECT under: Service Info> 29 - Non-DTC Diagnostics> Circuit Testing Procedures> Standard Procedure.
20. Install the buss nut provided in the repair kit into the slot above the buss with 5m hole, see (Fig. 7).

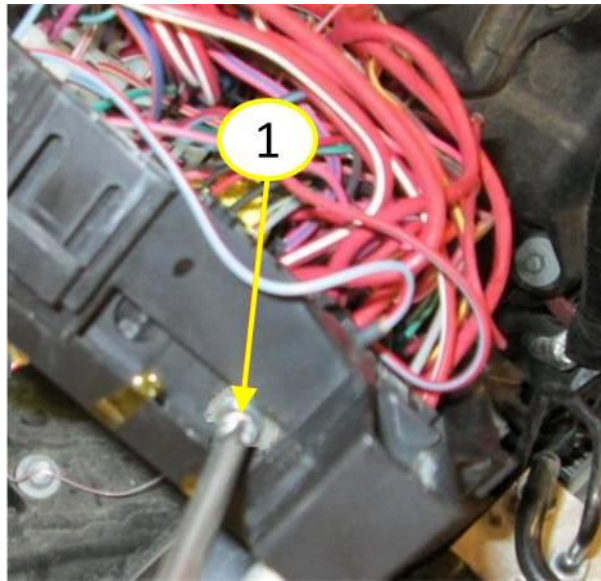
Fig. 8 Tighten Screw For Buss Bar

1 - Torque the screw to 2.9-3.9 Nm

-
21. Using the 5m screw provided in the repair kit, attach the wire installed in cavity number 53A with M5 eyelet to the buss nut. Torque the screw to 2.9-3.9 Nm, see (Fig. 8).

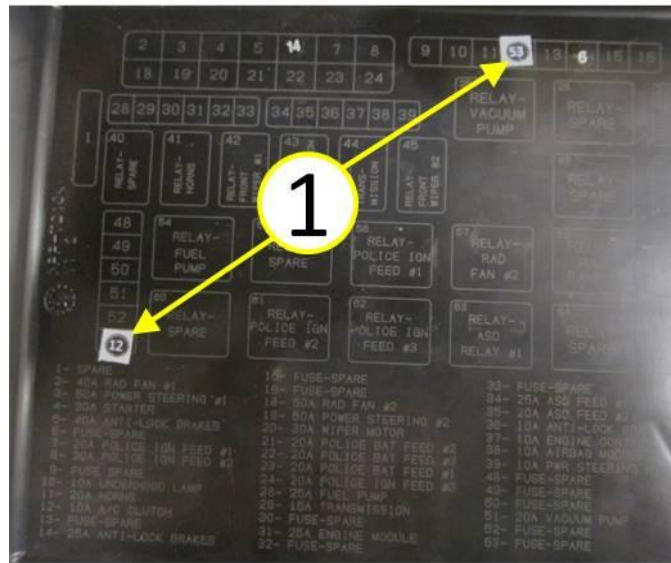
Fig. 9 New Fuse Label Location

1 - New fuse label

29. Install the new fuse location stickers provided in the repair kit, onto the fuse location diagram on the inside of the PDC cover.
