**NUMBER:** 23-024-14

Water In The Jack Storage Area

This bulletin involves sealing the left side fascia support flange.

2010 - 2012 (RT) Caravan / Town & Country / Grand Voyager

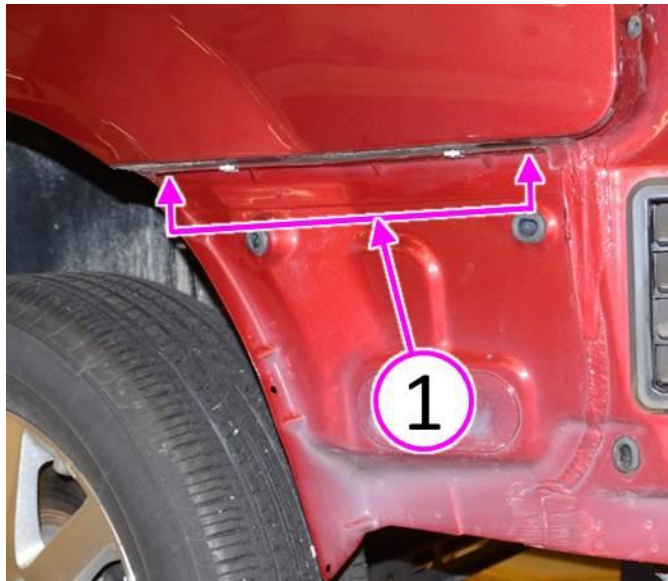
1 - Fascia Support Flange Slot

***Fig. 1 Clean Facia Support Flange Slot***

1. Remove the tail lamps in order to access the rear fascia fasteners. Refer to the detailed service procedures available in DealerCONNECT> TechCONNECT under: Service Info> 08 - Electrical> 8L - Lamps and Lighting> Lamps/Lighting - Exterior> LAMP, Tail> Removal.
2. Remove the rear fascia to expose the left side fascia support flange at the aft bottom of the bodyside. Refer to the detailed service procedures available in DealerCONNECT> TechCONNECT under: Service Info> 13 - Frame and Bumpers/Bumpers> FASCIA, Rear> Removal.
3. Clean inside the left side fascia support flange slot to remove any dirt or debris ([Fig. 1](#)).

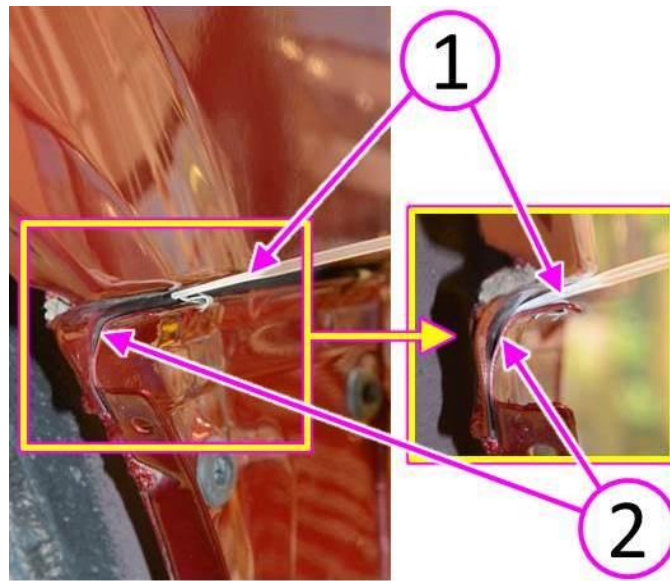
- 1 - Applicator Extension Tube
- 2 - Fascia Support Flange

***Fig. 2 Modify Applicator Tube To Fit Slot***

- 
4. Oval or flatten slightly the end of the Kent® Spray Leak Check sealer extension tube (1) in order to allow the tube to fit into the fascia support flange slot (2) ([Fig. 2](#)).

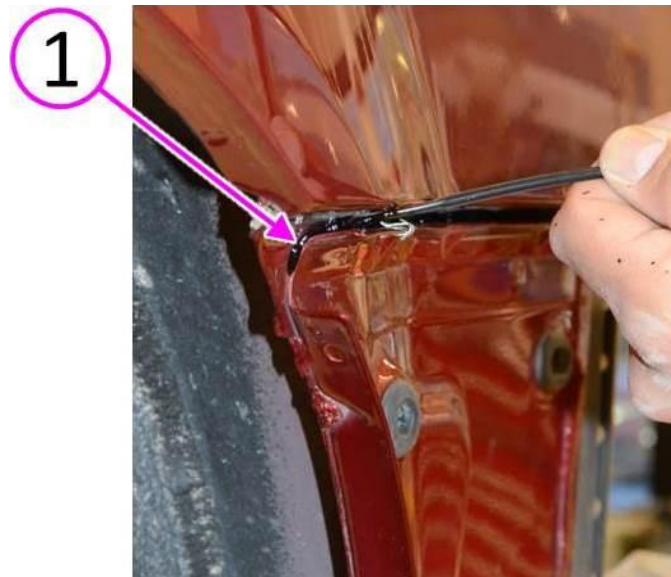
- 1 - Leak Check Sealer
-

***Fig. 3 Apply Sealer Into Back Of Slot***

- 
5. Use the extension tube to apply Kent® Spray Leak Check sealer into the entire length of the left side fascia support flange (Fig. 3) and (Fig. 4).

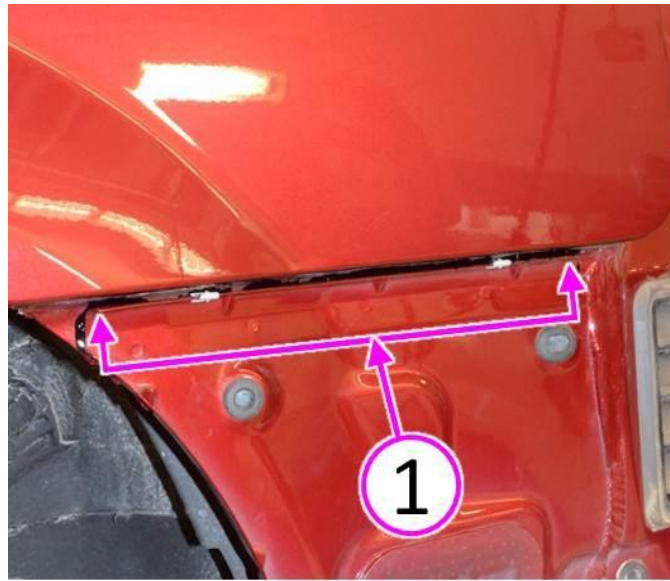
1 - Fascia Support Flange

***Fig. 4 Apply Sealer To Entire Length Of Slot***

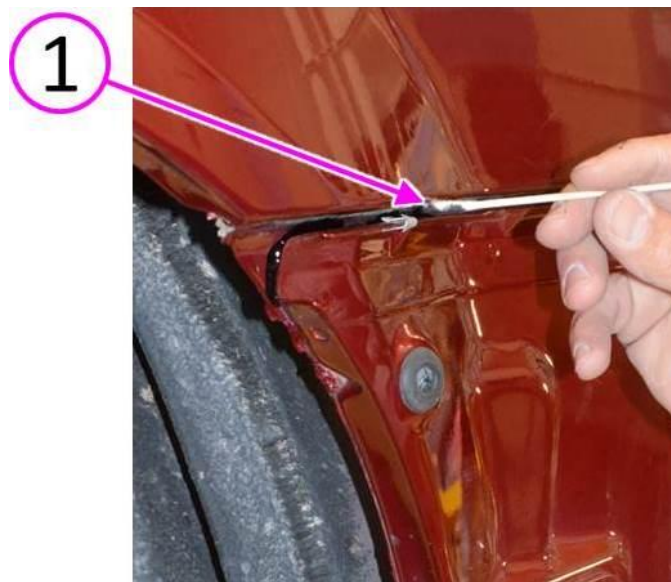
1 - Cotton Swab Or Equivalent

***Fig. 5 Remove Any Excess Sealer***

6. Using a cotton swab or equivalent tool, wipe away any excess sealer that may prevent installation of the rear fascia flange ([Fig. 5](#)).
