Technical Service Bulletin

00 PDI inspection - IQS supplement

00 13 57 2035669/2 November 11, 2013. Supersedes Technical Service Bulletin Group 00 number 13-56 dated November 1, 2013 for reasons listed below.

Model(s)	Year	VIN Range	Vehicle-Specific Equipment
A6, A7, Q5, Q7	2014	All	Not Applicable

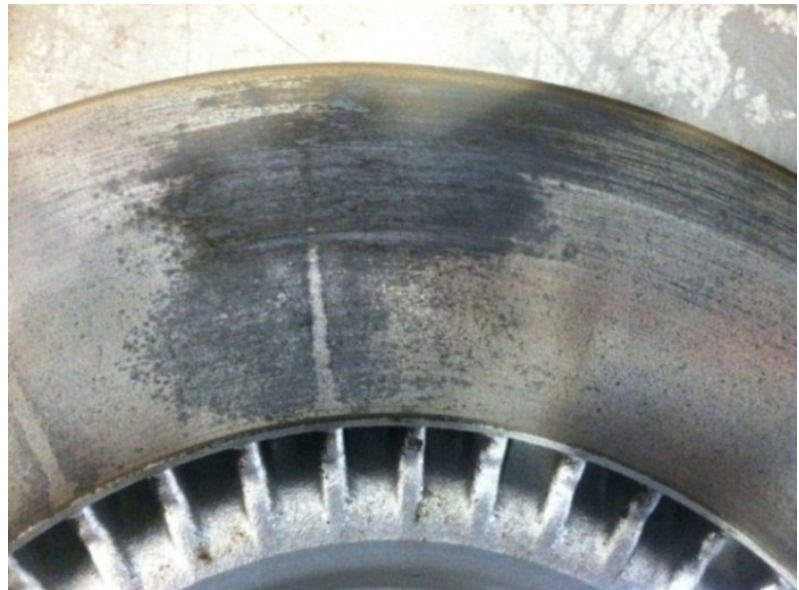
Figure 1. Brake pad marks on brake disc.

- If vibration or pulsation is felt while braking (in brake pedal or in entire vehicle) at speeds higher than 20 mph, put the vehicle on a lift and inspect the brake discs for pad marks (Figure 1).
- Replace only those brake discs that have pad marks (Figure 1). Use the following part numbers:
 - Front brake disc: **4G0615301A**
 - Rear brake disc: **4H0615601H**

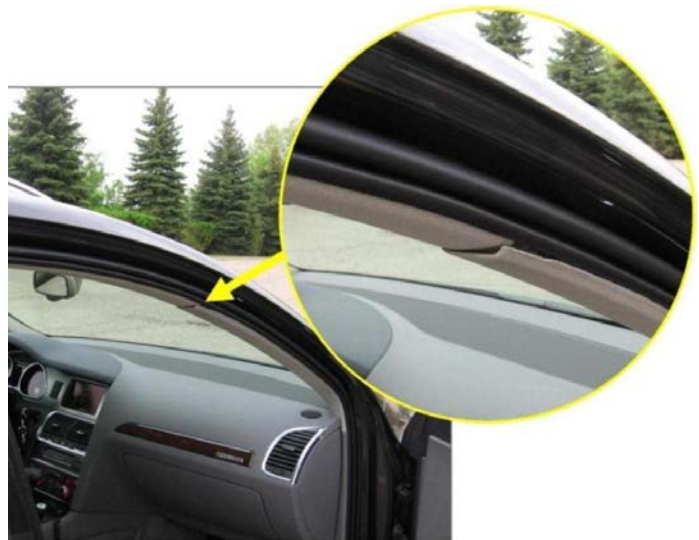
Figure 5. Loose A pillar trim.

- If the A pillar trim on either side of the vehicle is loose or ill-fitting as shown at right (Figure 5), replace the trim.

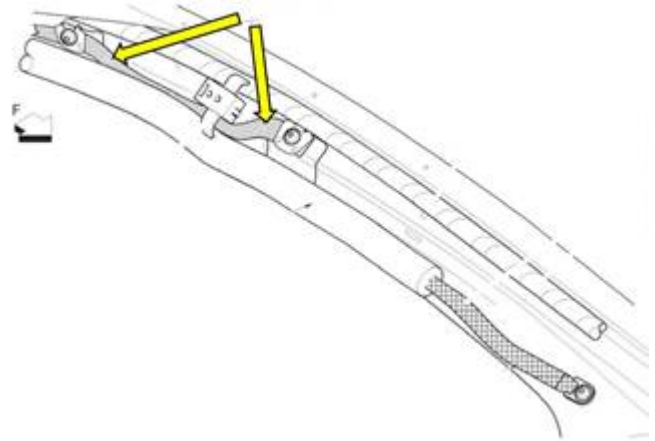
Figure 6. Location of the assembly support strap along A pillar trim bracket.

- When installing the new trim make certain that the assembly support strap is not trapped or pinched between the adapter and the A pillar structure (Figure 6).
