NUMBER: 08-100-14

Loss Of Power Heated Mirror Function - Recall P61 Interim Repair

2011 - 2013 (JK) Jeep Wrangler

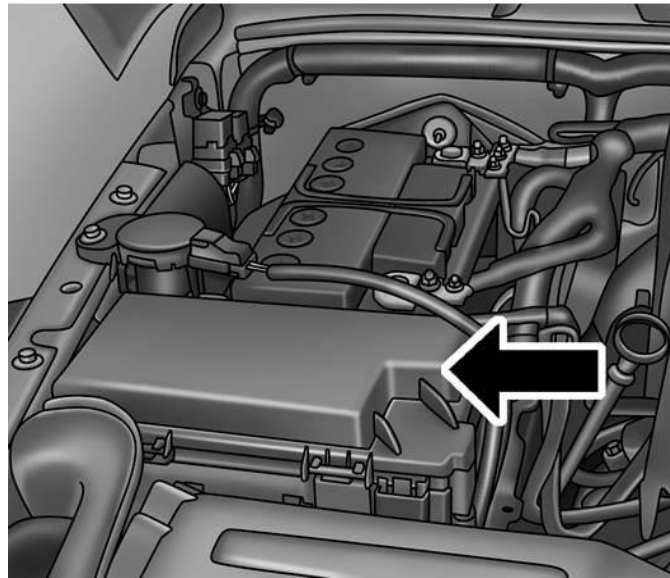
Fig. 1 Totally Integrated Power Module

The power side view mirrors may experience a loss of right and/or left heated power mirror function. Water may travel along the heated power mirror wiring harness and into the heated power mirror electrical connector(s). This can cause corrosion inside the heated mirror connector(s) and the formation of a resistive bridge between the power and ground electrical terminals. A resistive bridge between the power and ground electrical terminals in the heated power mirror connector(s) could cause an electrical fire without warning.

In the meantime, if the customer is uncomfortable with the current situation, remove the 10 amp red M35 heated mirrors fuse from the totally integrated power module (TIPM)([Fig. 1](#)). Refer to the fuse location printed on the back side of the TIPM cover.
