NUMBER: 08-092-14

Electronic Pedestrian Protection System Enhancement

This bulletin involves modifying the Electronic Pedestrian Protection System. Improved calibration for an extended range of driving condition.

2012 - 2013 (JC) Journey (International Only)

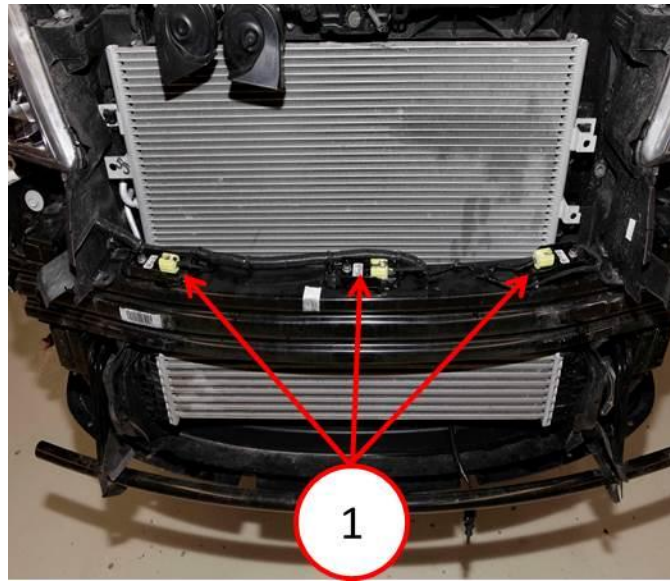
Fig. 1 Pedestrian Protection Sensor Jumper Harness

1 - 3 front bumper beam accelerometers.

- Using a Scan Tool (wiTECH™) with the appropriate Diagnostic Procedures available in TechCONNECT, verify the presence of the DTC's B276AC-13 or/and B276B-13 set in active status under the EPP (Electronic Pedestrian Protection Module) unit. If DTC's are present record them on the repair order and repair as necessary before proceeding further with this bulletin.
- Disconnect the battery negative cable.
- Remove the front fascia. Follow the detailed procedures available in DealerCONNECT/TECHCONNECT, Refer To 13- Frame and Bumpers- Bumpers- Fascia Front- >REMOVAL.
- Un-install the Pedestrian Protection Sensor jumper harness from front bumper beam(Fig. 1). Disconnect from pedestrian protection bumper mounted acceleration sensors and FEM harness.(Fig. 2).

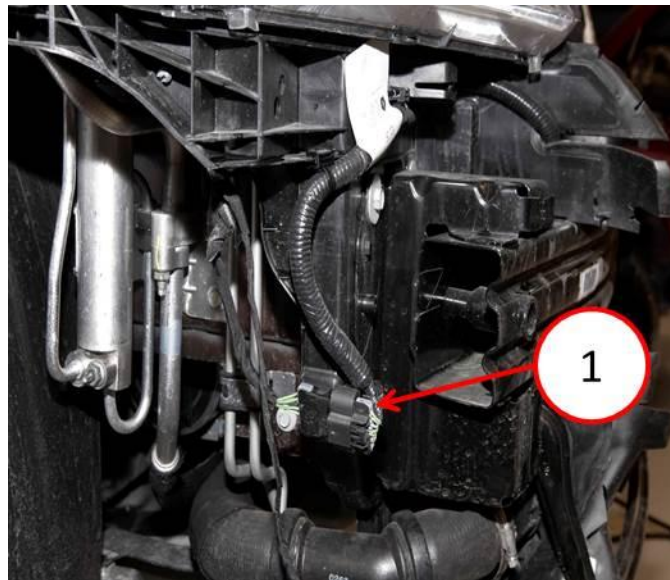
Fig. 2 FEM Harness

1 - FEM connector.

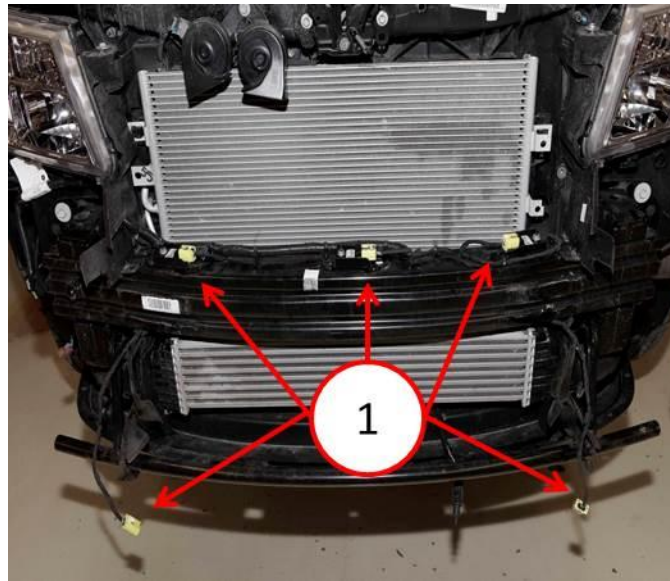
Fig. 3 New Pedestrian Protection Sensor Jumper Harness

1 - 5 sensor connectors.

5. Install new Pedestrian Protection Sensor jumper harness. Connect the three bumper beam mounted Pedestrian Protection sensors and the FEM connector. The remaining two 4-pin connectors are for the two added sensors. They are going to be connected during fascia re-installation([Fig. 3](#)).

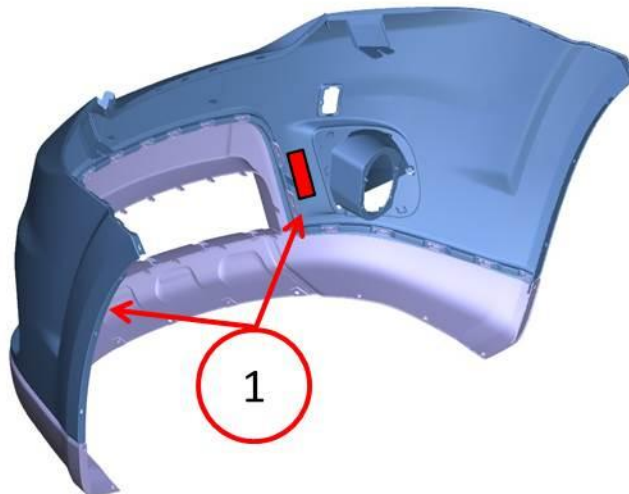
Fig. 4 Front Fascia

1 - Attachment location for left and right sensor brackets.

-
6. Identify attachment location for left and right sensor brackets on the back side of the fascia. They are located left and right of the grill(Fig. 4).

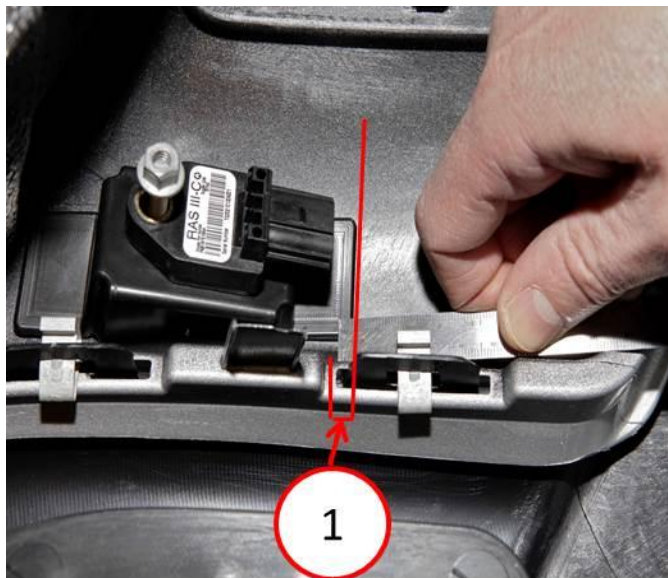
Fig. 6 Safety Sensor Bracket

1 - 5 mm

-
- Wipe away debris and clean thoroughly with an alcohol wipe the areas.
 - Mark right and left sensor bracket locations 5 mm below reference location on fascia([Fig. 6](#)).

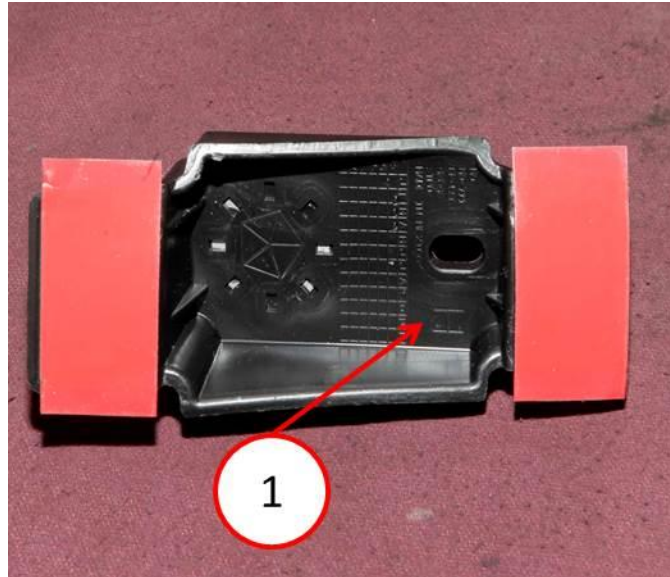
Fig. 7 Safety Sensor Bracket

1 - LH or RH marker location.

-
- Identify left and right sensor bracket looking the RH or LH markers([Fig. 7](#)).

NOTE: Use the LH marked bracket to install the left sensor looking the fascia from the driver prospective and the RH market bracket to install the right sensor.

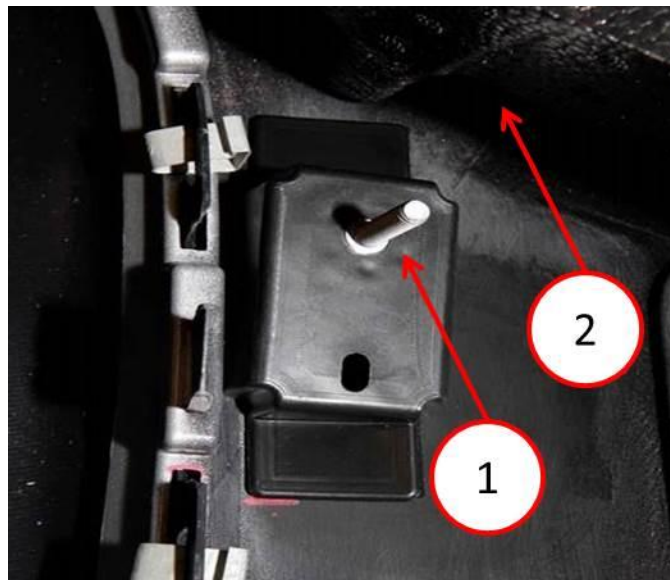
Fig. 11 Right Bracket Correct Installation

- 1 - Fastening Bolt
 - 2 - Foam Material
-

-
18. Using pull tab, remove protective backing from tape on the right sensor bracket tabs.
 19. Orientate sensor bracket with fastening bolt up relative to top of fascia (Fig. 11).
 20. Align the bottom sensor mounting tab with the location marker. Align sensor bracket vertically with the edge of fascia and firmly press into place (Fig. 11) and (Fig. 12). The bolt on the bracket is toward the top of the fascia, toward the foam.

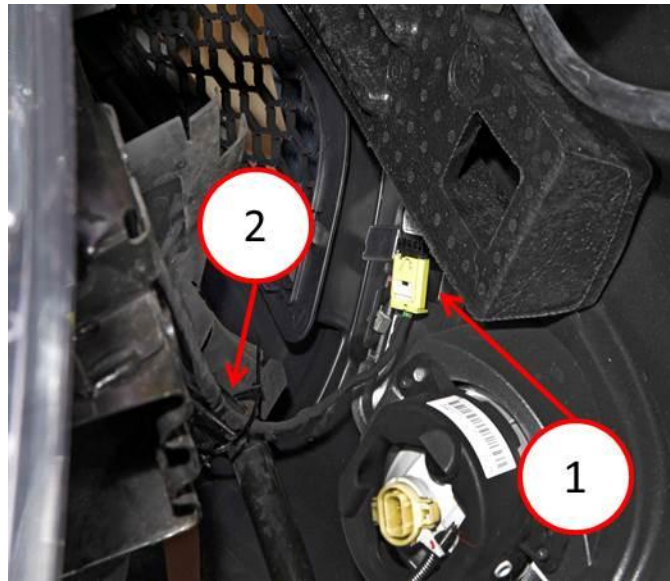
Fig. 16 Sensor Connector

- 1 - Right sensor connector
- 2 - Right zip tie location

-
24. Prior to installing the front fascia, secure the jumper harnesses to the frame using two zip ties as shown into the picture (Fig. 15) and connect the jumpers 4-pin connectors to the left and right sensors previously installed (Fig. 16).
