**NUMBER:** 23-027-14

Zinc Coating Missing From Left Rear Close Out Panel

2015                      (JK)                                      Wrangler

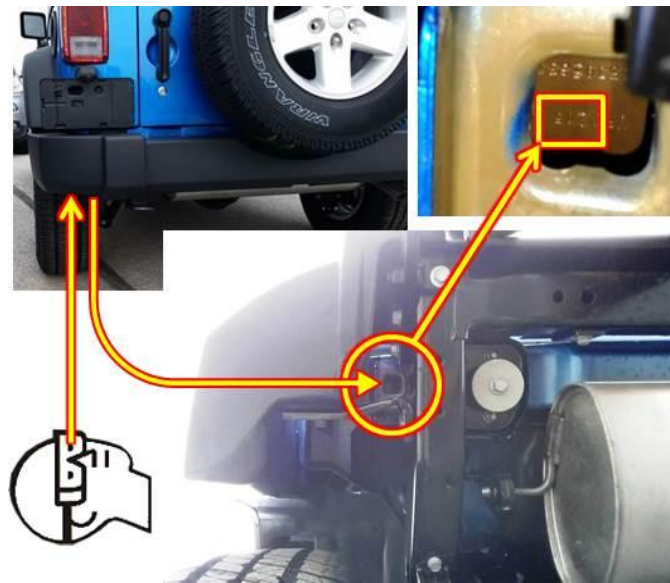
**Fig. 1 Left Rear Close Out Panel Inspection**

1. On the left rear corner of the vehicle, behind the wheel, next to the frame, using a flash light, look in the hole identified in (Fig. 1).
2. Inspect the Julian date on the left rear close out panel (Fig. 1) and (Fig. 2).
3. Was the Julian date 205 ? (Fig. 2)
  - a. YES>>> Contact your Area Manager or Business Center Customer Relations/Warranty Manager for buy back instructions.
  - b. NO>>> This bulletin does not apply. Return vehicle to stock or customer.
