ARTICLES CONTAINED IN THIS ISSUE

01 QMR OF THE MONTH

12 2014 FORESTER POWER REAR TAILGATE

02 DISCOLORATION OF CYLINDER WALLS

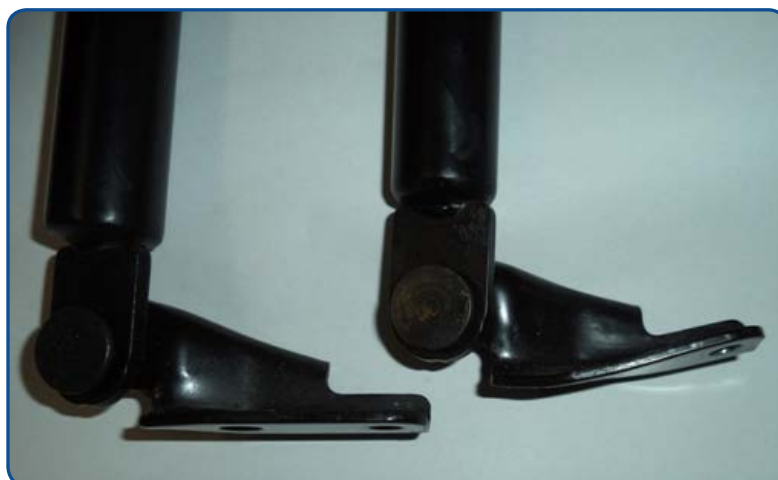
Should you receive a customer complaint of the power rear tailgate not working properly and you have checked the system for Diagnostic Trouble Codes and found a DTC B250F (Rotation Sensor Failure), make sure the rear gate stays are not bent at the attachment bracket as shown in this photo to the right. If this condition is confirmed, the gate stay will need to be replaced. Do not attempt to repair the bent bracket.

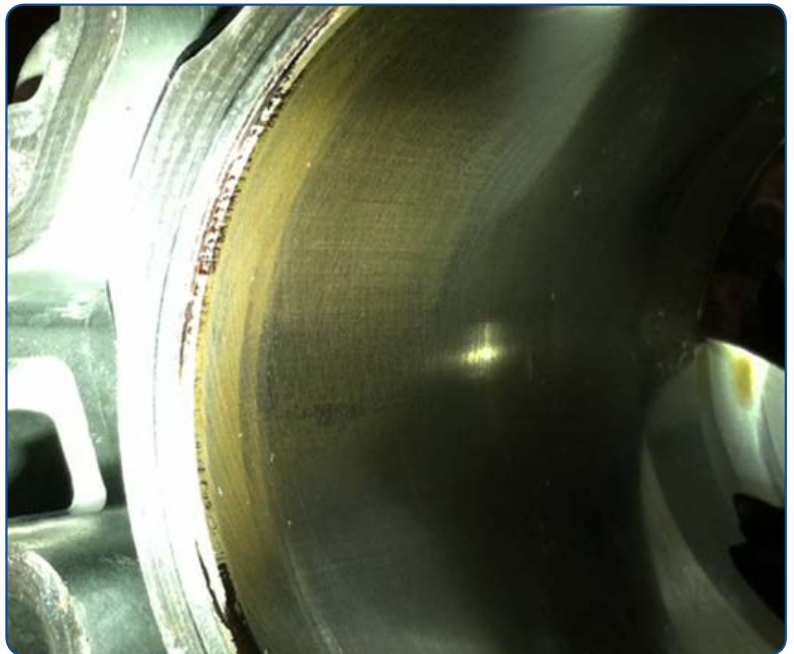
In some cases, the Technician also reports measurements are out of specification when measuring the cylinder bore. It is required per the Service Manual that the cylinder bore must be checked at 68 degrees Fahrenheit, otherwise some variations are normal. The photo to the right is an example of this discoloration. It is in no way harmful to install the updated piston rings and use the existing block.

The SOA Techline and Quality Assurance sections of the Service Department have recently had inquiries regarding cylinder wall discoloration noticed during installation of the updated piston rings.

All of the Oil Control Ring TSBs have been recently updated on STIS with additional helpful information based upon field feedback, please make sure to review all of the enhancements. We frequently encourage all technicians to download the very latest Service Bulletin from STIS before performing it to ensure they have the latest information available.
