# Technical Bulletin

Model(s)	Year	Eng. Code	Trans. Code	VIN Range From	VIN Range To
Passat	2011-2012	All	All	A3_BC000001	A3_CC025567
Passat	2014	All	All	A3_EC050001	A3_EC103000

**40 14 03** June 24, 2014 **2028353** Supersedes V401402 dated May 21, 2014 to extend the 2014 Passat VIN range.

### Front Suspension Creaking Noise

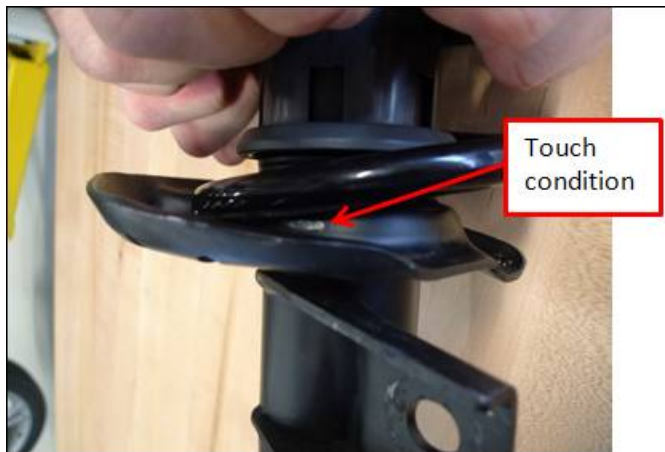
Figure 1

Front suspension creaking noise during suspension cycles (going over speed bumps or entering on an inclined surface).

Coil Spring is not formed correctly and rubs against the perch of the strut.

- Verify if a car with the creaking noise has the contact mark (on one side or on both sides) as shown in figure 1.

- Remove affected suspension strut and disassemble, see Repair Group 40 in Elsa.
- Apply touch up paint to the contact area of the strut perch and allow required drying time.

Use Rustoleum Cold Galvanizing Compound # V2185838 (or similar obtained locally), 2 coats.

Cover with Rustoleum Flat Black Spray Paint # V2178838 (or similar obtained locally), 1 coat.

- Install new spring on suspension strut (**per vehicle PR-codes**).
- Install suspension strut, see Repair Group 40 in Elsa.
