Model(s)	Year	Eng. Code	Trans. Code	VIN Range From	VIN Range To
Passat	2012-2013	All	All	A3_CC049991	A3_DC139587

55 14 03 September 24, 2014 **2033945** Supersedes Technical Bulletin V551302 dated June 10, 2013 to include fuel door sticker information.

Fuel Door Sticks or is Difficult to Open

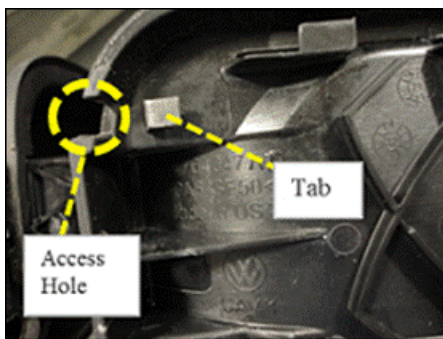
Figure 5

Close up of access hole and locking tab.

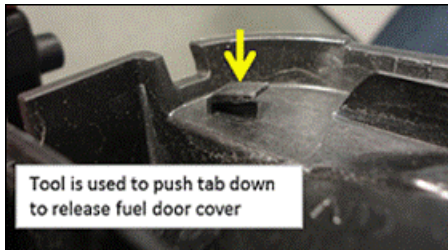
Figure 6

Close up of locking tab.

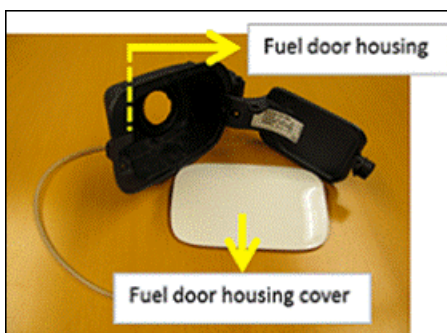
Figure 8

Picture of separated components.

When performing actions 1 and 2 together, the outer skin will slide and release from the inner hinge (Figure 8).
