Technical Bulletin

87 14 09 September 24, 2014 2019947 Supersedes T.B. V871205 dated September 7, 2012 to include additional models, model years and add additional flushing adapters.

Air Conditioning, Cleaning of the Refrigerant Circuit (U.S.Only)

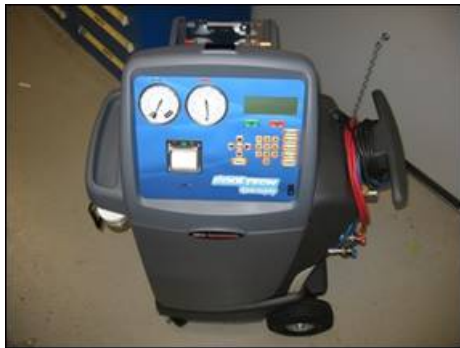
Figure 1. The ROB134APF Air Conditioning Service System with VAS 6337/1A Air Conditioning System Flushing Device.

- Use the ROB134APF Air Conditioning Service System with VAS 6337/1A Air Conditioning System Flushing Device (Figure 1) Used for effective refrigerant handling and air conditioning circuit flushing after air conditioning component failure.
- Now air conditioning system refrigerant recovery, evacuation, recharge *and* refrigerant circuit cleaning after component failure can be performed with a single servicing station.

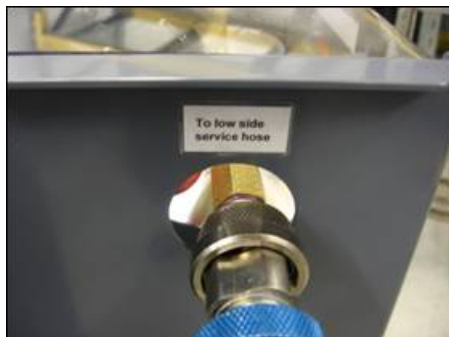
Figure 2. A flushing attachment port.

4. Once the appropriate adapters are in place, connect the service station to the vehicle through the air conditioning compressor hoses. The flushing attachment ports are labeled on the flusher (Figure 2 and Figure 3).

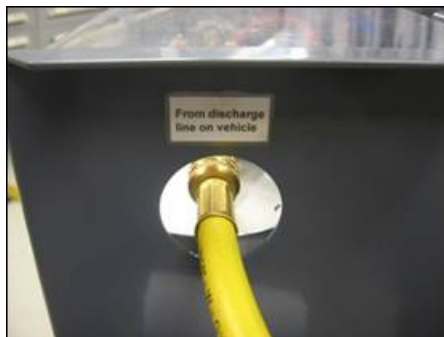
Figure 3. A flushing attachment port.

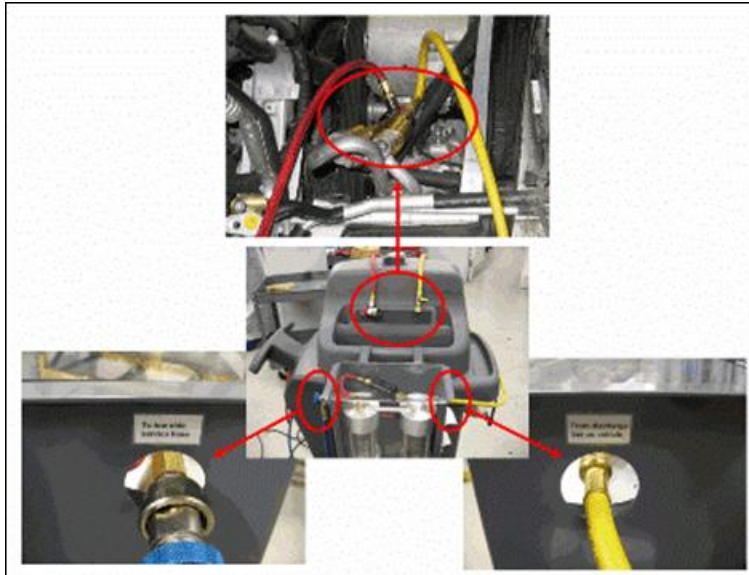
Figure 4. Connection strategy: Vehicle to service station to flushing device.

- This connection strategy allows for a system flush **in the opposite** direction of the normal refrigerant flow (Figure 4).

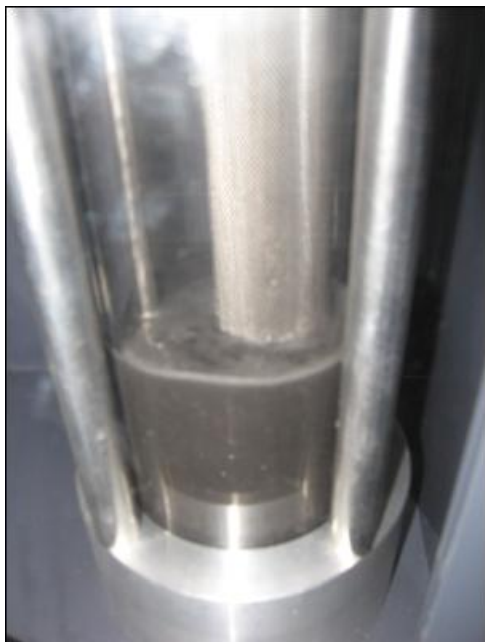
Figure 5. The first cycle.

- The flush program will begin with an evacuation of the system and a rate of rise test. This is necessary to test the integrity of the connections before the flush cycles begin. If the rate of rise test passes, the program will proceed into the flush cycles. (Figures 5 – 7). These cycles will occur automatically in succession.

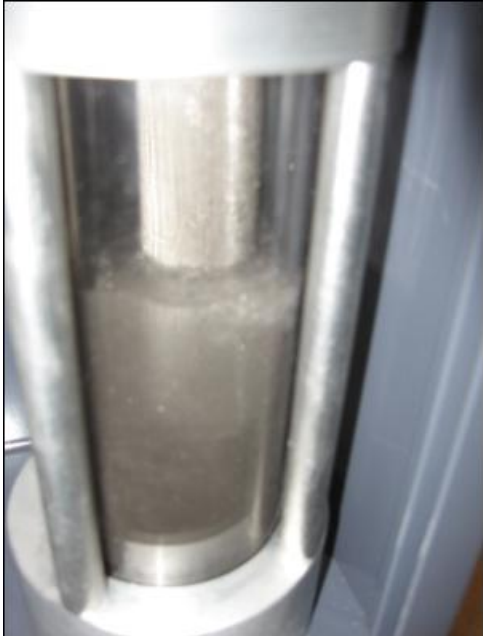
Figure 6. *The second cycle.*

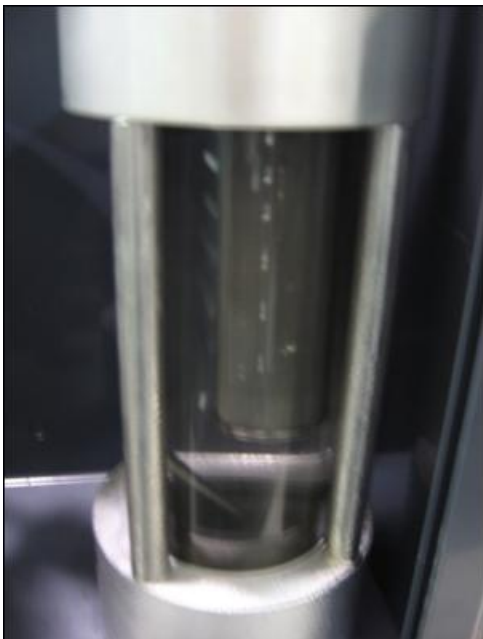
Figure 7. *The third cycle.*

- The debris is then rinsed from the circuit and contained within the filtration in the flusher. After the flush program, the system will be evacuated.

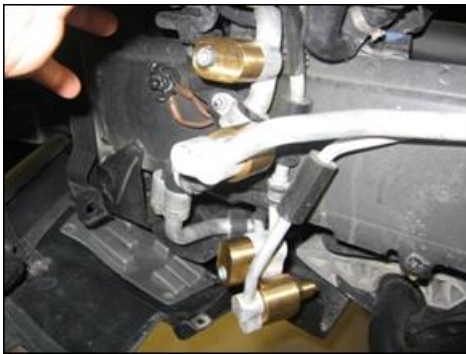
Figure 8. The location of the connections inside the left front wheelhouse on a Touareg with four zone climate control.

1. Separate the front and rear air conditioning systems for individual rinse operations.

The VAS 6338/1 contains the necessary adapters to separate the systems for the individual rinse operations.

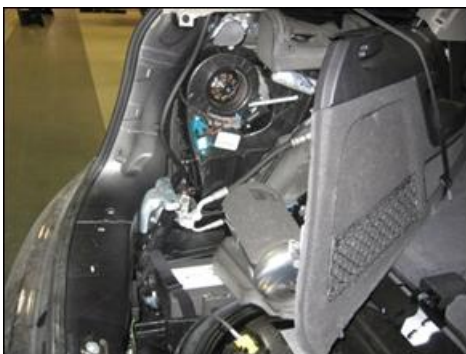
Figure 9. Location of rear air conditioning unit and expansion valve.

2. Bypass the rear expansion valve with an adapter from the VAS 6338/1.
3. Flush rear A/C.

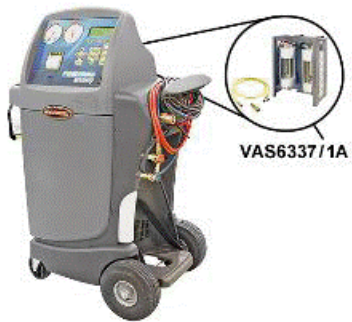
<p>ROB134APF</p>
<p>Air Conditioning System Flushing Device</p>

Tool Description	Tool No:
<p>Air Conditioning Service System.</p>

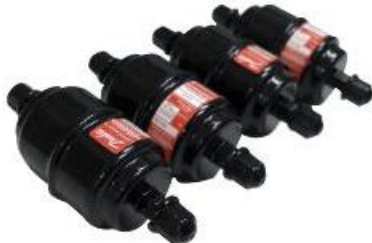
<p>Adapter set for refrigerant circuits</p>
