UPDATE Technical Bulletin

UPDATE – 01A3 Coolant Flush (NVLW) – U.S. ONLY

Model(s)	Year	Engine Code	Trans. Code
Passat	2014	1.8T (CPRA, CPKA)	All

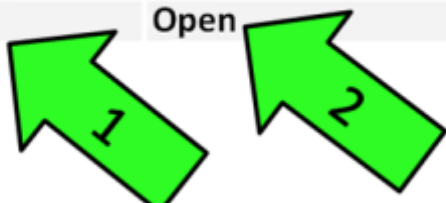
EXAMPLE

- Enter the VIN in ElsaWeb and proceed to the "Campaign/Action" screen.
- ⇐ Ensure that the Status is "Open" <arrow 2>.
- ⇐ Note all Applicable Criteria ID <arrow 1> for use in determining the correct work to be done and associated parts.

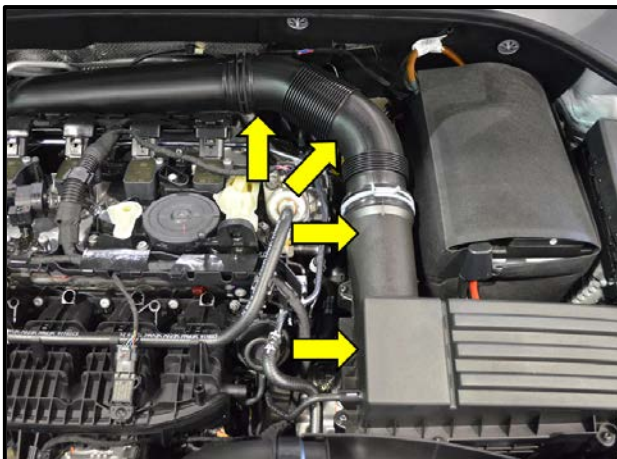
⇐ Remove the air filter housing and intake tube <arrows>.

Tip: It is only necessary to remove the first section of plastic duct work. Only the driver side of the engine area needs to be accessed during this repair.

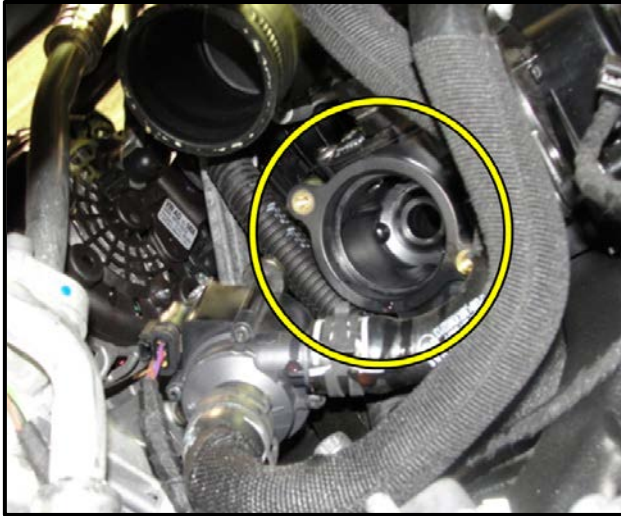
- Remove the fill cap from the cooling system reservoir.
- Raise the vehicle on an appropriate hoist.
- Remove the plastic underbody shield.
- Remove the lower charge air cooler hose between the charge air cooler itself, and the throttle body connection.
- Position a coolant drain pan under the vehicle.
- ⇐ Remove the thermostat housing and thermostat <circle>.
- Allow the cooling system to drain.

Tip: It is not necessary to remove the lower radiator hose from the thermostat housing. The housing can remain attached to the hose during the flush procedure.

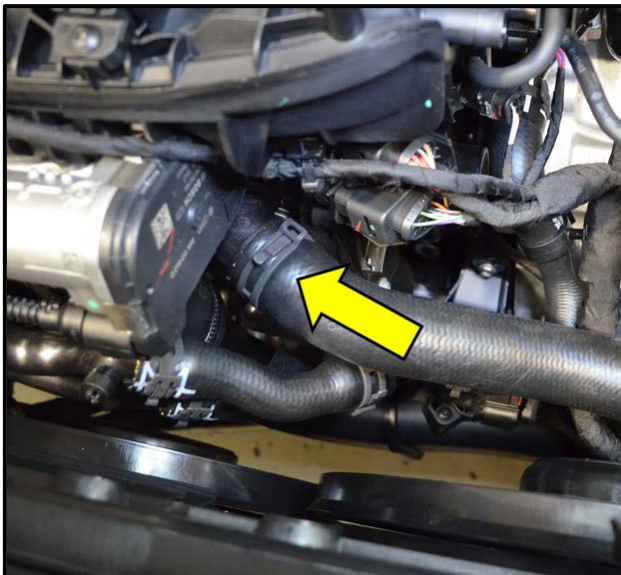
- Lower the vehicle to allow access to the top side of the engine compartment.
- ⇐ Disconnect the upper radiator hose from the engine <arrow>.

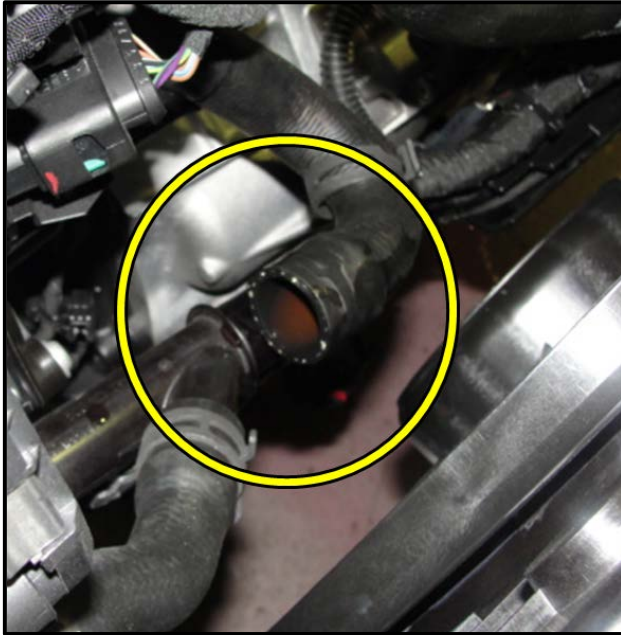
- ⇐ Disconnect the heater core hose from the “Y” connection near the driver side cooling fan <circle>.

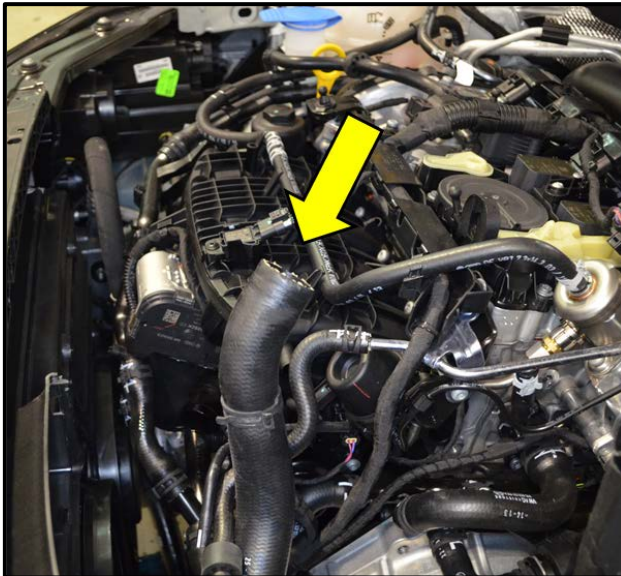
- ⇐ Using a hose and running water, flush the radiator by adding water to the disconnected end of the upper radiator hose <arrow>.
- Flush the radiator until only clean, clear water is coming out of the lower radiator hose.

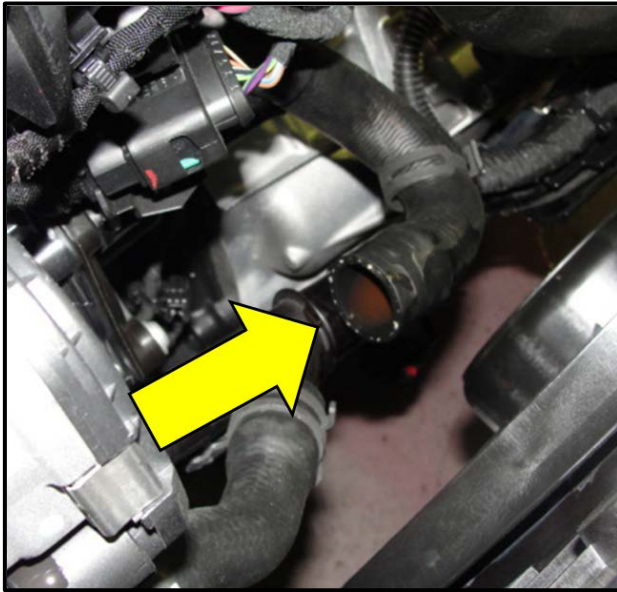
- ⇐ Using a hose and running water, flush the heater core by adding water to the heater core hose where shown <arrow>.
- The water, coolant, and any remaining contamination will flow out of both the open thermostat housing, as well as the male end of the “Y” connection.
- Flush the heater core until only clean, clear water is coming out of both the thermostat housing and the “Y” connection.

Tip: It will be necessary to use water pressure to flush the heater core. Use a shop towel to seal the fresh water hose to the heater hose during the flush procedure.

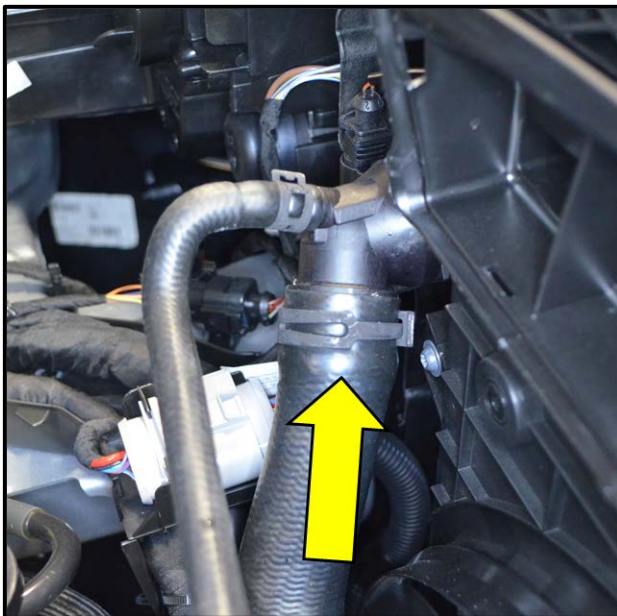
- Pour about one gallon of clean water into the cooling system reservoir.
- Reinstall the fill cap onto the cooling system reservoir.
- Reattach the upper radiator hose to the engine.
- ⇐ Remove the upper radiator hose from the radiator (clamped connection) as shown <arrow>.

WARNING: The fill cap **MUST** be reinstalled onto the cooling system reservoir prior to flushing the engine block.

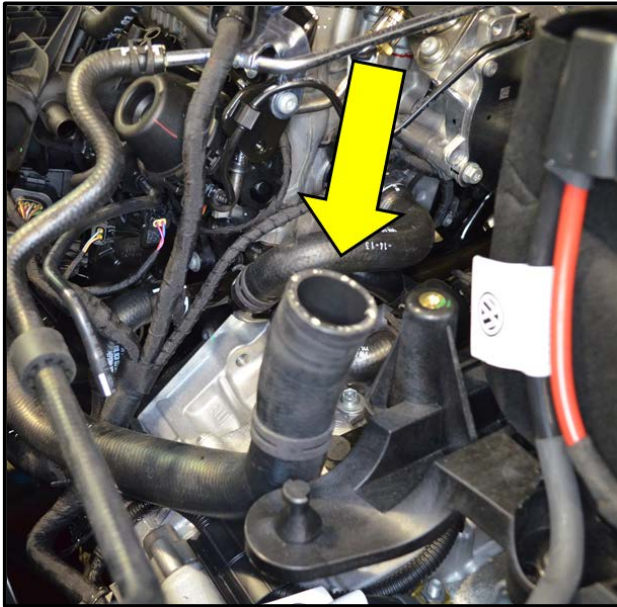
- ⇐ Using a hose and running water, flush the engine block by adding water to the upper radiator hose where shown <arrow>.
- The water, coolant, and any remaining contamination will flow out of the open thermostat housing.
 - Flush the engine block until only clean, clear water is coming out of the thermostat housing.

Tip: It will be necessary to use water pressure to flush the engine block. Use a shop towel to seal the fresh water hose to the upper radiator hose during the flush procedure.

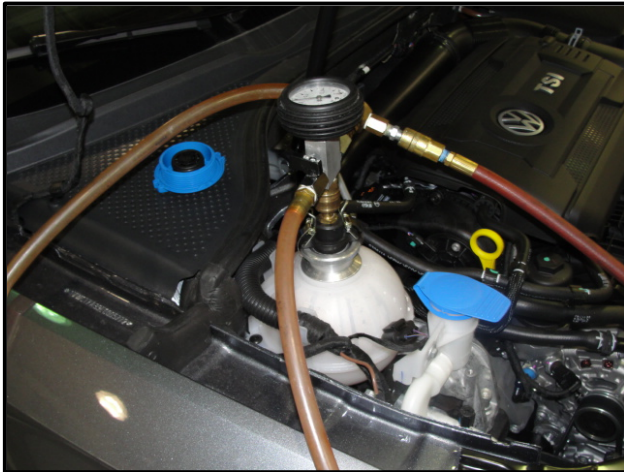
- Refill the cooling system using the VAS 6096 Coolant System Charge Kit and VAG 1274/8 adapter. Refer to ElsaWeb Repair Manual→Engine→19 Cooling System for instructions on filling.
- When the system is full remove the tool and fitting from the coolant reservoir.
- Install the fill cap onto the coolant reservoir.
- Start the vehicle, let it idle, allow it to reach operating temp, and monitor the coolant level to verify the system was properly filled.
