Service Bulletin

SUBJECT: Service Update for Inventory and Customer Vehicles
Door Striker Appearance
Expires with Base Warranty

MODELS: 2014 Chevrolet Cruze

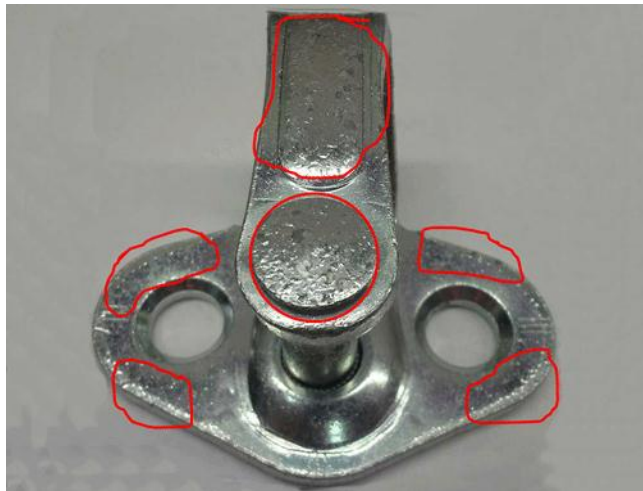
3975216

This bulletin provides a service procedure to replace all door strikers on **certain** 2014 model year Chevrolet Cruze vehicles. The door strikers on these vehicles may have been incorrectly plated, giving the appearance of "pitting". There are no safety issues with the strikers; this is only an appearance issue.

Example of Unacceptable Part

For vehicles that have unacceptable parts, use the following steps to replace the side door latch striker(s).
