SUBJECT: Service Update for Inventory and Customer Vehicles
220 Amp Generator Fuse Block Corrosion
Expires with Base Warranty

MODELS: 2015 Chevrolet Silverado 2500 HD
2015 GMC Sierra 2500 HD
Equipped with 220 Amp Generator RPO KW5

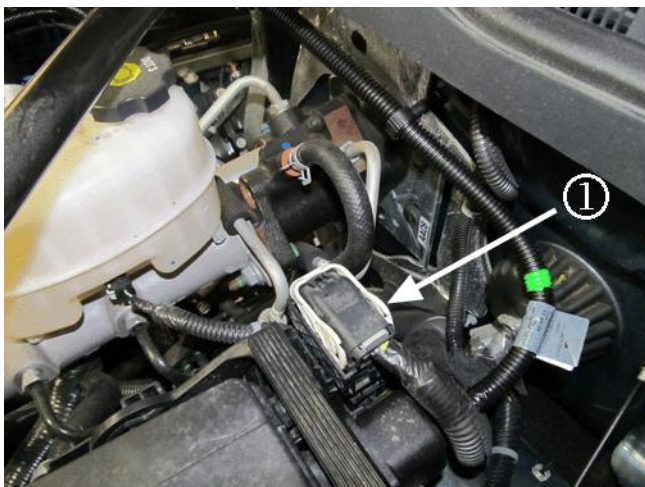
4001472

Tip: Shown in the graphic above, for easier access to the positive battery cable fastener at the junction box, disconnect the X121 connector (1).

5. Mount the new fuse battery distribution unit engine compartment block by snapping the block onto the battery lip.

Note: If disconnected during previous step, reconnect the X121 connector (1) after installation of the new cable.

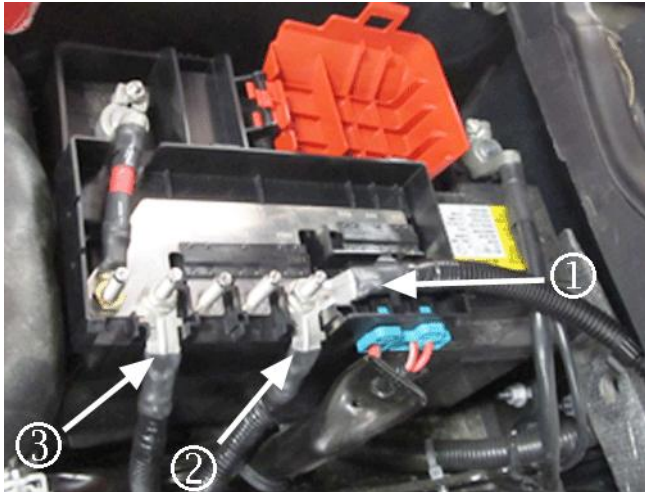
4001475

Note: Position the rearward generator harness eyelet (2) on rear post at stamping #2, on top of the positive battery cable eyelet (1) at stamping #1. Position the forward harness eyelet (3) on the forward post at stamping #5.

9. Install the new generator battery control wiring harness. Refer to *Generator Battery Control Wiring Harness Replacement (L96, LC8)* in SI.

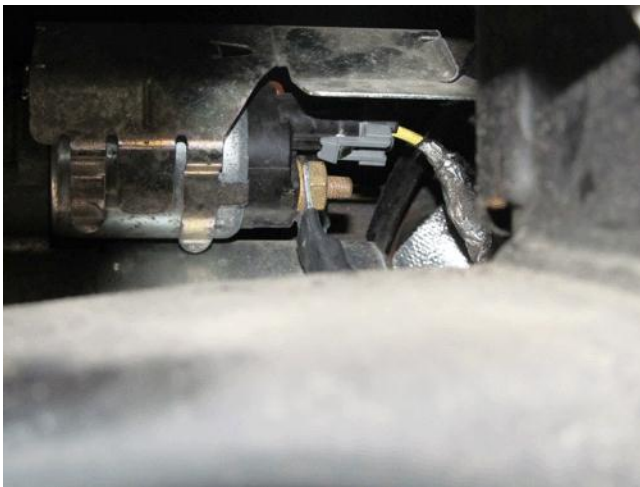
4001476

Tip: Shown in the graphic below, for some vehicle models the cable connection at the starter and the retainer connection to the frame may be easier accomplished through the right wheelhouse liner.

10. Complete the installation of the fuse battery distribution unit engine compartment block. Refer to *Fuse Battery Distribution Unit Engine Compartment Block Replacement* in SI.
11. Reinstall the upper intake manifold sight shield. Refer to *Upper Intake Manifold Sight Shield Replacement*. SI.
