# Technical Service Bulletin

## 40 Shock absorber leaks: assessment aid

40 14 41 2018194/6 July 2, 2014. Supersedes Technical Service Bulletin Group 40 number 13-34 dated September 23, 2013 for reasons listed below.

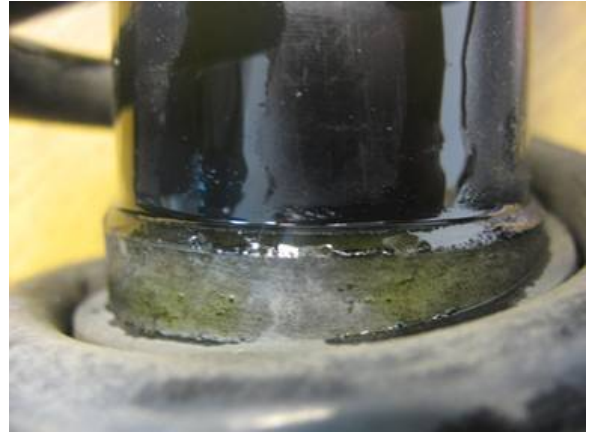
A leaking shock absorber is characterized by a wet film of oil running down the pipe (Figure 1 and Figure 2).

*Figure 1. A leaking shock absorber.*

Leaking shock absorbers need to be replaced.

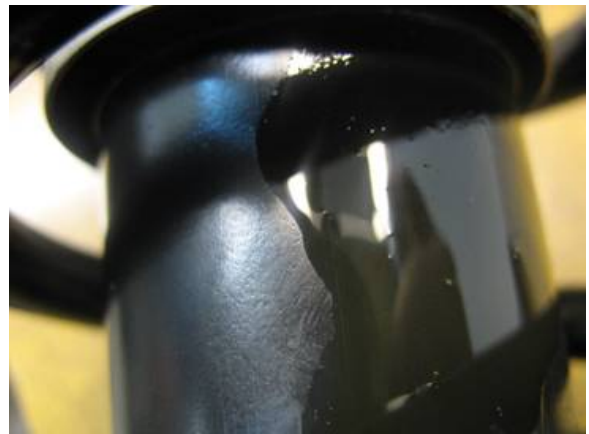
*Figure 2. A leaking shock absorber.*

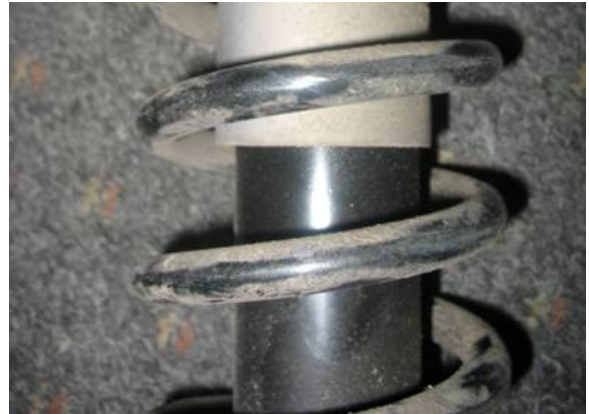
A light film of dried oil or oil marks on the pipe beneath the dust guard are not a clear indicator of a leaking shock. These marks are a result of residue from when the shock was filled during production, or of slight condensation in the seal area. This small amount of oil is for lubrication and it reduces wear on the seal (Figure 3 and Figure 4).

*Figure 3. A shock absorber that is not leaking.*

This condition does not affect the shock absorber. No repair is necessary.
