# Service Bulletin

Bulletin No.: PI0686B

**Subject:** Front Seat Lateral Movement, Clunk, Squeak, Click Noise or Shift While Cornering

**Models:** 2012-2014 Buick Verano  
2011-2014 Chevrolet Cruze  
2014 Chevrolet SS  
Equipped with RPO A53, ADS, AH4 6-Way Power or 6-Way Manual Driver or Passenger Seat

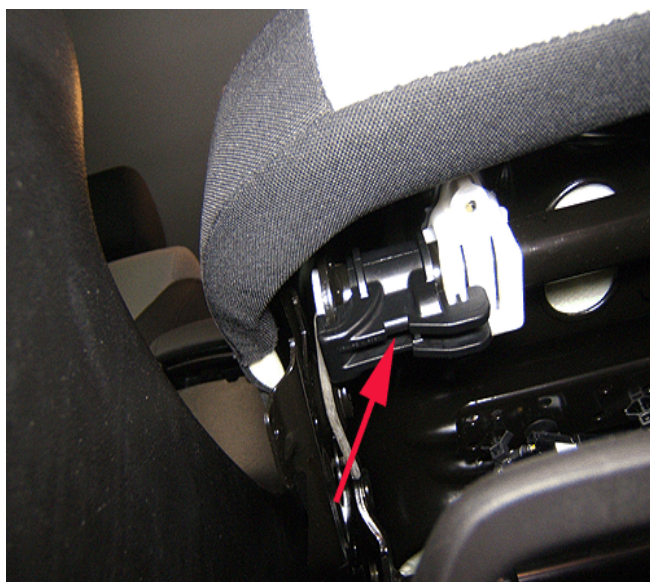
2773109

2. Locate the front crossbar as shown (1).
  - Identify the inboard guide block (2) on manually adjusted seats (closest to center console).
  - Identify the outboard guide block (2) on power adjusted seats (closest to door).

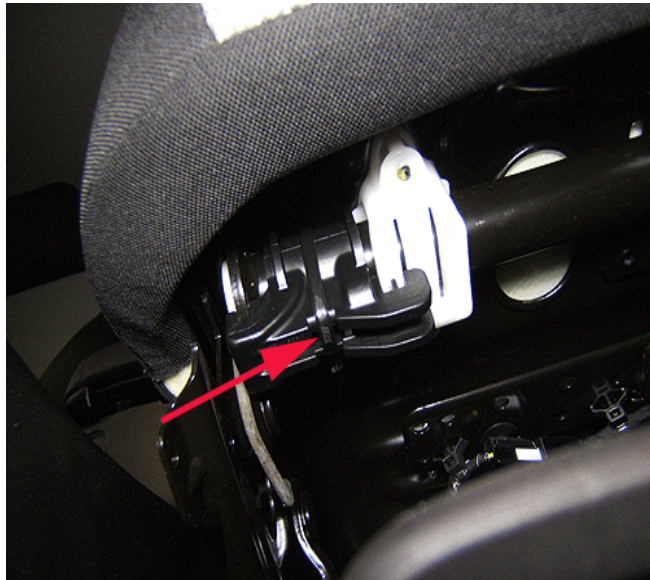
2773113

**Note:** Spray Super Lube, P/N 12346241, or equivalent to the areas on the white clip, as shown in the illustration above, to ensure that the noise is eliminated.
