## INSTRUCTION TO SERVICE

**ITS: 5322**

| <b>SUBJECT:</b> | ISE Cooling Loop Bypass Removal |

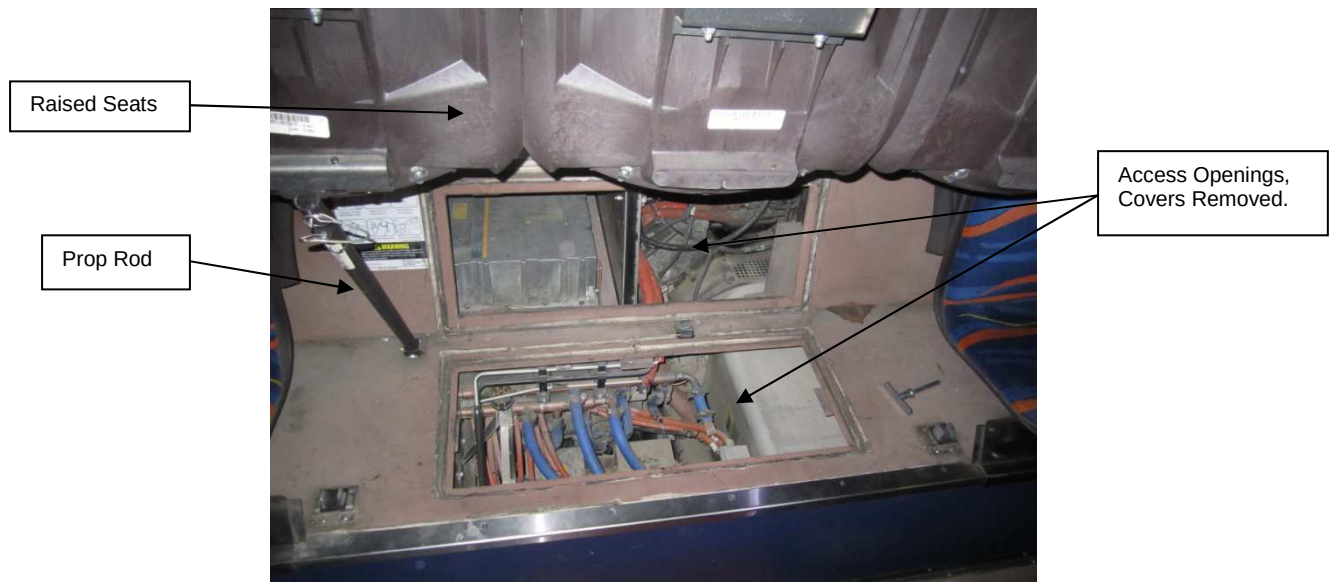
**Figure 1: Access Openings Under Chesterfield Seats.**

2. Locate the center three chesterfield seats at the rear of the passenger compartment. Pivot the seats upward and install the prop rod to allow access to the removable panels under and behind the seats. Figure 1.

3. Using a square key, release the access cover latches and remove the access covers. Figure 1.
