Technical Service Bulletin

57 Door cannot be opened from outside, it can only be opened from inside

57 14 99 2029151/5 January 3, 2014. Supersedes Technical Service Bulletin Group 57 number 13-87 dated March 27, 2013 for reasons listed below.

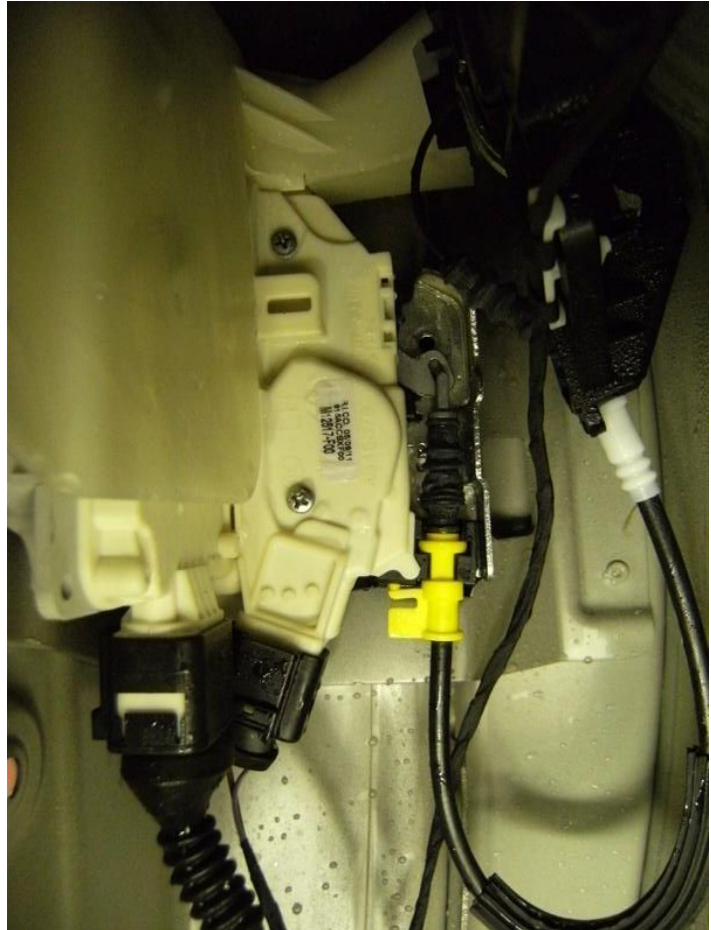
When fitting the Bowden cable from the mounting bar to the door lock, the cable can get kinked. In some cases, this can increase the inner friction of the strand in the Bowden cable. As a result, the door lock stays in pressed position or does not completely return to its zero position (Figure 1).

Figure 1. Bowden cable routing.

1. Replace the cable. The bow does not need to be replaced unless damage to the component is evident. Remove/install the latch carrier ("bow" according to ETKA) and Bowden cable together, as a set, according to the repair manual:

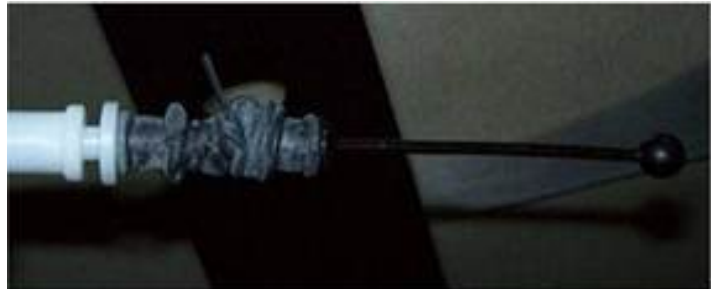
When the Bowden cable gets twisted during the installation, the rubber grommets can get distorted. Consequently, the Bowden cable has a too-high inner friction and the door lock does not move to the zero position (Figure 2).

Figure 2. Distorted rubber grommets.

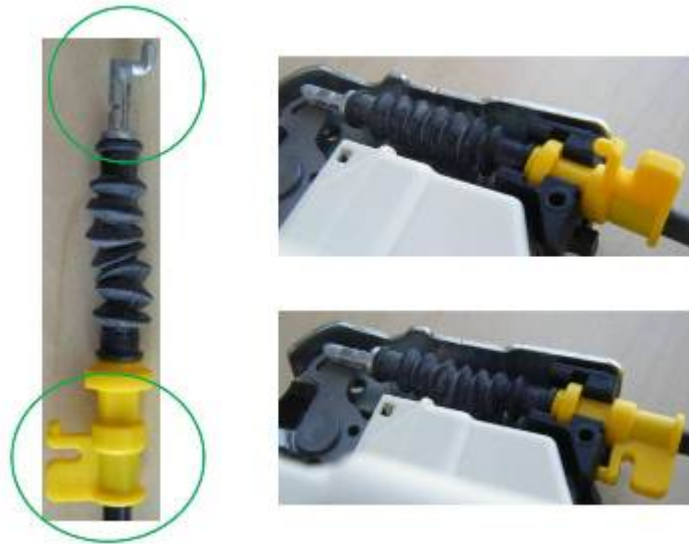
Improved cable with 'L'-shaped attachment (Figure 3). Improved positioning of the locking collar.

Figure 3. Improved cable.

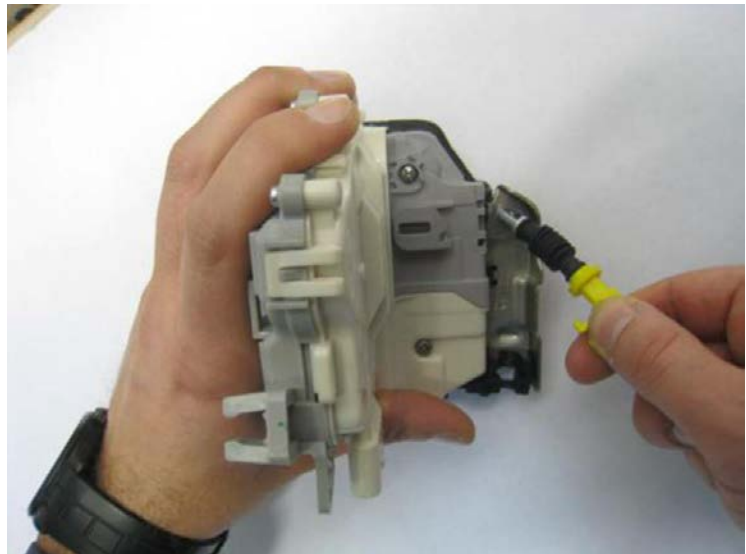
Figure 4. Holding the yellow sleeve in the lock.

- a. Position the Bowden cable by holding the yellow sleeve in the lock (Figure 4).

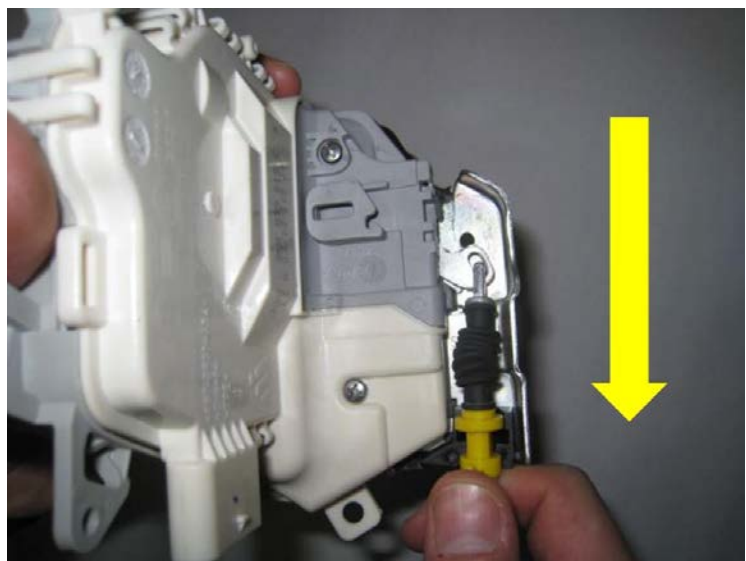
Figure 5. Pulling down the Bowden cable.

- b. Pull down the Bowden cable by holding the yellow sleeve (Figure 5). The locking mechanism is pulled along and the Bowden cable is locked. Slot in the yellow locking mechanism to the left.

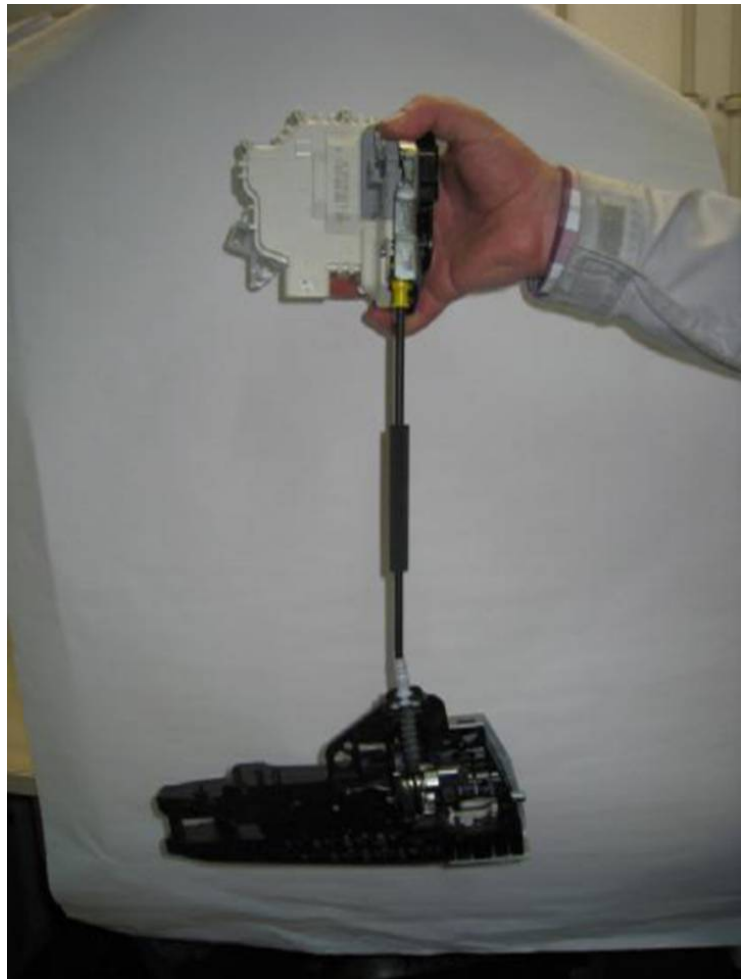
Figure 6. Do not turn the lock or the mounting bar.

- c. Do *not* twist the Bowden cable after the installation. To avoid twisting the cable, turn neither the lock nor the mounting bar (Figure 6).
