## TECHNICAL BULLETIN

LTB00566NAS3

## Fuel Gauge Operation Inaccurate

**CONDITION SUMMARY:****Changes are NOT highlighted.****Situation:** The fuel gauge may be inoperative or inaccurate.**Cause:** These issues may be caused by fretting corrosion across the fuel sender harness pins inside the fuel tank.

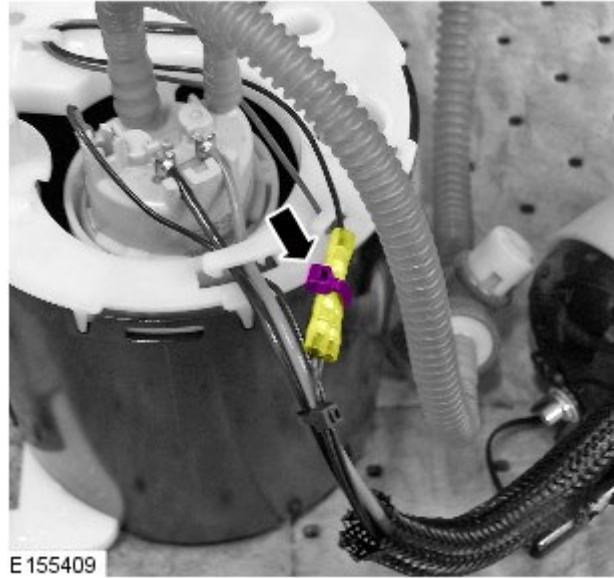
E155409

**9.** Using a suitable tie strap, secure the two splices together.
