<b>POLARIS TECHNICAL SERVICE BULLETIN</b>		
Date: October 30, 2013 Revised: 01/27/2014 Expiration Date: December 31, 2015	<div style="text-align: center; font-size: 2em; font-weight: bold;">GEM</div>	Bulletin Number: L-13-03 / A / B Model Year(s): 2012-2013
<input type="checkbox"/> Safety Bulletin	<input checked="" type="checkbox"/> <b>Service Bulletin</b>	<input type="checkbox"/> Service Alert Fax <input type="checkbox"/> Production Update Kit
Distribution: <input type="checkbox"/> Owner / Principle <input type="checkbox"/> Service Manager <input type="checkbox"/> Sales Manager <input type="checkbox"/> Parts Manager <input type="checkbox"/> Technicians		
<i>This Service Bulletin is located at <a href="http://www.polarisdealers.com">www.polarisdealers.com</a></i> <small>-Confidential and Proprietary-</small>

**Subject: 2012-2013 GEM e6 / eXLD Deka 8G8VGC Battery Replacement**

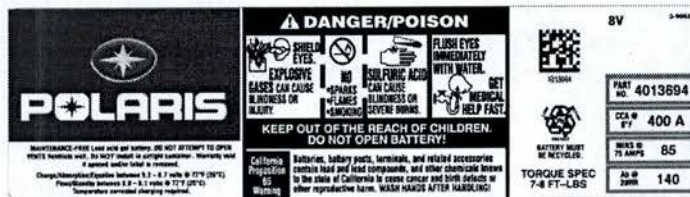
This issue could cause a short circuit that could cause decreased performance of the battery to the point of premature failure. In a small number of instances, a short could ignite the gas produced in a battery during charging causing the battery to rupture or "explode" within the battery compartment. **Therefore, the battery compartment should not be opened and the battery should not be handled within 24 hours after charging.** This is crucial to prevent injuries during this replacement effort! Operators should always exercise extreme caution while working with or around batteries. Please reference the below image of the Polaris 4013694 label that provides important battery safety information.

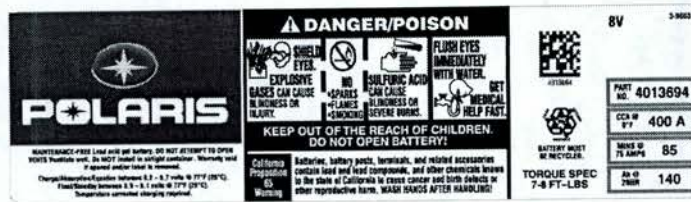
This issue could cause a short circuit that could cause decreased performance of the battery to the point of premature failure. In a small number of instances, a short could ignite the gas produced in a battery during charging causing the battery to rupture or "explode" within the battery compartment. **Therefore, the battery compartment should not be opened and the battery should not be handled within 24 hours after charging.** This is crucial to prevent injuries during this replacement effort! Operators should always exercise extreme caution while working with or around batteries. Please reference the below image of the Polaris 4013694 label that provides important battery safety information.
