**New Jersey Transit: Interior Coolant Line P-Clamp
Replacement**

Property and Top Bus Number: New Jersey Transit – 31 LFW – 2012 - 305000

Issue: Coolant Line P-Clamps Breaking / Loose

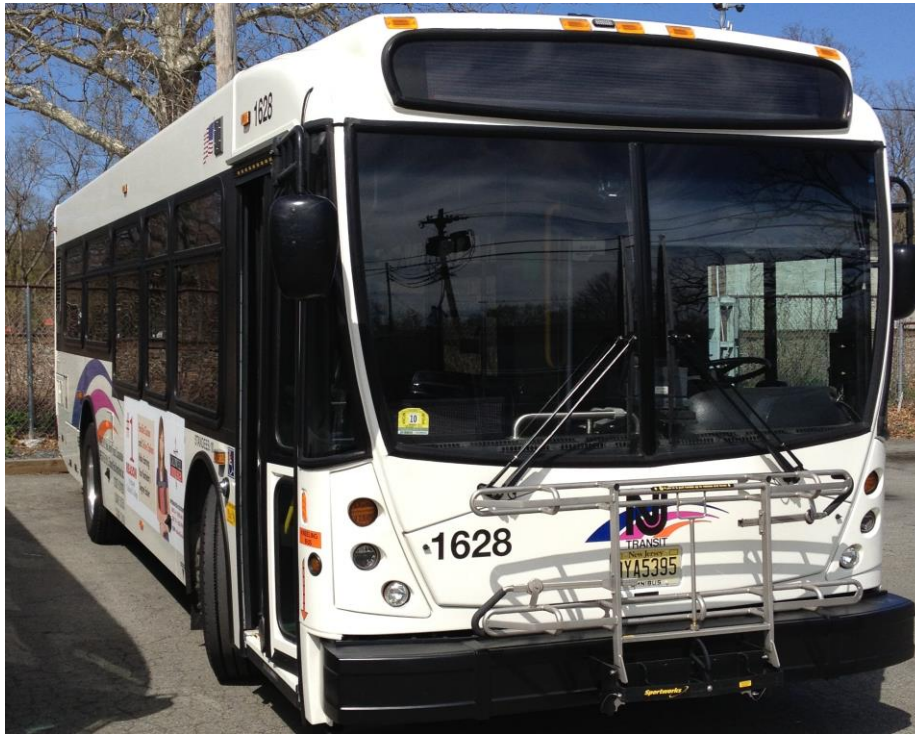
Reason/ cause: Aluminum P-Clamps for Interior Coolant Lines Weak & Do Not Provide Enough Support

Solution: Replace Existing Aluminum P-Clamps with Stainless Steel P-Clamps

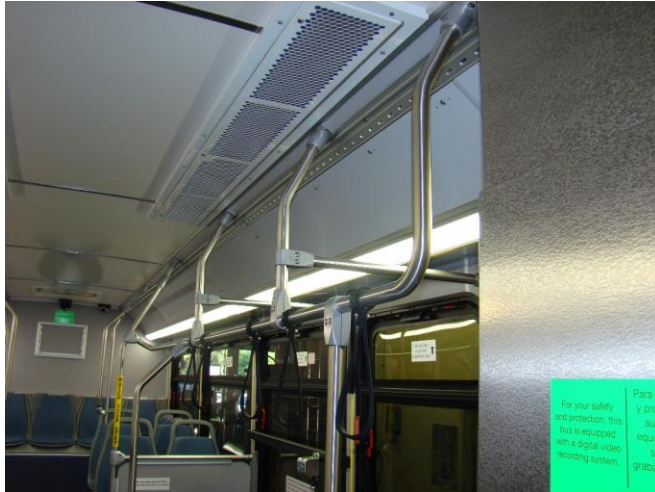
1. Park the bus and apply the parking brake.
2. Locate the street side light panels & open to access the interior coolant lines (see below)

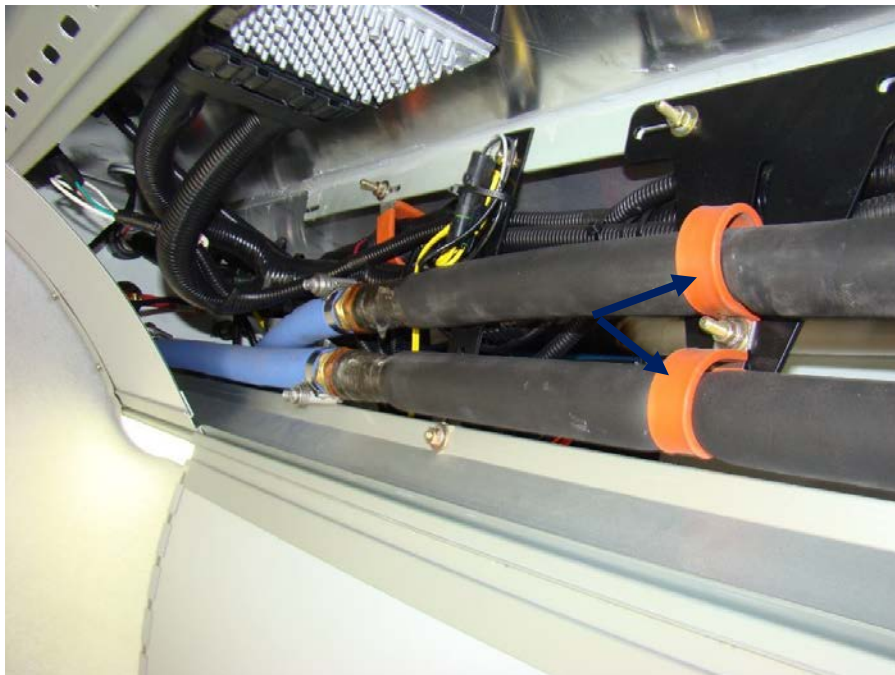
3. Starting from the rear of the bus remove the p-clamps shown (see below).

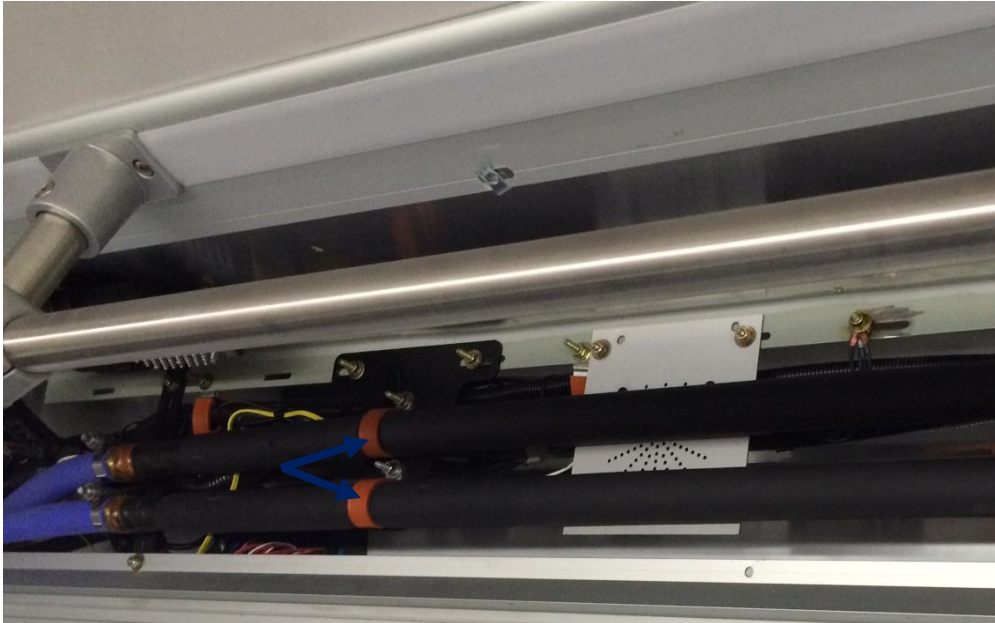
4. Upon installing the the new p-clamps separate the coolant lines on the mounting bracket using the slotted holes in the bracket (see below). When installing the new clamps raise the hardware all the way to the top of the slotted holes.

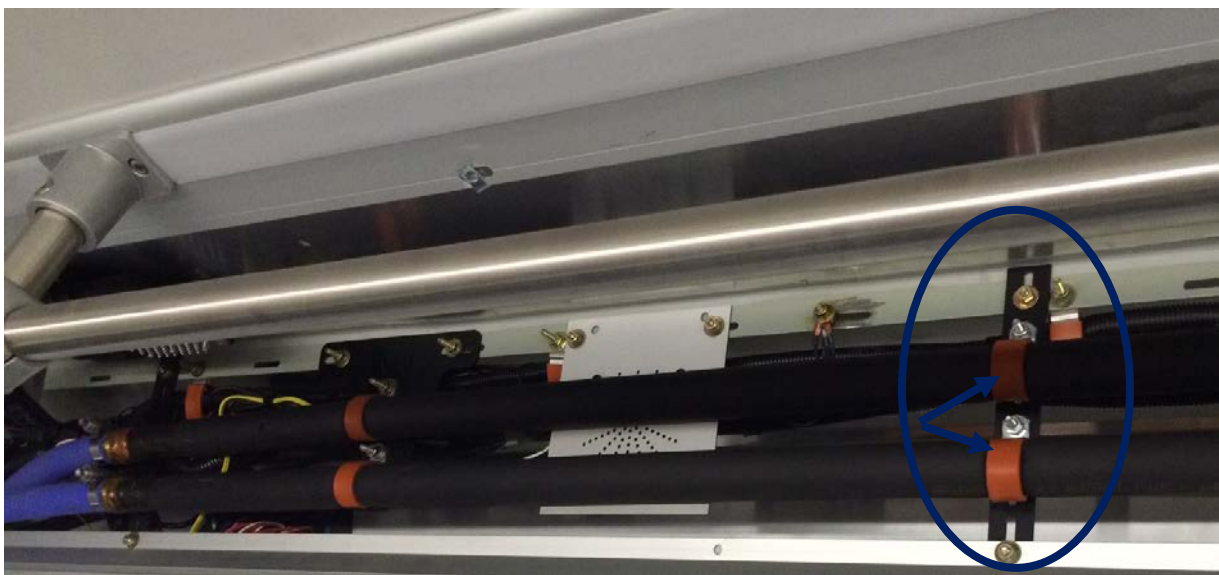
5. Using the existing bracket, add two new p-clamps as shown below (see below).

NOTE: If mounting bracket is not positioned as shown above, it needs to be relocated to this position.

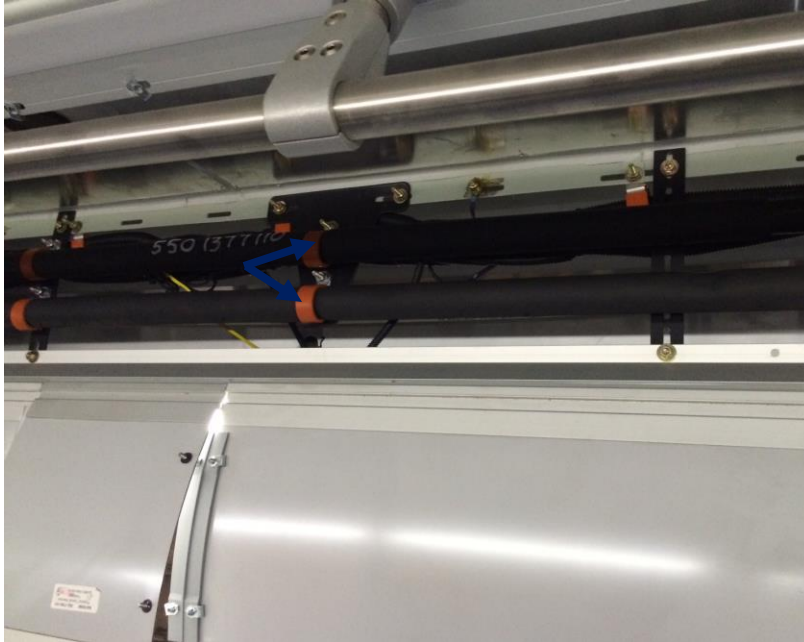
6. Using the same method as used in step 4, replace the two p-clamps as shown below (see below).

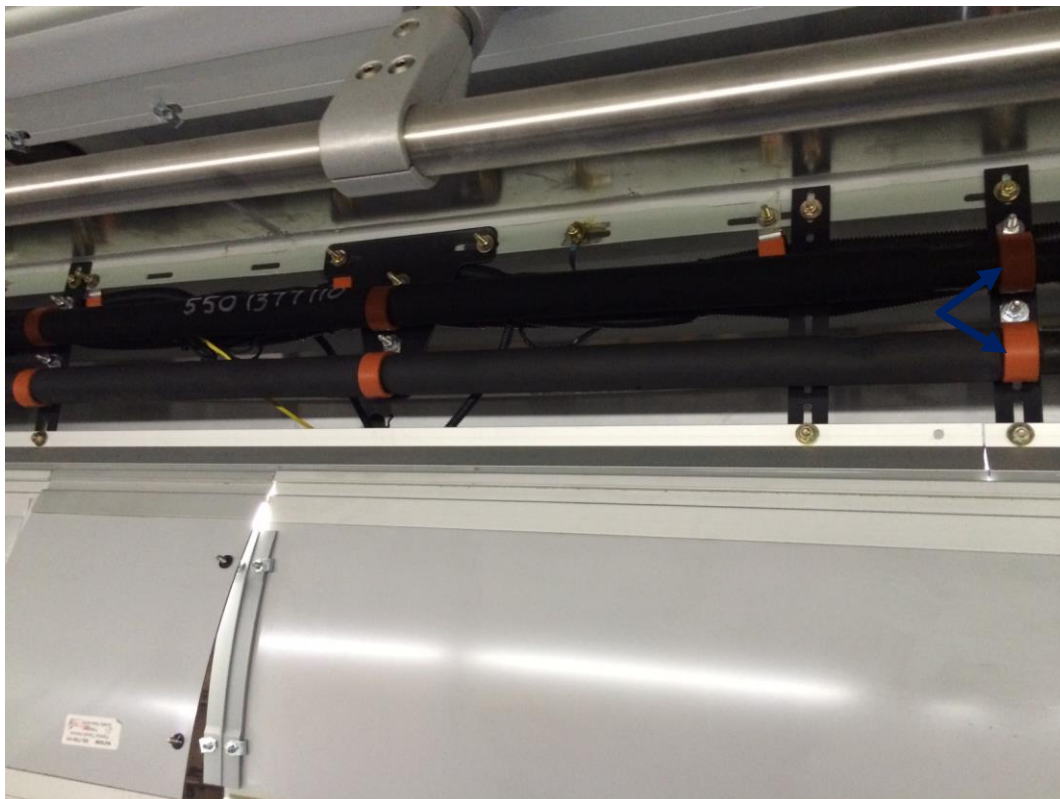
7. Using the existing bracket, add two p-clamps as shown below (see below).

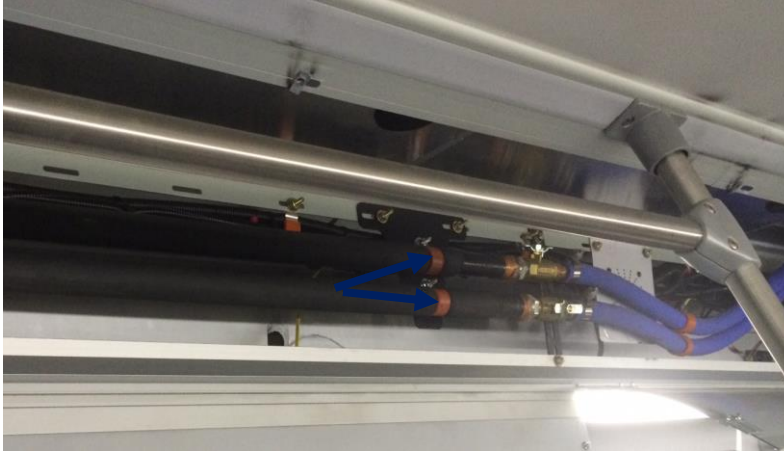
8. Replace the p-clamps as shown below using the same method as step 4 & 6 (see below).

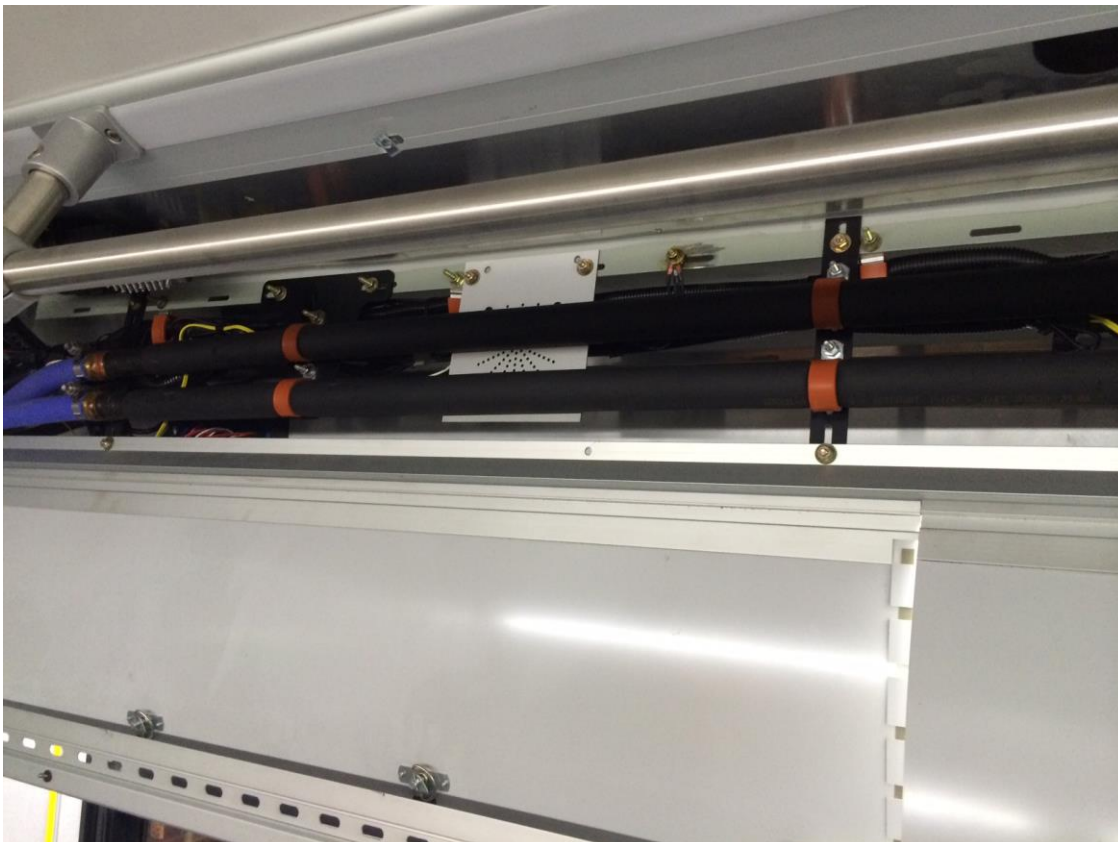
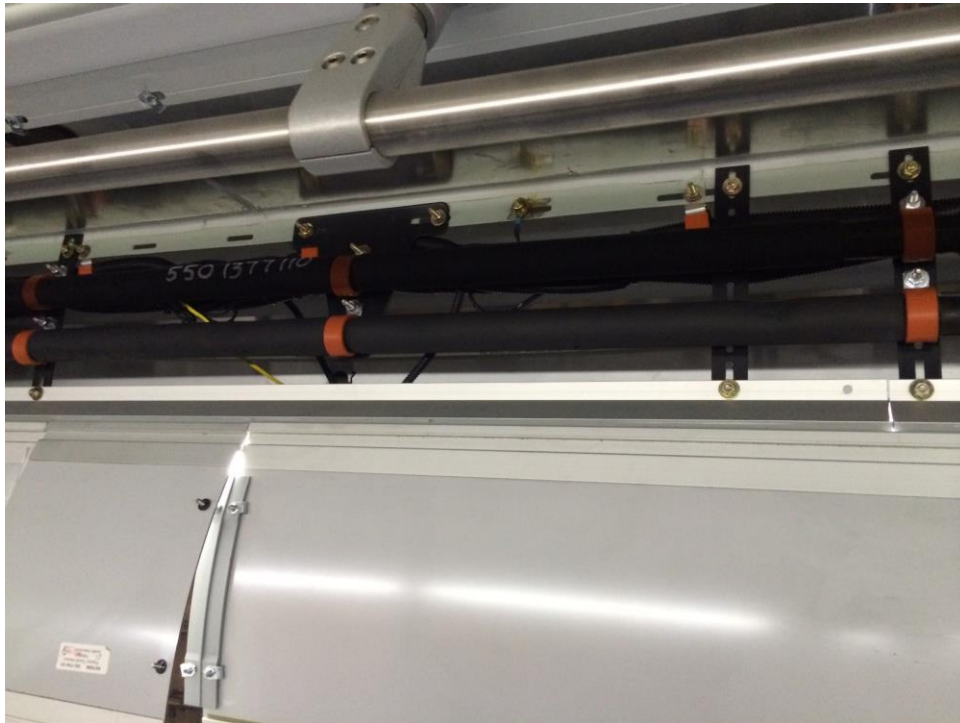
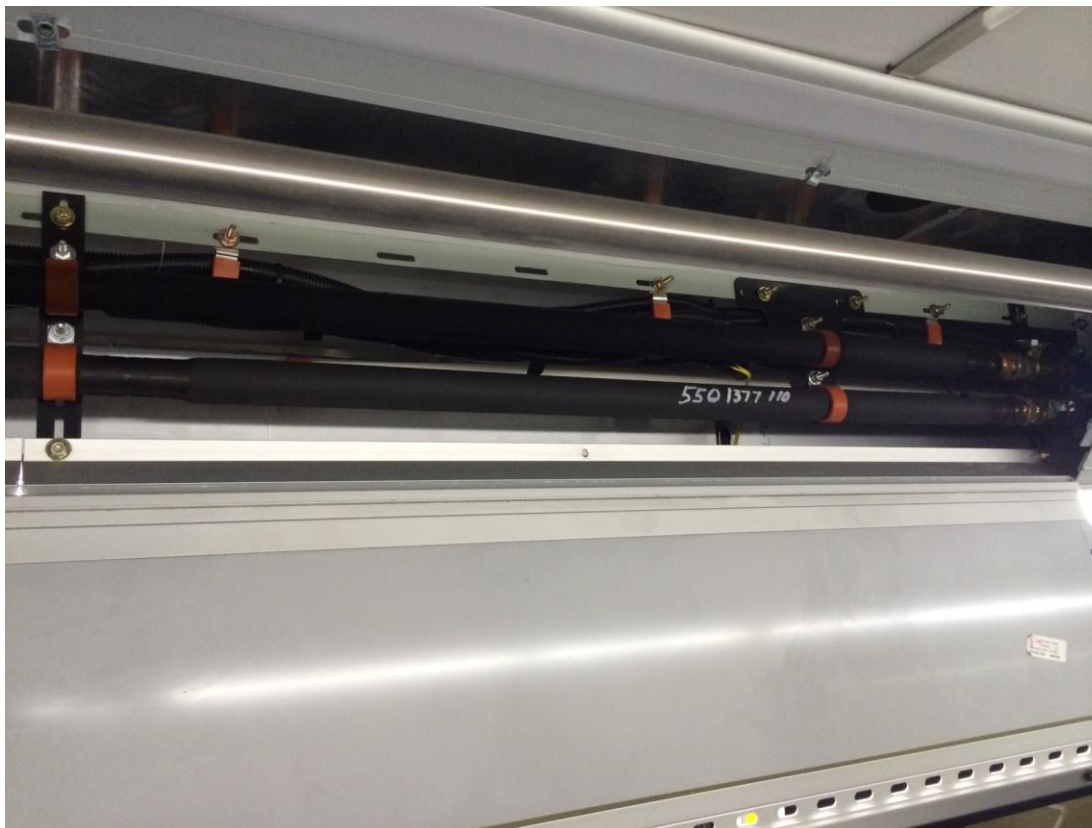
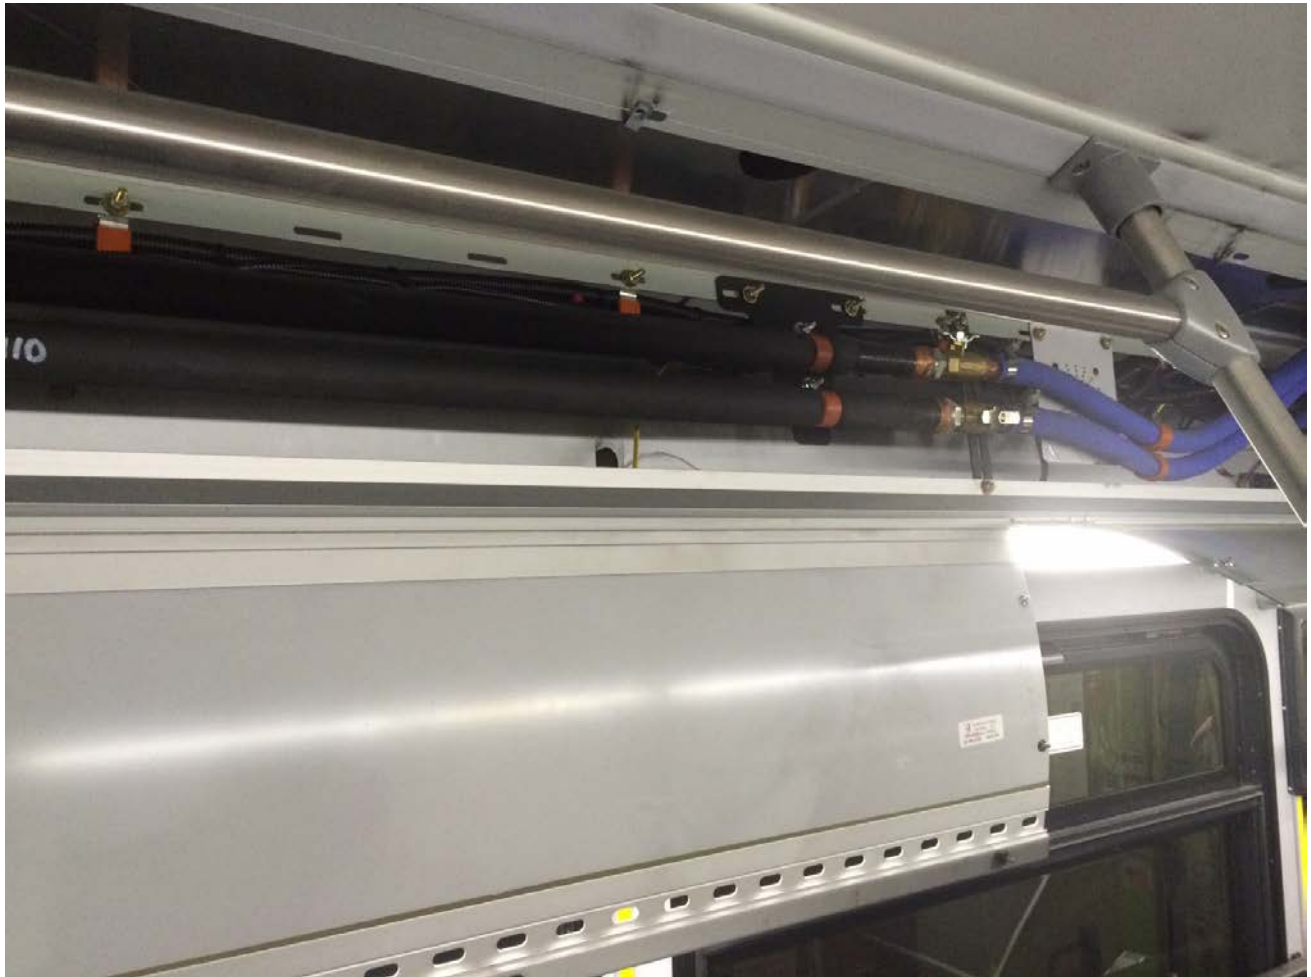
See below pictures for final installation:
