Installation Procedure for Product Link PL420 Retrofit {7606}

On Highway Truck:

CT660 (S/N: TRK1-UP; TKL1-UP; TGT1-UP; TSW1-UP; TSY1-UP)

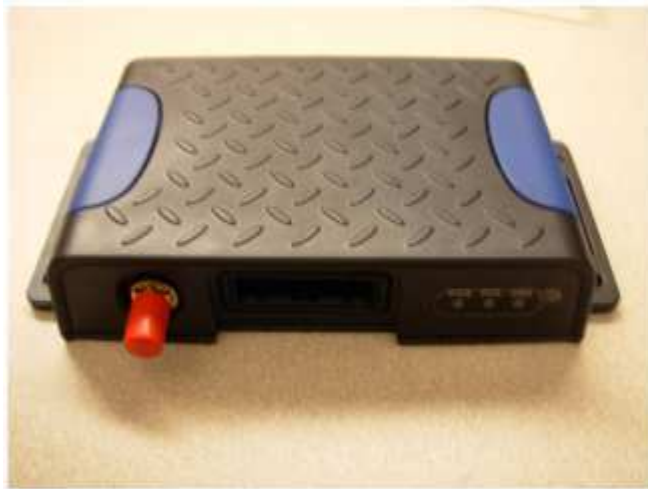
Illustration 1

377-9503 Communication Electronic Control Module (PL420)

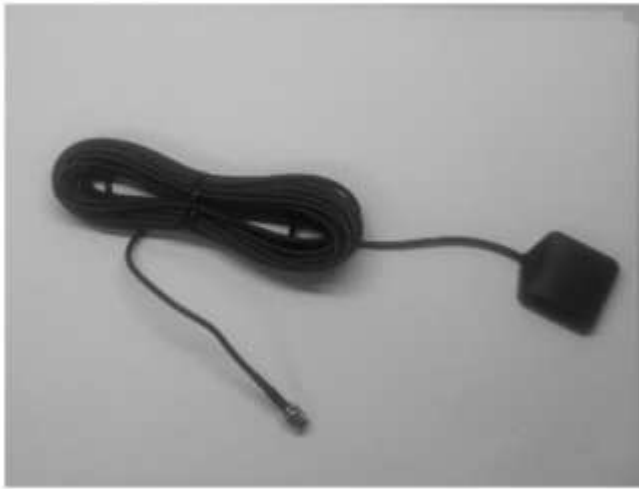
Illustration 2

375-6374 Antenna

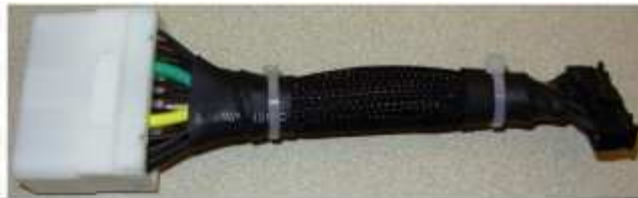
Illustration 3

390-2510 Control Harness As (Voc truck factory install harness (Tyco connector on right))

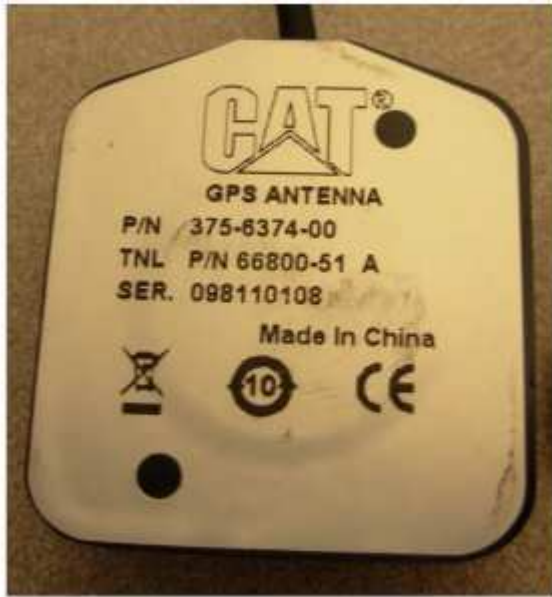
Illustration 4

375-6374 Antenna

Note: The antenna is preassembled with lock washer, nut, 0.5 mm (0.02 inch) coaxial cable and radio connectors. Brackets that are specific for the truck may be available for the application.

- To comply with regulations of FCC for RF human body safety, ensure that antenna is mounted more than 500 mm (19.7 inch) from truck operator.
- Orient the antenna so that the top of the antenna is in a horizontal position with a clear 360 degree view of the sky. In-dash installation is acceptable/recommended depending on placement. For CT660 retrofits, the antenna should be installed under the storage compartment in the non-metallic dash.

- Mount the antenna more than 500 mm (19.7 inch) from the PL420 in order to minimize interference between the radio and the antenna.
- Keep a distance between the PL420 antenna and other antennas that transmit a radio signal. Caterpillar recommends a distance of 1 m (3.3 ft). Keep no less than 500 mm (19.7 inch) between the PL420 antenna and other antennas that transmit a radio signal. The list of radio antennas to maintain a distance from include the citizen band radio, data radio and commercial communication radios.

- Keep in mind the routing of the antenna cable. Do not route the antenna cable near any source of extreme heat (exhaust). Do not mount the antenna or the antenna cable so that the limitations of temperature -40°C (-40.0°F) and 85°C (185.0°F) are exceeded.
- Route the antenna cable so the cable would not be subject to abrasion or pinching.
- Route the antenna cable with a minimum bend radius of 49.5 mm (1.94 inch). Bend radius depends on the type of cable used. Do not bend the radius any less than ten times the diameter of the cable. The cable used is LMR 200UF .

The mounting hole diameter considered is 19 mm (0.75 inch).

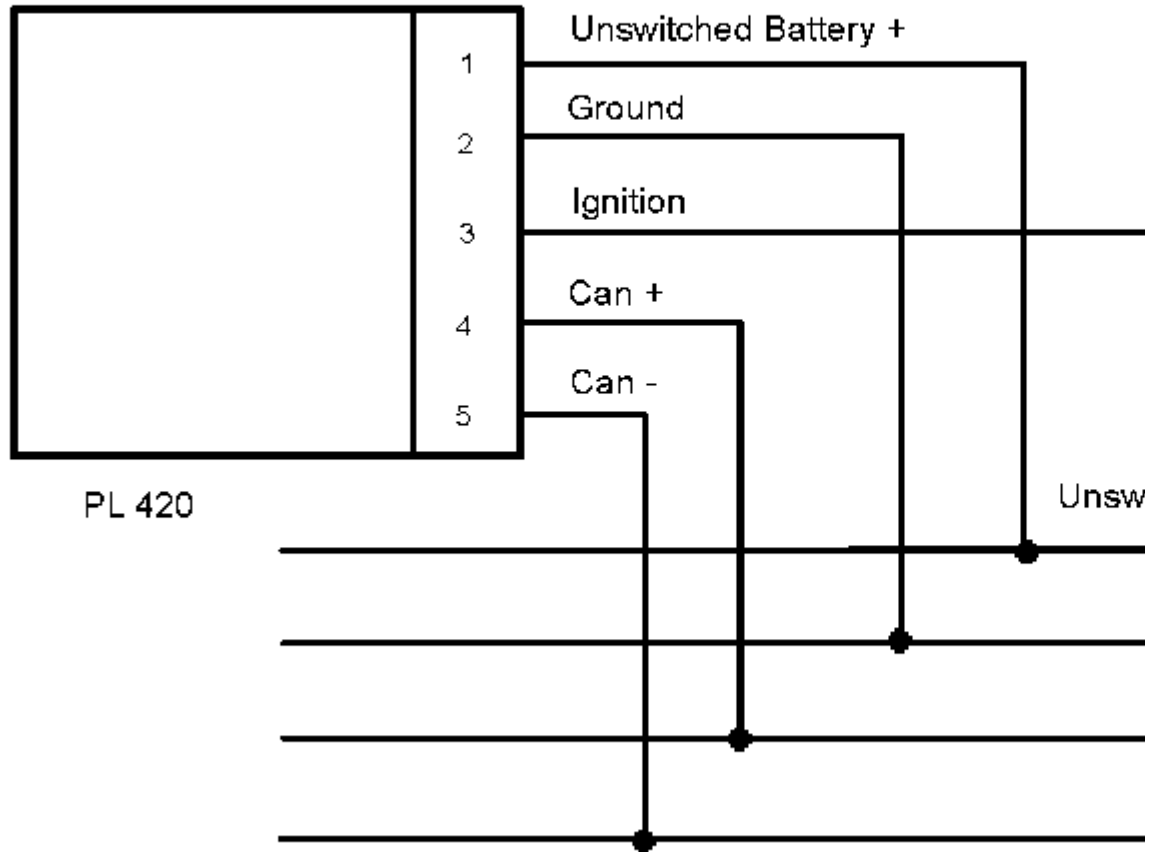
Illustration 5

PL420 Wiring Schematic

Voc Truck Factory Install Harness Wiring Chart		
Voc Truck PL420	Function	Tyco Connector
7	N/A	6
8	N/A	7
9	N/A	8
10	N/A	9
11	N/A	10

12	N/A	11
13	N/A	12
14	N/A	13
16	N/A	14
17	N/A	15
18	N/A	16
19	CAN +	17
20	CAN -	4
21	Ground	5
22	N/A	2
23	Ignition	3
24	BATT +	1

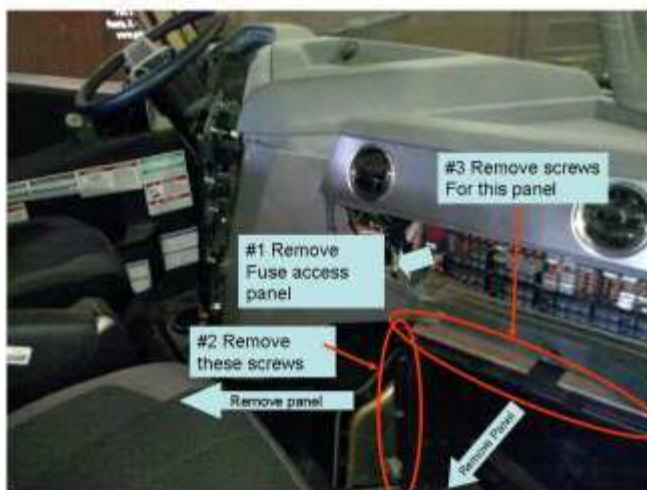
Illustration 7

CT660 dash with panels removed

- (1) Fuse access panel
- (2) Vertical kick panel
- (3) Lower kick panel screws

1. Remove the fuse panel cover (1). Remove the panel, when sitting in the passenger seat and with your hand at the top of the cover panel, by pulling toward the passenger seat.

2. Remove the vertical kick panel (2) exposed by removing the fuse panel cover. There are 4 Torx head screws along the edge closest to the firewall. After removing the screws, remove the panel by pulling from between the seats.
3. Remove the lower front kick panel under the fuse panel by first removing 4 Torx screws (3) at the top of the panel. These screws are accessible after the fuse panel cover is removed. After removing the screws, gently work the blind latches loose and remove the panel.

Note: Too much twisting can break the blind latch post on the panel.

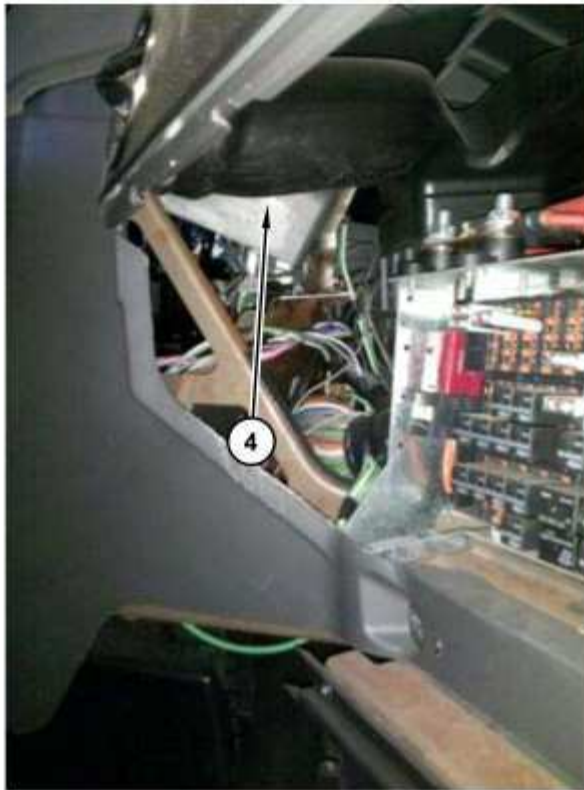
Illustration 8

CT660 dash with panels removed

(4) Clean area where GPS antenna is to be mounted

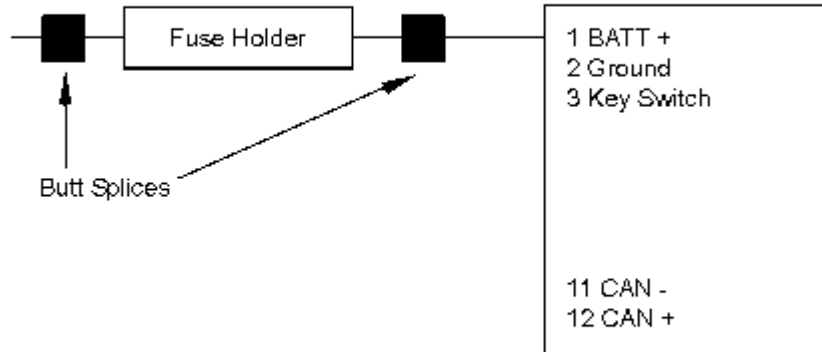
Illustration 12

2. After verifying the harness connector wiring, install the fuse holder in the Red wire to Pin 1 of the connector. Install a 1 Amp fuse into the fuse holder.
3. Route the fuse holder next to the PL420 pigtail. Use a plastic zip tie to secure the fuse holder to the pigtail for easy serviceability.
4. Verify that the PL420 internal battery is connected. Remove the back cover and inspect the battery connector. Insure that the battery is installed. Replace the cover and continue with the installation.

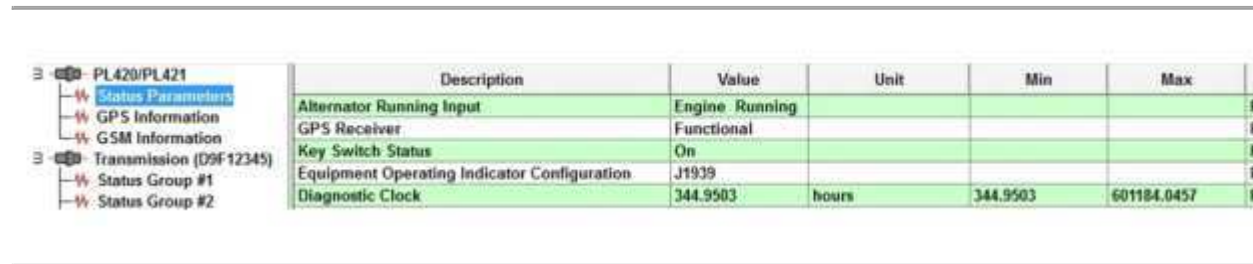
Illustration 18

Description	Value	Unit	Min	Max
Alternator Running Input	Engine Running			
GPS Receiver	Functional			
Key Switch Status	On			
Equipment Operating Indicator Configuration	J1939			
Diagnostic Clock	344.9503	hours	344.9503	601184.0457

- Record screen shots of the ECM summary and all three Status Screens. Paste screen shots into Word file. Record VIN # in the same Word file. Refer to Illustration 15 through Illustration 18.

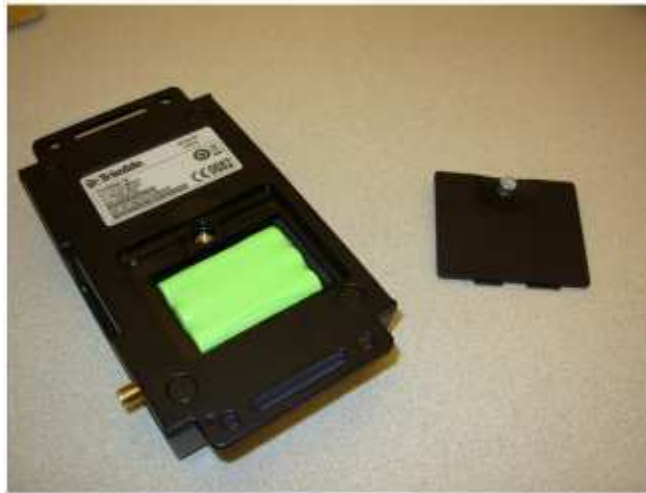
Illustration 19

4. Remove SIM card access cover and set aside.

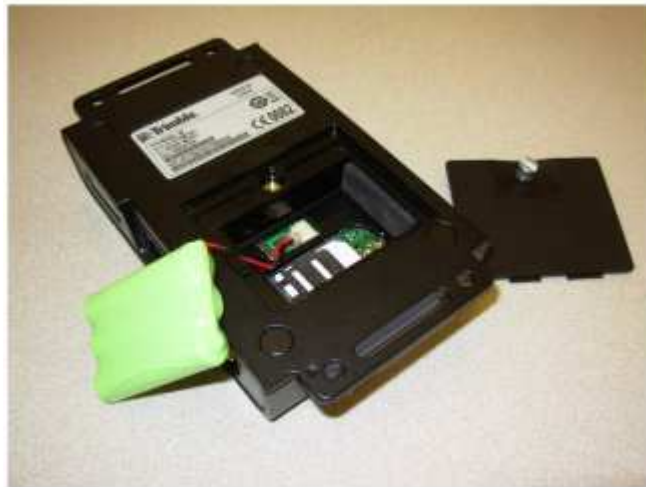
Illustration 20

5. Carefully remove the battery from the compartment.

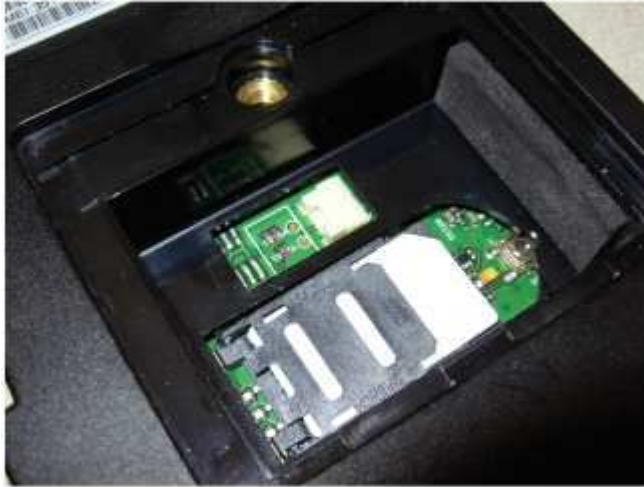
Illustration 21

- Carefully slide SIM card retainer in the direction of the arrow to unlock the clip.

Very little force is required to unlock the SIM card retainer. Do not use sharp tools.

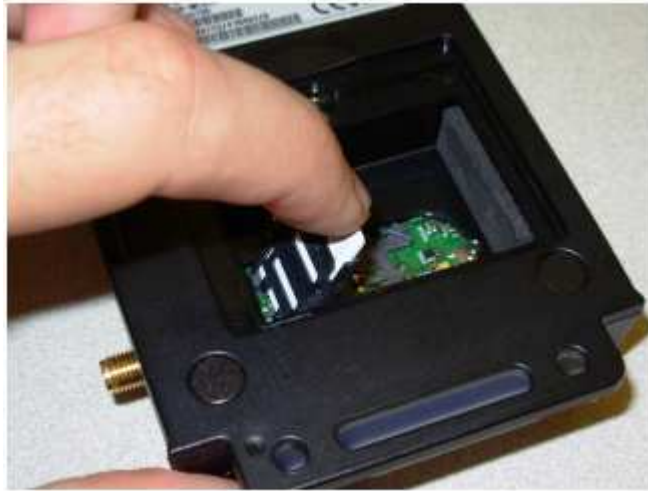
Illustration 22

7. Carefully pull the SIM card and retainer perpendicular to the contacts.

Note: The SIM card contacts will push the card and retainer up to facilitate grasping of the card and retainer.

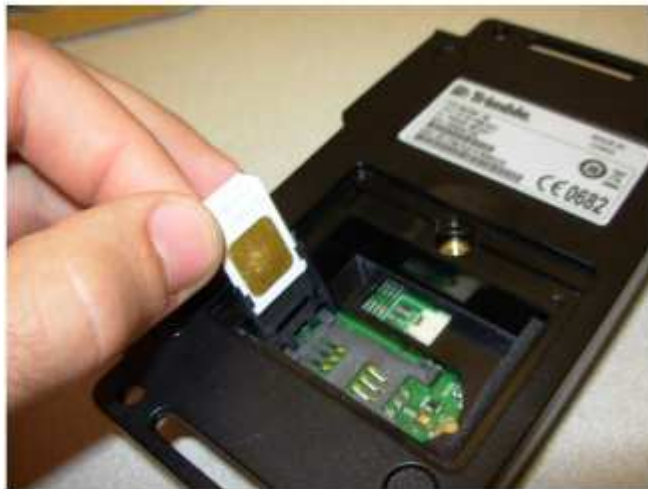
Illustration 23

8. Grasp the SIM card with your thumb and forefinger and pull the SIM card from the retainer.
