# BBCV Ford Transmission Inspect Harness Routing – Oil Cooler Hose Connection

Models Affected: 2013-2015 BBCV Visions with Ford Propane Engines

**SB-10055247-7795**

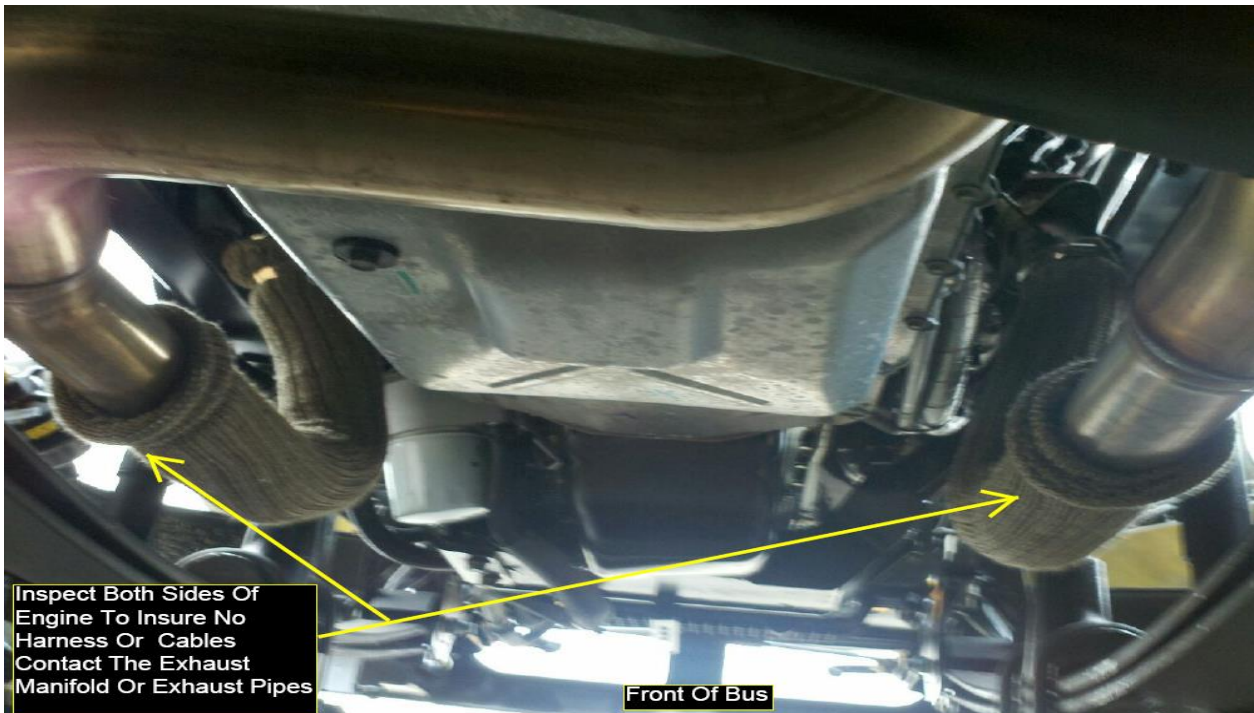
1. Park bus on level surface, apply parking brake, turn off ignition and remove key.
2. Chock wheels
3. Caution, engine, transmission, and exhaust manifold **MUST be at ambient** temperature before proceeding.
4. Inspect transmission harness routing to insure no contact with exhaust manifold or exhaust pipes. Note: Check both sides of engine. See photos and illustration of correct harness routing.
5. If required, reroute and secure harness as shown to prevent contact with engine exhaust manifold or exhaust pipes.

Inspect and, if required, relocate and secure transmission harness. Check for proper connection and installation of transmission oil cooler hoses to transmission cooler and transmission tube assembly.

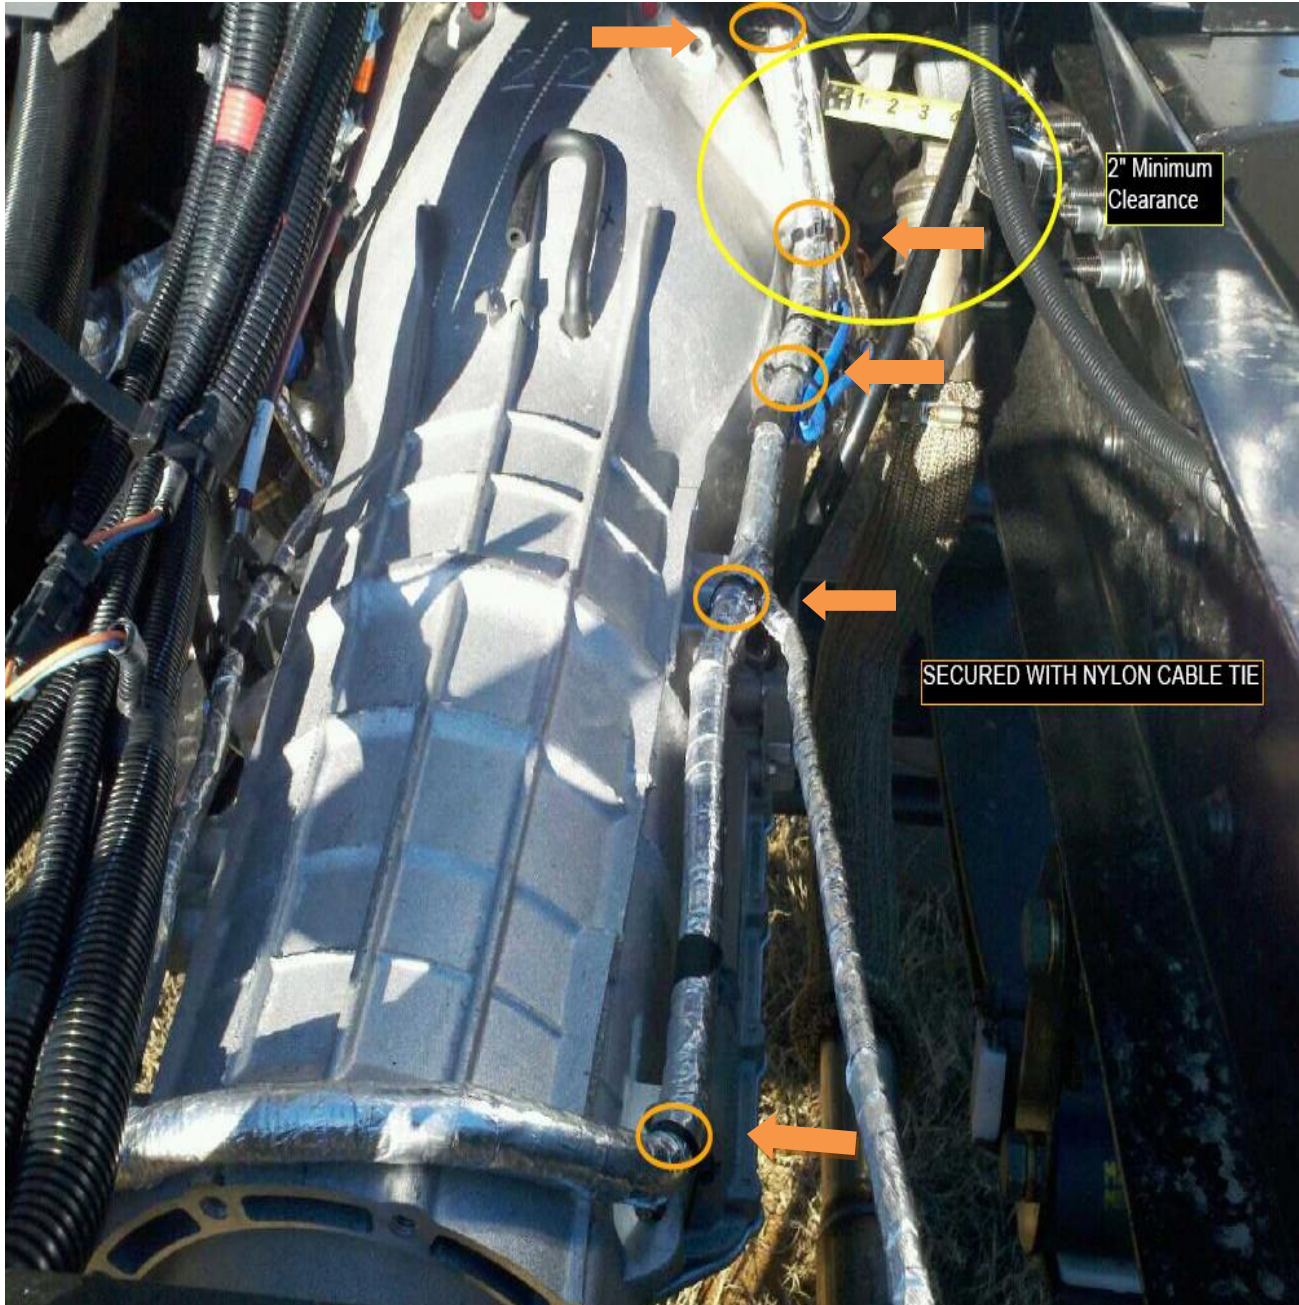
Note: Insure harness is routed and secured to maintain a minimum 2" clearance away from exhaust. See circled areas of photo below.

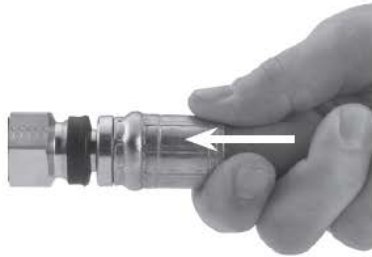
**Correct Method**

Align the STC fitting on the hose assembly with the STC connector. Push the hose fitting into the mating connector until you feel a definite snap and a solid stop.

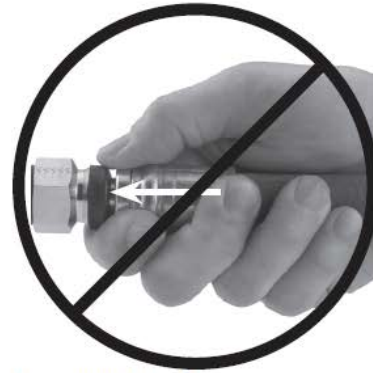
**Incorrect Method**

Do not hold sleeve during assembly

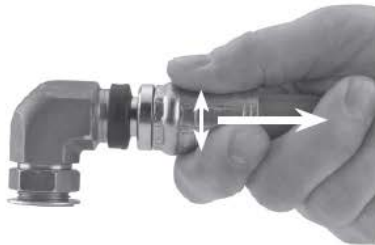
**Correct Method**

Verify that the STC connection has been made successfully by pulling on the connection to make sure that the male connector has been properly inserted into female connector. Be sure that the direction of pull is parallel to the axis of the STC connection.

Pulling parallel to the connections axis

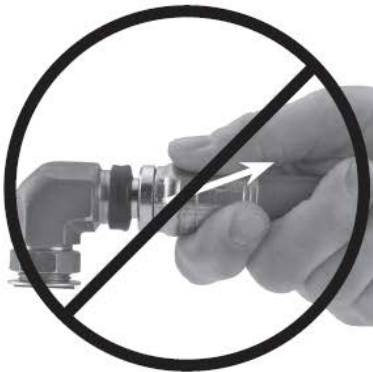
**Incorrect Method**

Pulling at an angle to connections axis

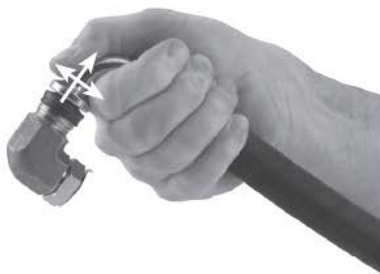
**Correct Method**

Pulling on the fitting such that the motion is parallel to the connections axis.

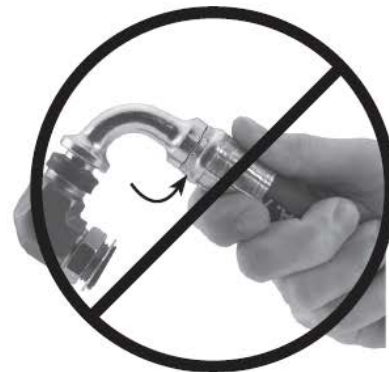
**Incorrect Method**

Subjecting the connection to a sideload by pulling on the hose.
