# SB-10055295-5974

Airbox Drainpipe Repair Kit  
Models: M.Y. '12-'13-'14 1199 and M.Y. '14 899 Panigale Panigale (all model versions)  
Service Bulletin SVC-14-010

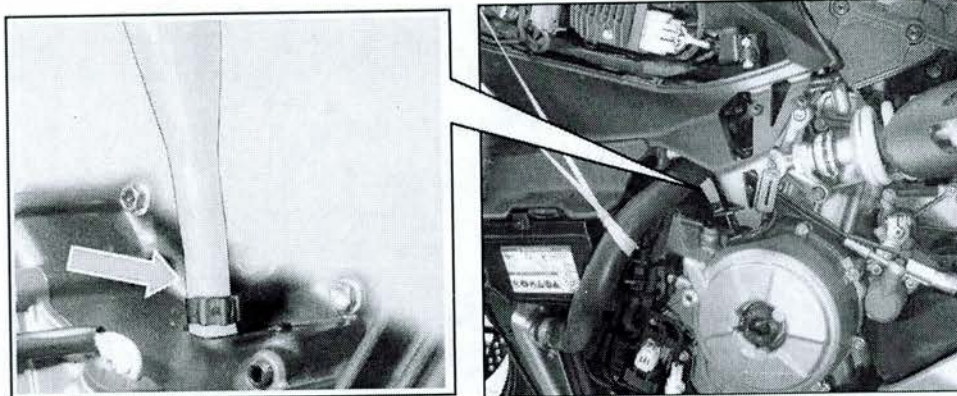
Regarding the above models, Ducati have received some isolated reports of minor oil leaks from the airbox bottom rubber drain tube near the clamp securing the tube to the union fitted on the crankcase. The leak is caused by damage to the tube.

For this reason, a repair kit has been created, part no.69927171A. This allows for repair of the leak without removing the airbox from the vehicle, making it no longer necessary to replace the airbox bottom for the repair operation.

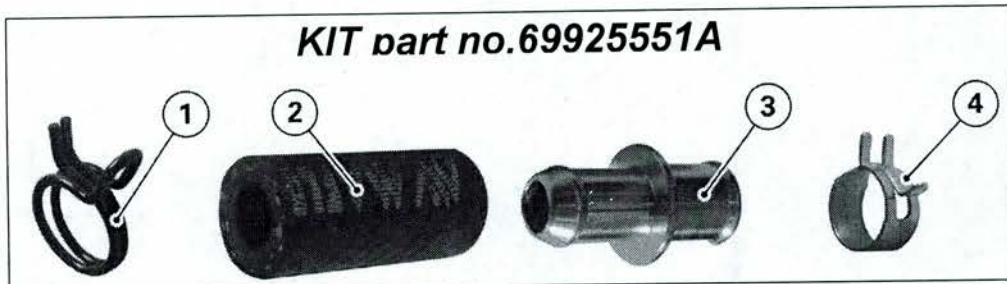
The airbox drain tube repair kit no. 69927171A is made of: a **spring clamp (1)**, a **cloth coated rubber pipe (2)**, a **male-male union (3)** and a **flat spring clamp (4)**.
