**SB-10055490-3492**

**SERVICE BULLETIN**

**2008 – 2014 ROGUE; MAIN HARNESS TO BODY HARNESS  
ELECTRICAL CONNECTOR CORROSION**

**APPLIED VEHICLES:** 2008 – 2013 Rogue (S35)  
2014 Rogue Select (S35)

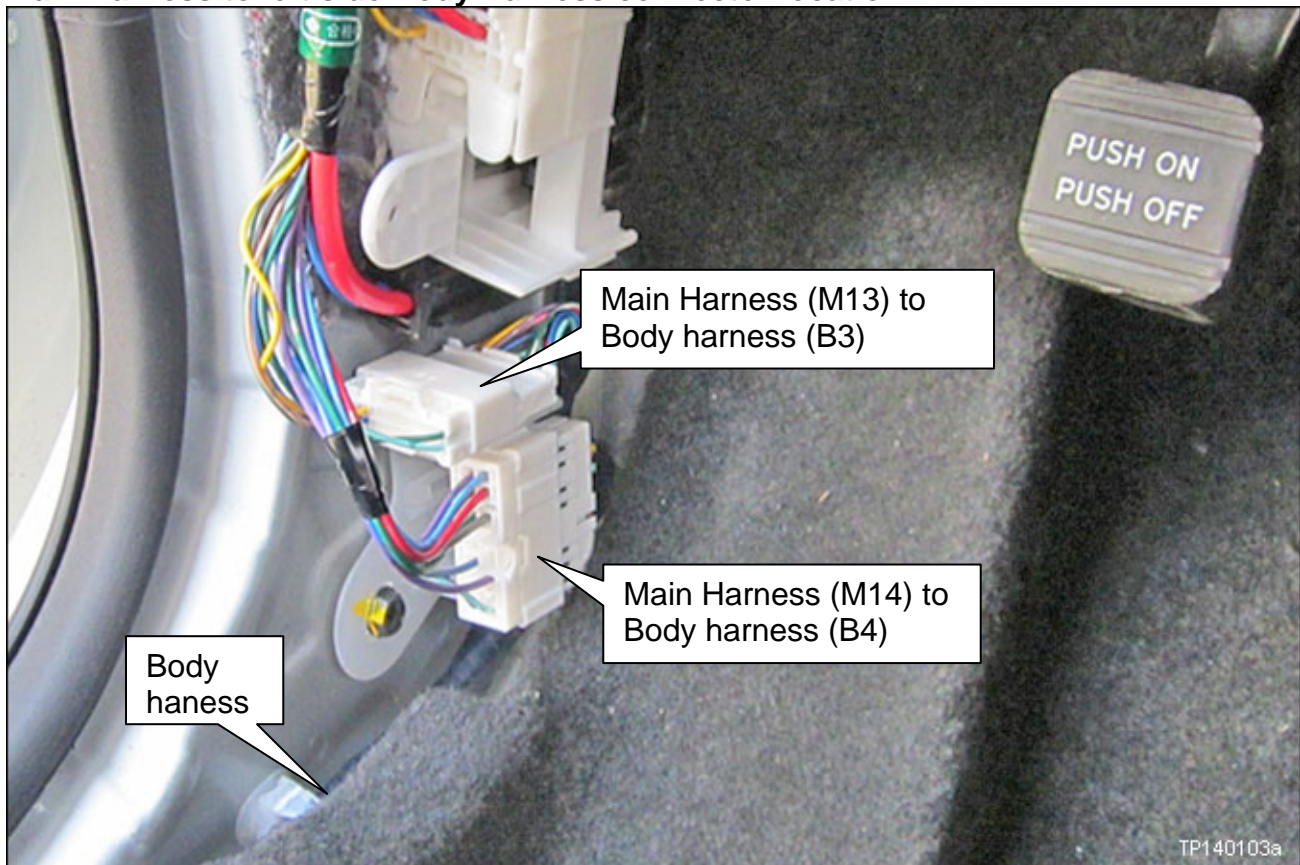
An electrical issue caused by corrosion in the Main Harness to Body Harness connectors located at the bottom of the driver side A-pillar.

- Connector numbers M13 to B3 and/or M14 to B4.

## Main Harness to left side Body Harness connector location

- Examples of electrical issues that may occur are; power seat inoperative, power windows inoperative, radio inoperative, horn sounds on its own, etc.
- See Figure 1 on page 2 for connector location.

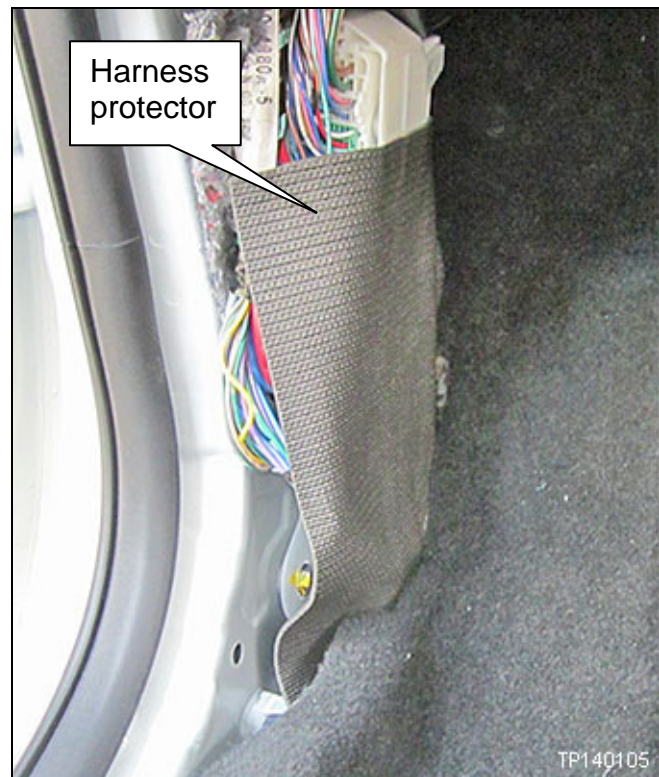
- During harness repair, cover connectors M13/B3 and M14/B4 with harness protector as shown.
- Harness protector is listed in the Parts Information.
- Two protectors come in the package, only one is needed.

1. Inspect connectors M13, M14, B3, and B4.
2. Perform repair to the connectors as needed.
  - Use harness repair kit J-48817 as needed to perform repairs.  
**NOTE:** For instructions on using harness repair kit J-48817, refer to **ASIST >> Tech-Mate >> Tech-Mate Tools & Equipment >> Harness Repair Kit User Guide.**
  - If necessary, replace the Main Harness and/or Body Harness:  
**NOTE:** If needed, refer to the Electronic Service Manual (ESM) for harness replacement information.
  - During harness repair, cover connectors M13/B3 and M14/B4 with harness protector (see Figure 2 on the next page).
