Airbox Drainpipe Repair Kit  
 Models: M.Y. '12-'13-'14 1199 and M.Y. '14 899 Panigale Panigale (all model versions)  
 Service Bulletin SVC-14-010

Date: April 1, 2014  
 To: Dealer Principal, General Manager, Service Manager, and Service Technician  
 From: Austin Gray, Technical Director; Jonathan LaForte, Technical Manager

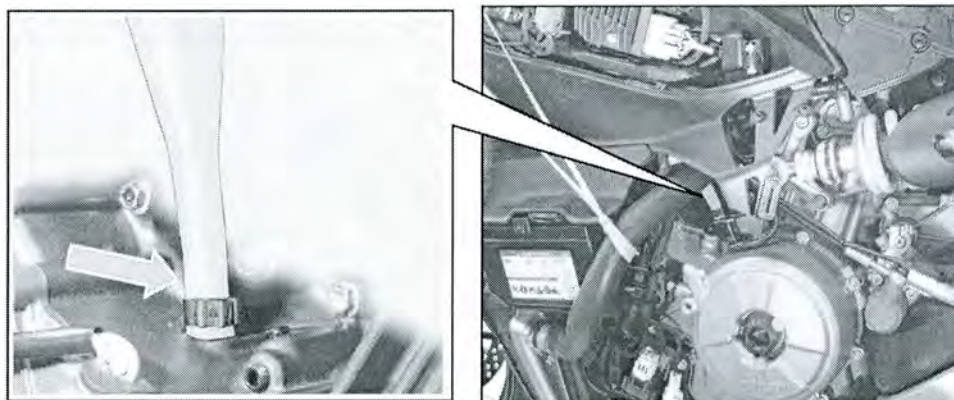
Regarding the above models, Ducati have received some isolated reports of minor oil leaks from the airbox bottom rubber drain tube near the clamp securing the tube to the union fitted on the crankcase. The leak is caused by damage to the tube.

For this reason, a repair kit has been created, part no.69927171A. This allows for repair of the leak without removing the airbox from the vehicle, making it no longer necessary to replace the airbox bottom for the repair operation.

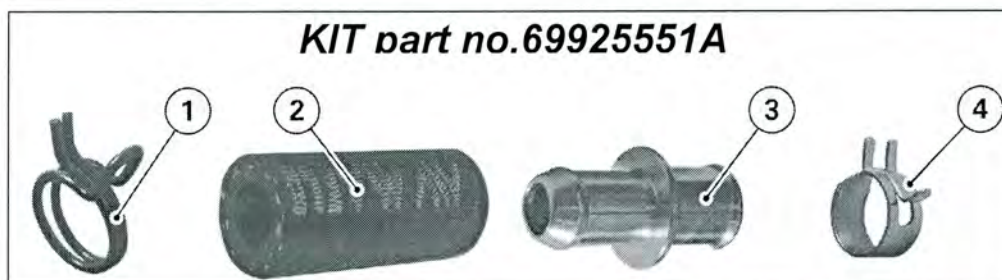
The airbox drain tube repair kit no. 69927171A is made of: a **spring clamp (1)**, a **cloth coated rubber pipe (2)**, a **male-male union (3)** and a **flat spring clamp (4)**.
