## Gateway – Furnace air flow and overheating

5SFSG4120DE264319 THRU 5SFSG4128EE278180  
2013 and 2014 Gateway 3650BH

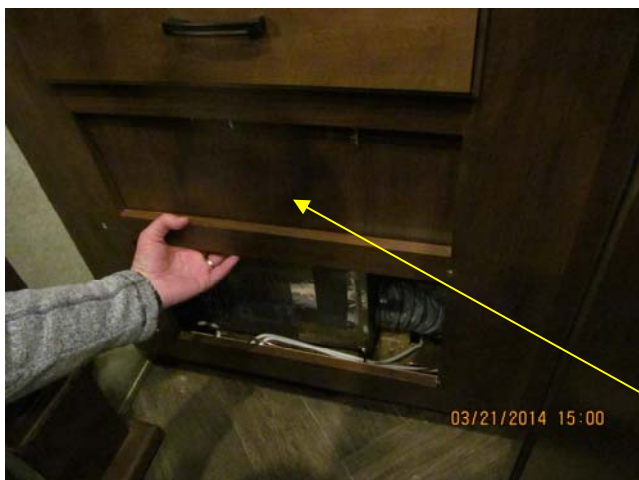
Remove the block off panel.

- 1) Remove current air grill and block off panel directly above furnace grill.

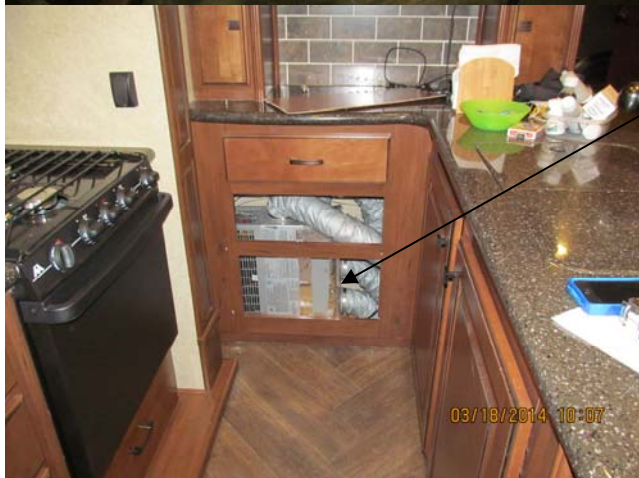
Remove fresh air grill

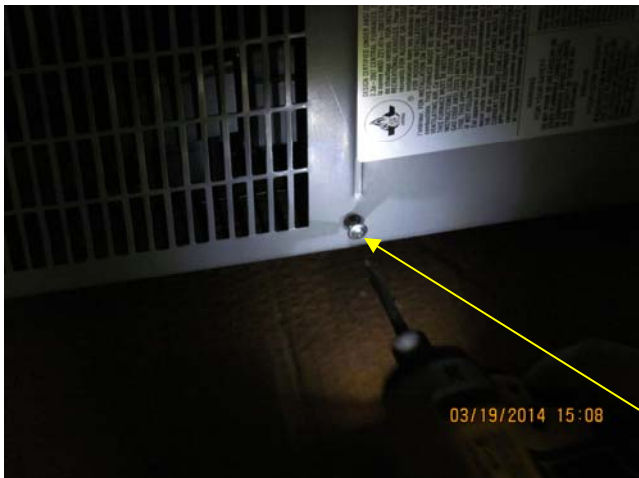
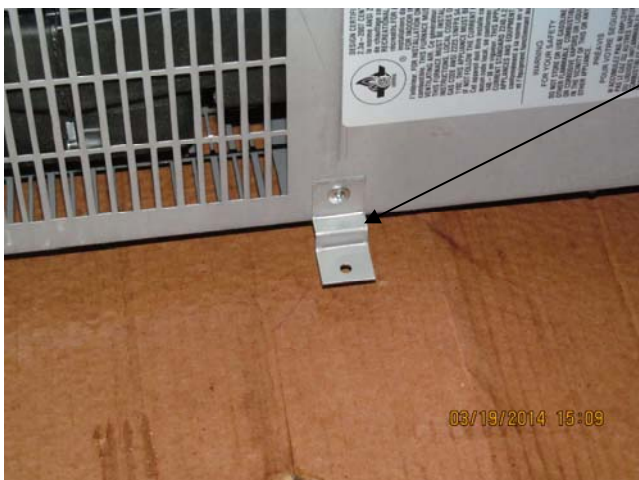
Support leg – should be on bottom, if no leg is present remove screw and attach L-bracket to prevent furnace movement.

2) Check furnace and confirm that support leg is in place.

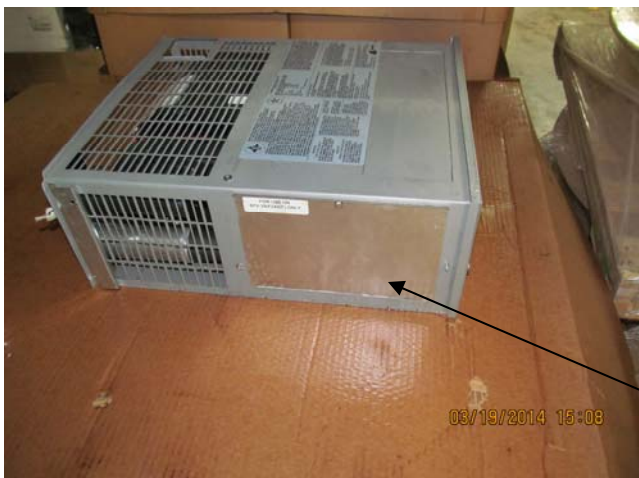
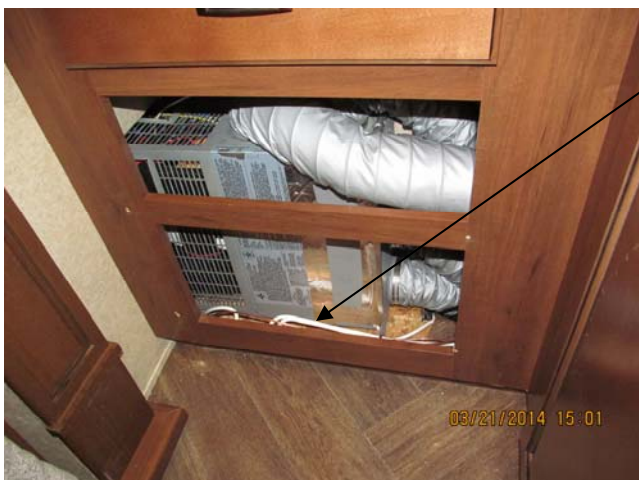
Block off panel on  
bottom of furnace.

Feel in this location to  
confirm panel is in  
place.

- 3) Check furnace and confirm that bottom discharge block off plate is installed. You can feel bottom of the furnace to check the location/installation of block off panel.

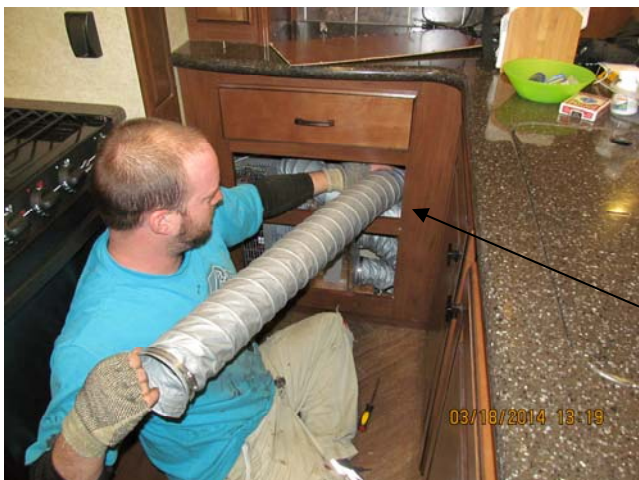
Starting at the furnace, disconnect each duct and pull all excess through floor, cut and reinstall on furnace.

- 4) Check ducting at each register (bunk room, @ kitchen base, bath, front bedroom) to see if there is excessive length-pull as tight as possible and re-connect.

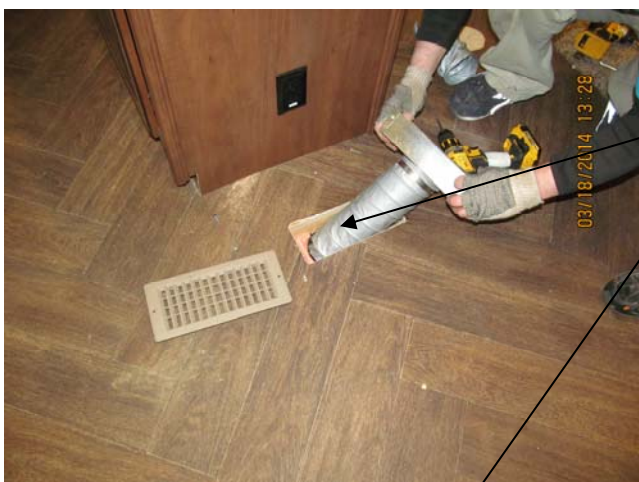
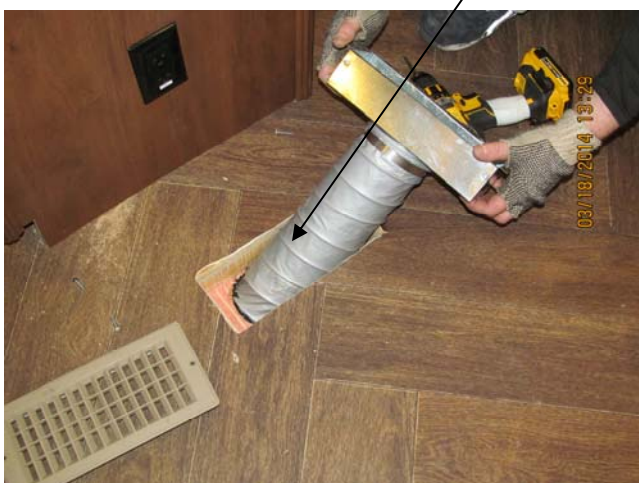
Starting in the bunk room pull floor register and pull all excess duct up through floor, cut off excess and reinstall floor register.

Repeat this process for each floor register (kitchen, upper bath and bedroom)  
NOTE: you may have to open access panel in pass through compartment to pull all access duct for upper deck.

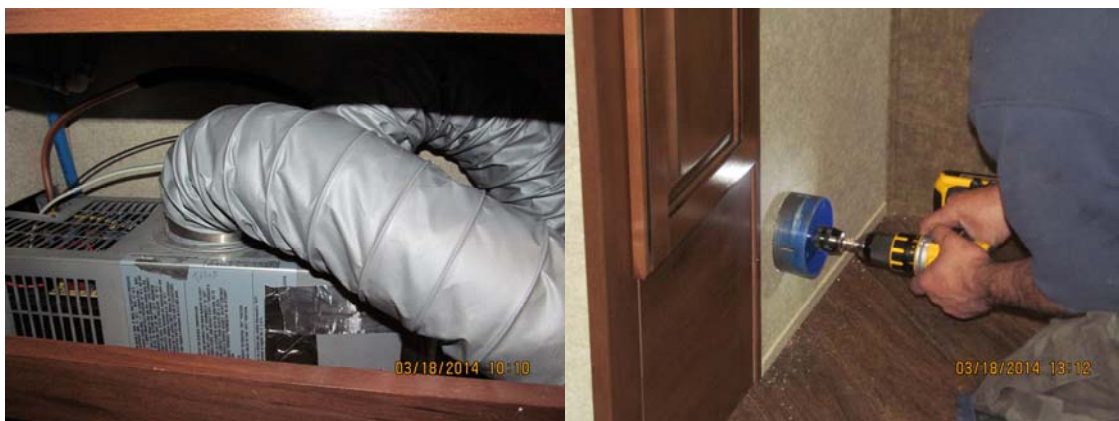
- Add duct to top of furnace.
- Cut opening for register in wall

- 5) Add a fifth duct (remove knockout on top of furnace and run flex duct to rear under pantry & lavatory in half bath out to living room toward dinette).

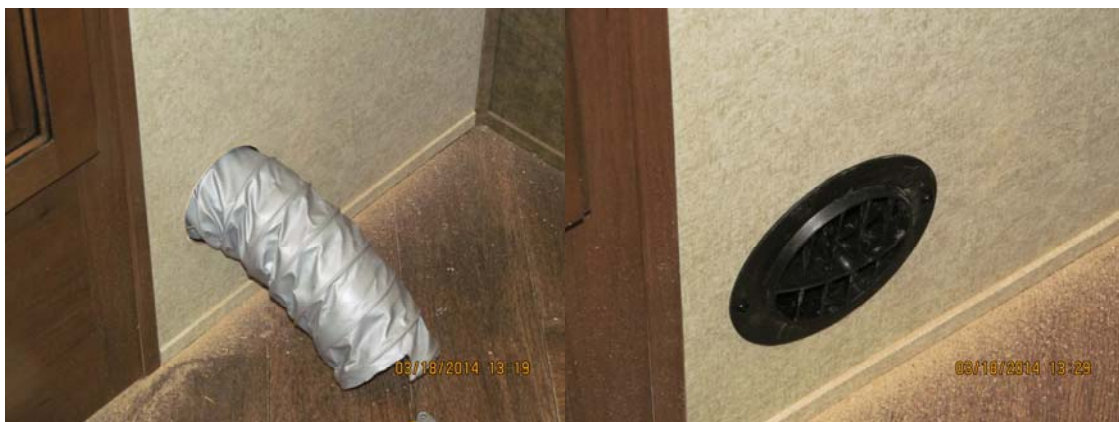
- Run duct from furnace through wall under the bath lavatory and through wall into living room.
- Install register.

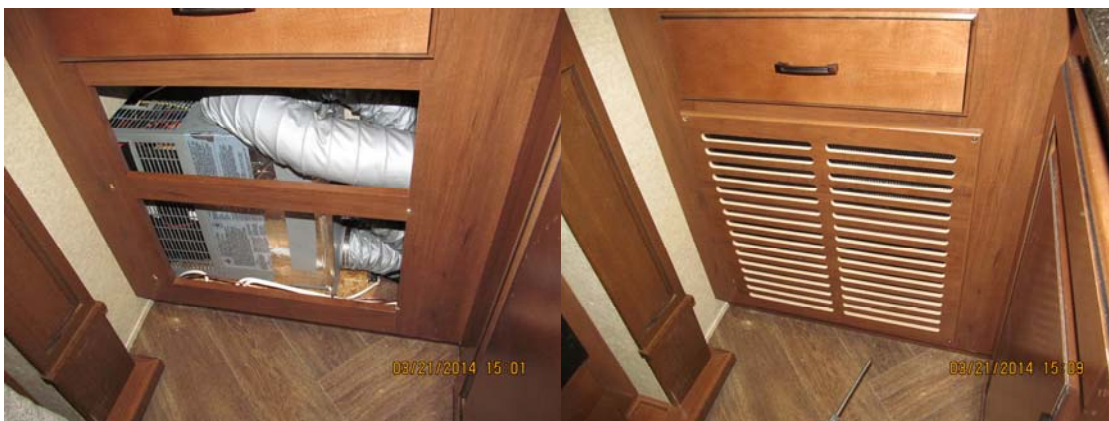
- 6) Remove panel above current return air door and replace with 22 x 22 grill (add expanded metal to back of grill) install over old area and openings below kitchen drawer.

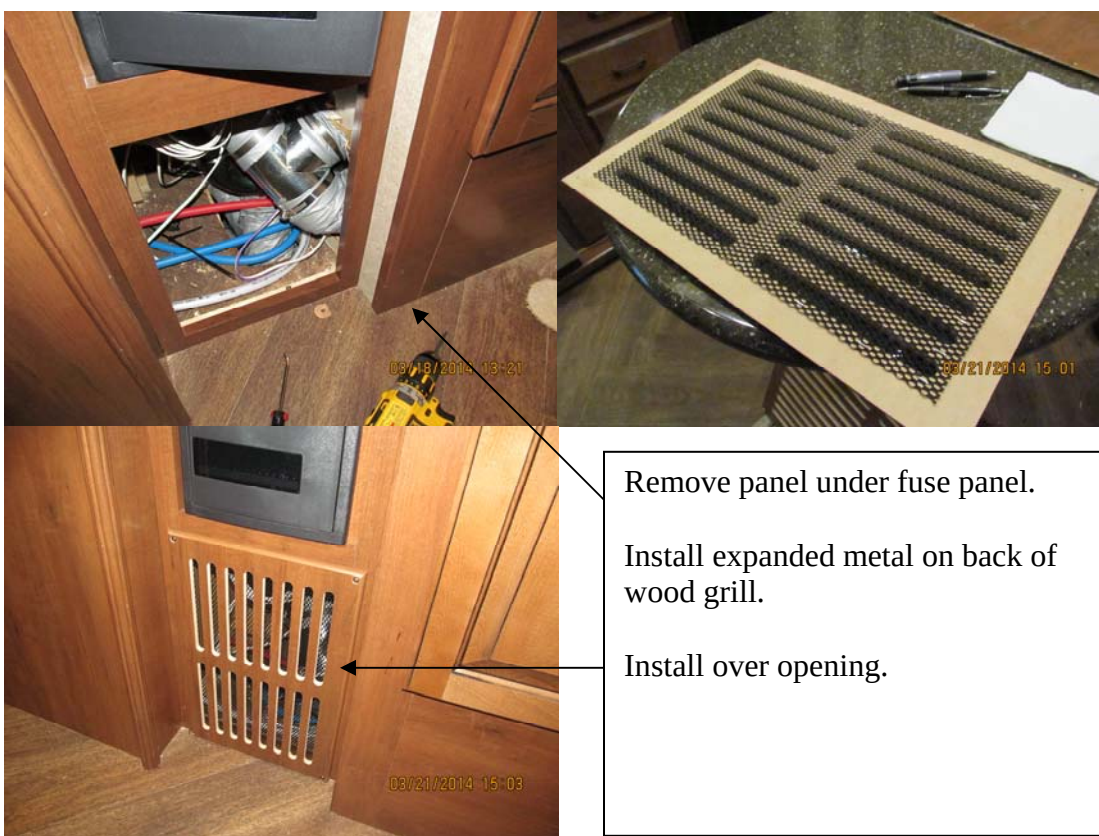
- 7) Remove panel below panel box and replace with 12 x 18 grill (add expanded metal to back of grill, and install grill over opening.
